CIVIL AVIATION AUTHORITY OF THE PHILIPPINES
Aircraft Accident Investigation and Inquiry Board
Aircraft Accident Report

Aircraft Registration No. : RP-C3190

Aircraft Type/Model : A319-111

Type of Occurrence : Runway Overshot

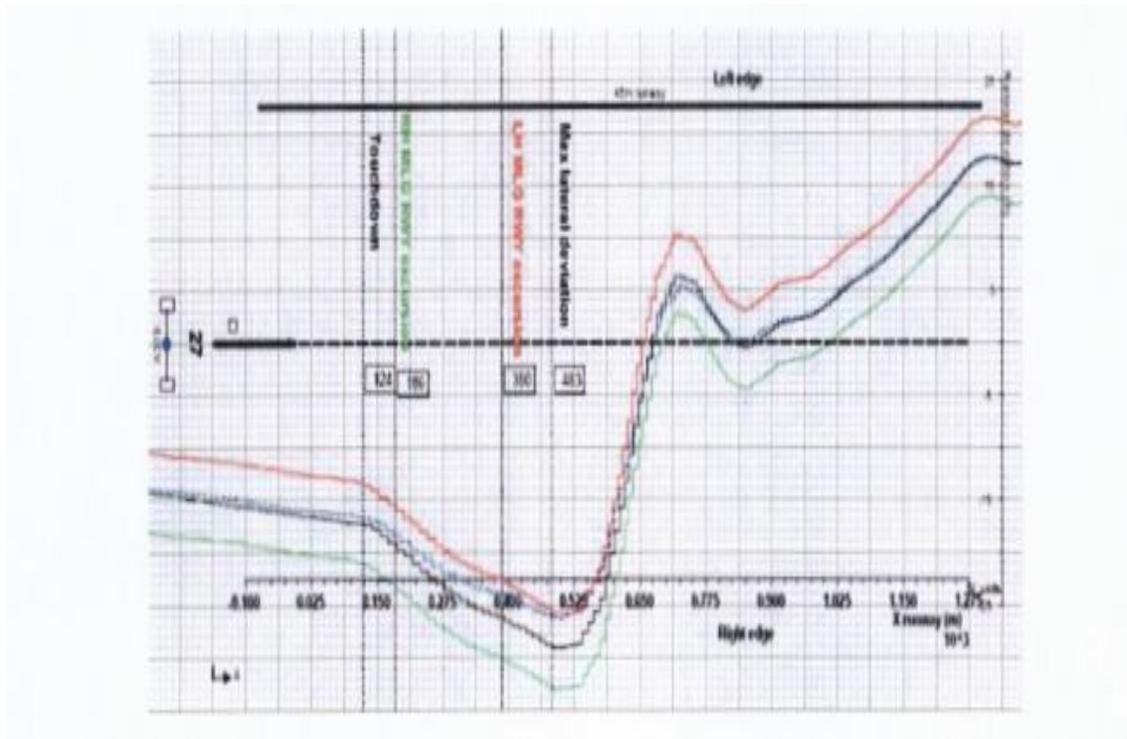
aircraft was clearly seen as it made its final approach and that the aircraft was not aligned with the runway center line having a deviation angle of two (2) degrees causing it to miss the right pave portion of the runway after the PIC pulled back the aircraft at the center of the runway before finally making a full stop.

Aircraft Trajectory and Lateral Deviation: The touchdown of the main landing gear went out the edge of the runway. The RH MLG exited the paved surface approximately 400 meters after touch down.

The pilot failed to maintain adequate alignment until the touchdown with low visibility.

- CAAP-FSIS shall ensure that PIC Training in Airbus 319/320 adequately contains event proficiency on low visibility non-precision approach skills/techniques including decision-making for a GO-AROUND.
- CAAP-FSIS and the Philippine Air Carriers operating A319/320 shall ensure that Pilot Training give emphasis specifically on approach/landing during low visibility by non-precision conditions for accident prevention.
