Republic of the Philippines
DEPARTMENT OF TRANSPORTATION
CIVIL AVIATION AUTHORITY OF THE PHILIPPINES
MIA Road, Pasay City 1300

(PRELIMINARY REPORT)

Aircraft Registration No. : RP-C3567
Aircraft Type/Model : Cessna 172S
Operator : Alpha Aviation Group (Philippines), Inc.
Address of Operator : 1092 Jose Abad Santos Ave. Clark Freeport Zone
Pampanga 2023
Place of Incident : Brgy. Comillas, La Paz, Tarlac
Date/Time of Incident : June 11, 2019/ 0945H
Type of Operation : Flight Training
Phase of Flight : Approach
Type of Occurrence : Forced Landing

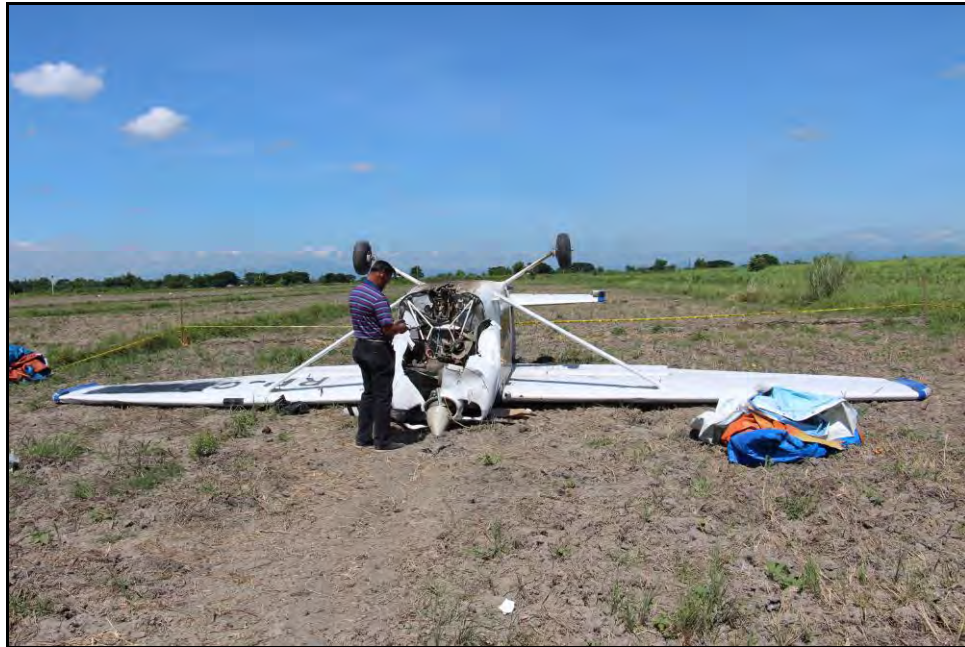
Figure 1: RP-C3567 on its final resting point

Upon touchdown, the aircraft rolled for approximately 60 meters in uneven surface and subsequently nose down. The aircraft came to rest in an upside-down position with last heading of 70 degrees and grid coordinates of 5 24.461 N, 120 41.550 E. The nosewheel separated from the fuselage while the engine bay including mounting and attachments sustained substantial damage.
