FINAL REPORT

RP-C8229
COSTRUZIONI AERONAUTICHE TECNAM S.P.A.,
TECNAM P2006T

DATE OF OCCURRENCE: MAY 12, 2023

TITLE: Incident involving a Costruzioni Aeronautiche Tecnam P2006T type of aircraft with Registry Number RP-C8229 owned and operated by First Aviation Academy, Inc. that had a gear up landing incident at Subic Bay International Airport (RPLB), Subic Bay Freeport Zone, Zambales, Philippines, on May 12, 2023 at about 0844H/0044 UTC.

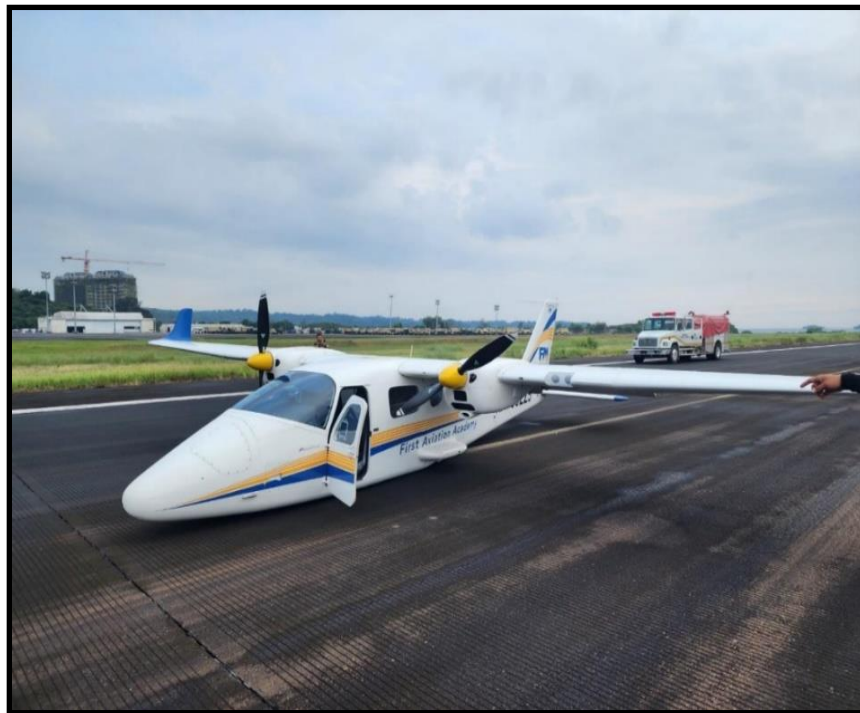
The FI then performed troubleshooting while on the downwind leg and noticed that the circuit breaker (CB) for the landing gears had popped out. He pushed the CB back once, and the “Landing Gear Pump—On” annunciated. Following this, they made another pass to the tower to verify the status of its landing gear. Once again, the crew received confirmation that the landing gear had not deployed. Thereafter, the FI requested to proceed again over Grande Island to perform “Emergency Landing Gear Extension”. While completing the actions based on the checklist, the Pilots noticed that the right-hand (RH) emergency landing gear valve lever extension was missing and could not be functional. After making another pass with the tower, the FI received confirmation that their landing gears remained unextended. The FI decided to proceed back again over Grande Island to perform a series of G-maneuvers in order to aid in the extension of its gears, but to no avail. The FI advised ATC that they would perform circling for thirty (30) minutes to burn fuel and reduce the aircraft weight. The FI then requested to perform three (3) low passes to simulate the gear-up landing. On its fourth (4th) and last approach, the FI committed to performing the landing without landing gear. The aircraft touched down abeam marker 7 of runway 07 and continued skidding forward for approximately 700 feet from its touched-down point until it finally stopped at approximately 300 feet before marker 6 of runway 07. The aircraft finally settled at grid coordinates of 14°47'33.162"N, 120°16'0.12"E, and a heading of 068°. ATC immediately dispatched the ARFF, together with FAA’s maintenance personnel. They responded immediately to the incident site to assist the pilots and secure the aircraft. No fire ensued, and the pilots safely deplaned the aircraft.

Figure 1. Aircraft’s final resting point.

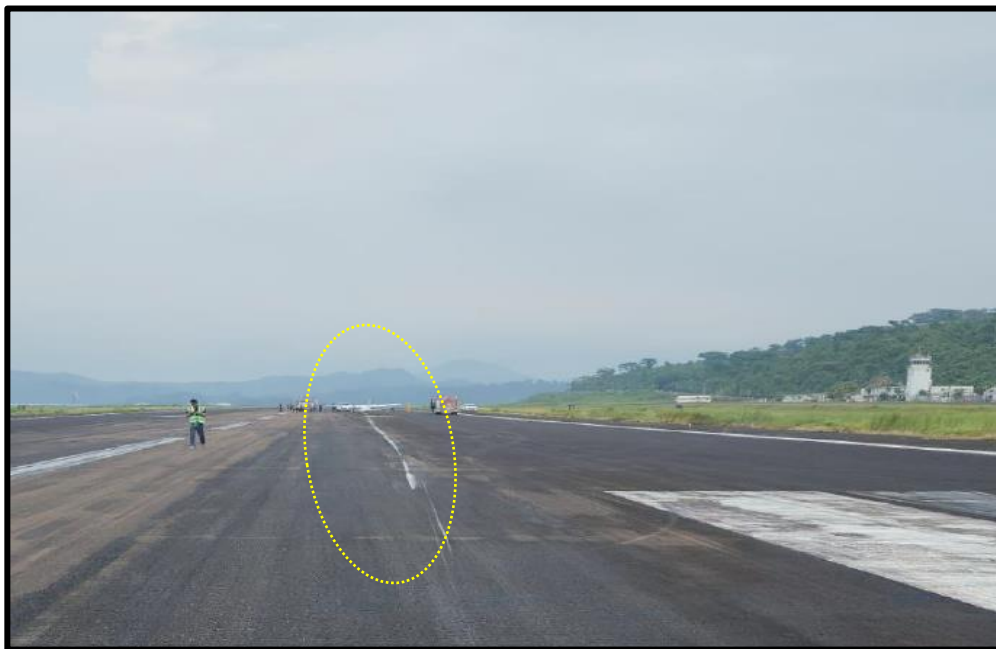
RPLB runway 07 sustained surface scar damage due to aircraft fuselage craping.

The aircraft touched down abeam marker 7 of runway 07 and continued skidding forward for approximately 700 feet until coming to a halt about 300 feet before marker 6 (Figure 2). The aircraft's final stopping point was at grid coordinates 14° 4733.162N, 120° 160.12E, with a general heading of 068°. The FAA personnel, together with the airport's RFFS, rushed quickly to the incident location to help the pilots and secure the aircraft. No fire broke out, and the pilots successfully deplaned the aircraft.

Figure 2 – The aircraft's touched down point and visible skid marks over RWY 07.

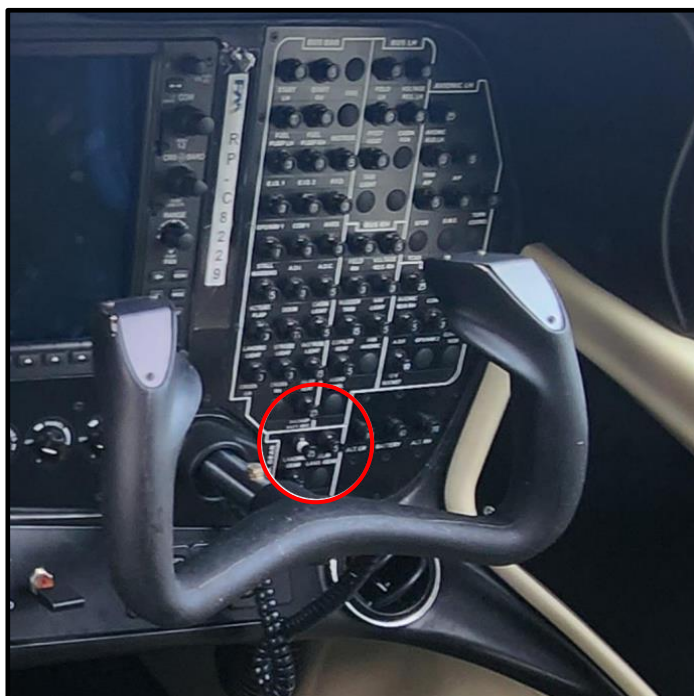
On May 13, 2023, AAIIB investigators, together with FAA mechanics and representatives, examined the aircraft, its engine, and its propellers. The aircraft logbooks revealed no significant findings. It was also noticed that the circuit breaker (CB) for the landing gears had popped out, which indicates a landing gear fault. On the same day, we performed the aircraft landing gear extension with the help of a mobile crane to test its functionality.

Figure 2 – Landing gear CB's.

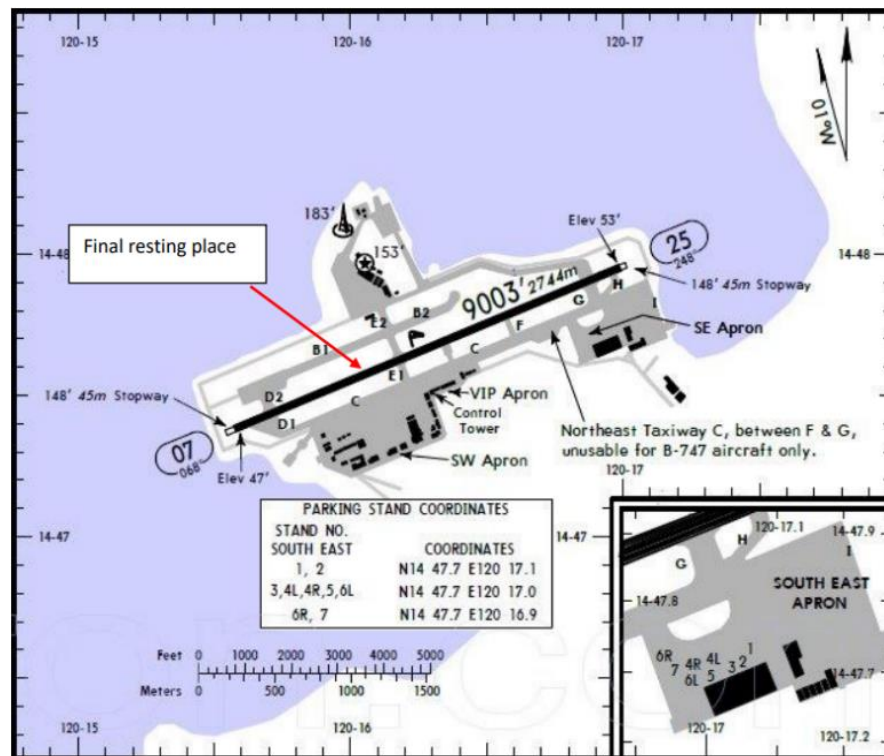
2.2 Runway Condition

Figure 3 – The aircraft at its final location on RPLB.

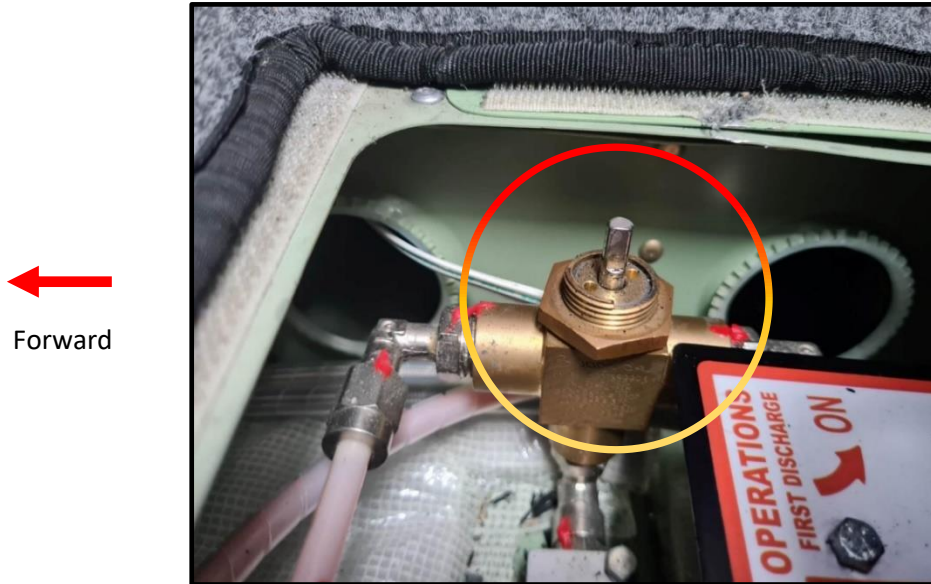
A review of the aircraft maintenance logbook did not reveal significant findings or maintenance conducted related to the landing gears. The failure to extend the landing gears was due to a faulty electric motor, which was later replaced. On the other hand, the alternate landing gear extension system was not used due to a missing lever attached to the valve. The

lever's absence prevents the valve from rotating, thereby preventing the landing gears from extending (Figure 4).

Figure 4 – The missing RH emergency landing gear valve lever.

- a. Missing alternate landing gear extension valve lever.

- a. Reduction of hydraulic periodic inspection from 100 hours to 50 hours.
- b. Provision of multi-function tool to each aircraft.
- c. Included in their training procedures the landing gear retraction and extension provisions.
- d. Performed landing gear maintenance as per aircraft manufacturer safety bulletin before the aircraft was released back to service.

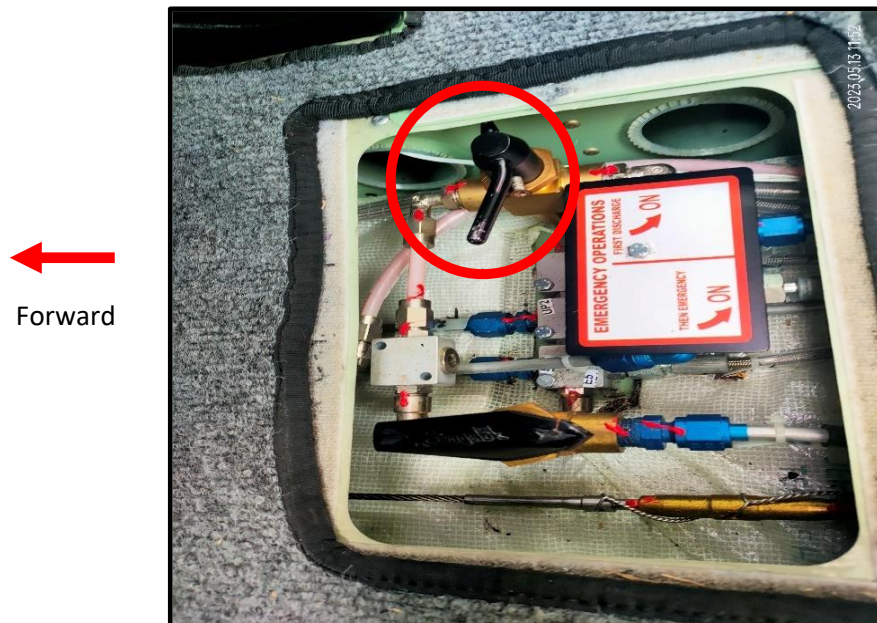
A mobile crane lifted the aircraft to perform the landing gear extension. The missing emergency landing gear extension valve lever was replaced (Figure 5). The aircraft battery was used to extend the landing gear normally. Similar to earlier, the landing gear CBs popped out. Alternate landing gear extensions were then applied following the checklist provided (Figure 6). All landing gears were deployed in accordance with the manufacturer's checklist, and the results were satisfactory.

Figure 5 – Valve lever replacement.

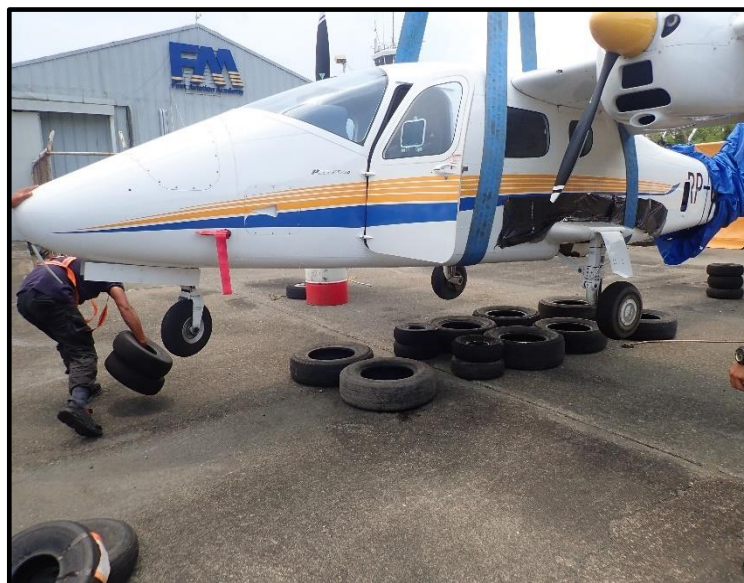
Figure 7 – The landing gears was deployed.

A review of the maintenance procedures revealed that the inspection of the alternate landing gear extension valve included a 100-hour periodic inspection being conducted by the operator. However, landing gear and alternate landing gear system tests are not regularly performed. The operator should strictly follow the inspections required in the maintenance program to ensure its reliability.
