FINAL REPORT

RP-C9986
CESSNA 152

OPERATOR: STRIKE WING AVIATION TRAINING CENTER INC.

DATE OF OCCURRENCE: FEBRUARY 26, 2019

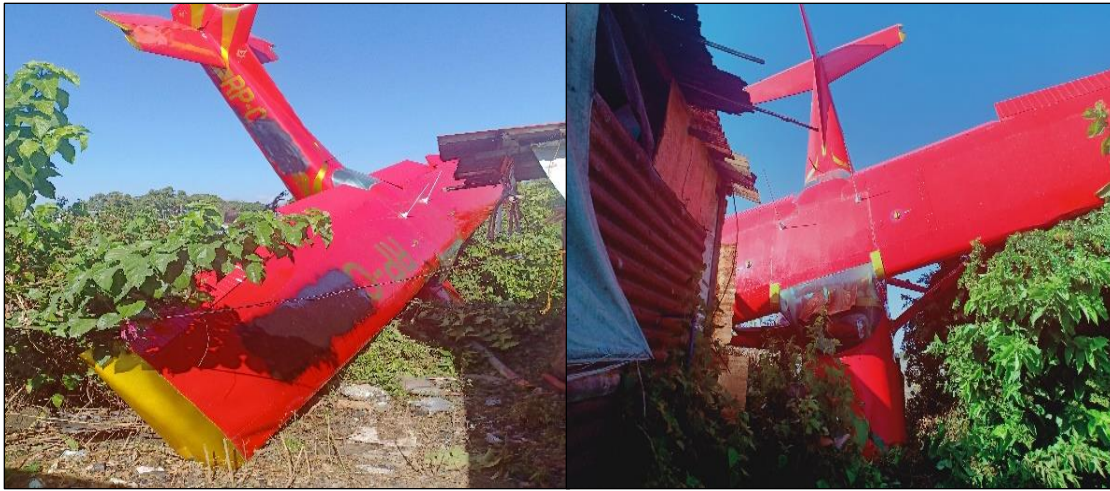
The aircraft sustained minor damage to the nose wheel assembly and dents on the leading edges. Following the impact, no post-crash fire ensued.

Fig 1-Final resting place of RP-C9986 at the end of RWY 17 Plaridel Airport

The aircraft came to a complete stop in a nose-down position in the airport perimeter fence, heading 180 degrees with grid coordinates of 14 53.215 N and 120 51.196 E. The aircraft sustained damage to the nose wheel assembly, the RH main wheel was misaligned, and there were dents on the wings leading edges and ailerons.

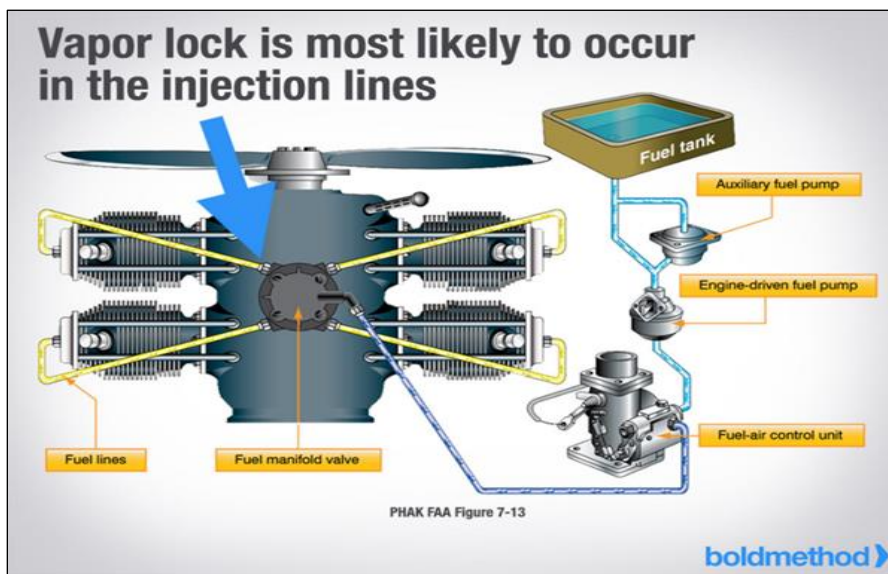
Figure 2.4A -The vapor lock process

When liquid fuel transforms into vapor in the fuel delivery system of gasoline-fueled internal combustion engines, it causes a vapor lock problem. This disrupts the operation of the fuel pump, causing a loss of feed pressure to the carburetor or fuel injection system, resulting in a transient loss of power. As fuel travels to the injector nozzles to spray into the intake manifold, the fuel injector lines after the flow divider are most likely to experience vapor lock. (Figure 2.4A). Vapor lock is typically experienced when you try to start your plane after a quick turn (shut down and restart within 30 minutes), but in some rare cases, it can occur in flight.

In this case, the loss of aircraft power was likely temporary because of the presence of vapor. It appears that the pressure release mechanism on the fuel cap on the right wing could have caused the vapor to develop.

- 5.1** Following the occurrence, Strike Wing Aviation Training Center Inc. (SWATCI) initiated the following safety corrective actions:
- a.** Conducted re-training and proficiency check to the FI focusing on emergency procedures.
 - b.** Replaced the fuel cap with pressure value release mechanism.

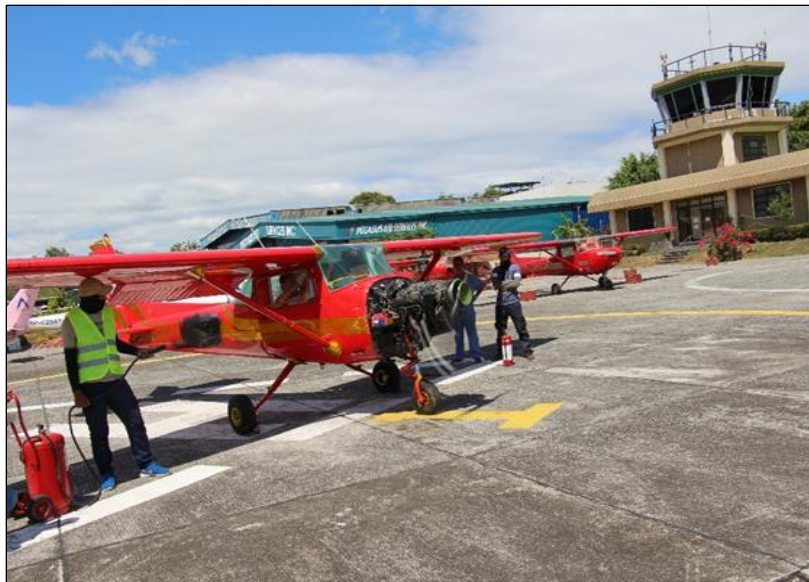
Figure 2.4B- The aircraft performing run-up after the incident

After the recovery of the aircraft from the incident site, it was towed to the ramp and subjected to further inspection. A run-up was conducted on the aircraft to further determine the cause of the momentary engine power loss. During the run-up (Figure 2.4B), the aircraft engine parameters were normal and did not display any discrepancies.

7. A visual meteorological condition prevailed at the time of the occurrence.
8. The aircraft engine parameters were normal and did not display any discrepancies during the run-up following the incident.
