FINAL REPORT

RP-R2354
AG CAT G-164A

DATE OF OCCURRENCE: APRIL 15, 2019

***PLACE OF OCCURRENCE: BRGY. SIGAYAN, LAMBAYONG, SULTAN
KUDARAT, PHILIPPINES***

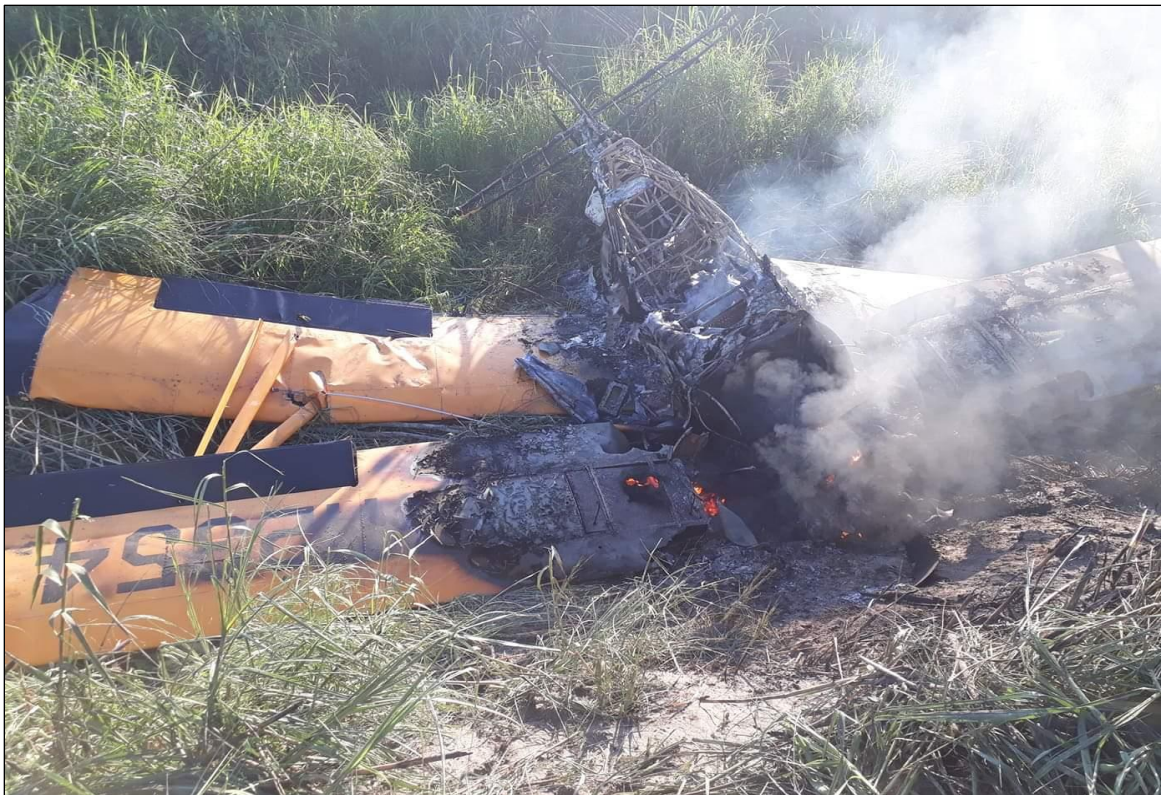
Figure 1- RP-R2354 being consumed by fire when it crashed landed on a marsh land.

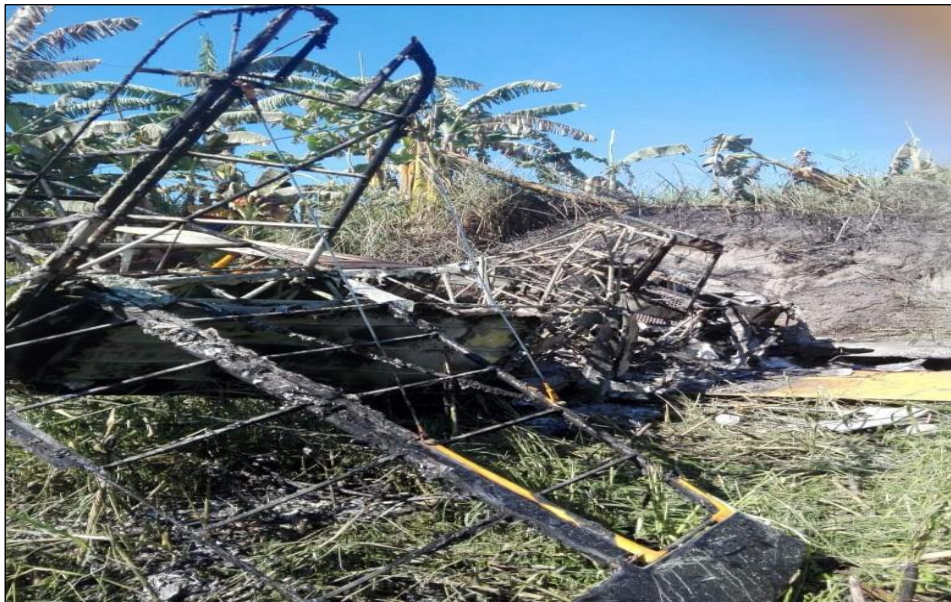
The aircraft settled on marsh land and caught fire upon impact at Brgy. Sigayan, Lambayong, Sultan Kudarat. The aircraft's final resting point was located at 6° 49.305 N, 124° 34.485 E, and the last heading was 228 degrees. The fire consumed the engine, cockpit, fuselage, and a portion of the wings.

Figure 2- The aircraft wreckage.

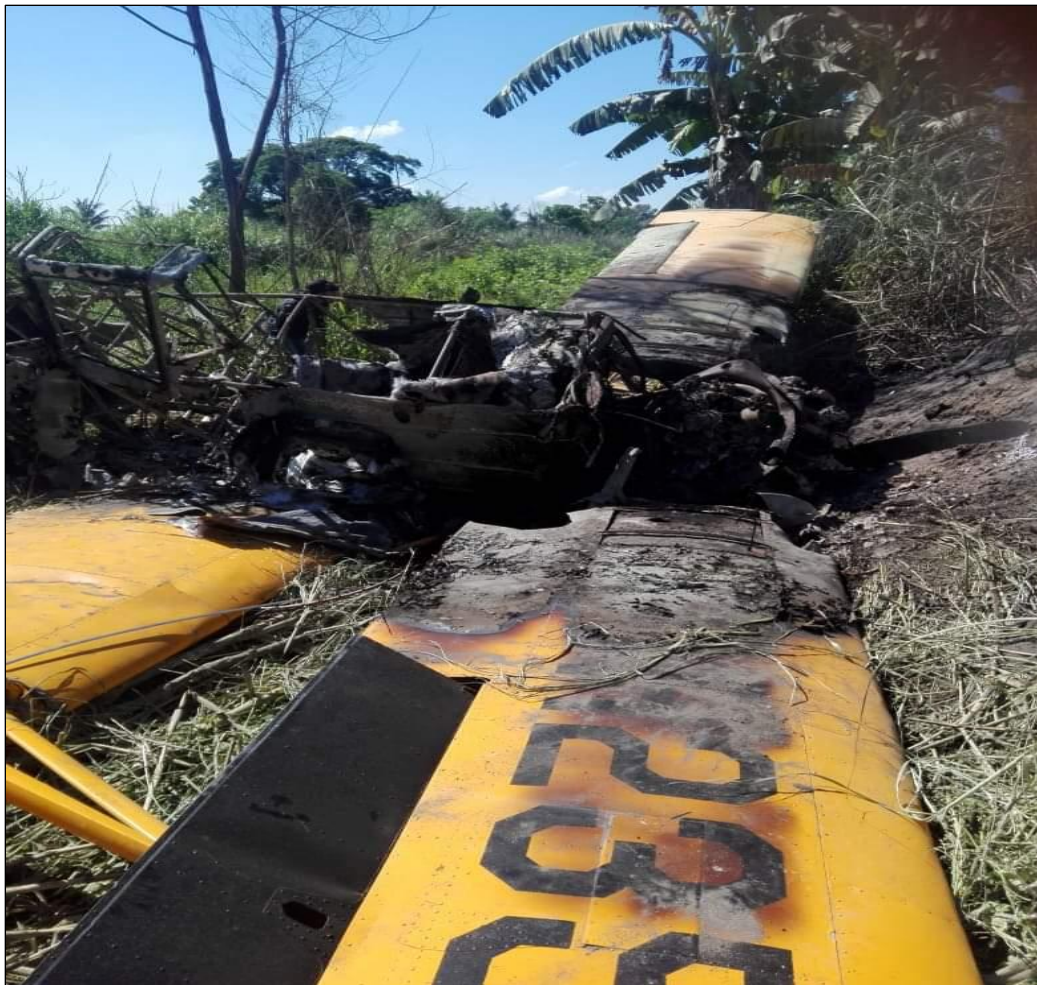
On April 15, 2019 at about 0520H, RP-R2354 was scheduled to conduct its first spraying activity at Datu Sangki, Lambayong, Sultan Kudarat. On takeoff during the initial climb, the pilot claimed that the climb was flat and decided to return to the runway. However, while initiating a right turn, the aircraft entered into stall and subsequently crashed into the ground. The aircraft settled on marsh land and caught fire upon impact at Brgy. Sigayan, Lambayong, Sultan Kudarat.

Figure 3- The aircraft wreckage after the accident.
