AIRCRAFT ACCIDENT INVESTIGATION AND INQUIRY BOARD

FINAL REPORT

RP-C1993 **TECNAM P2002-JF**

TITLE: An incident involving a Tecnam P2022-JF type of aircraft with Registry Number RP-C1993.

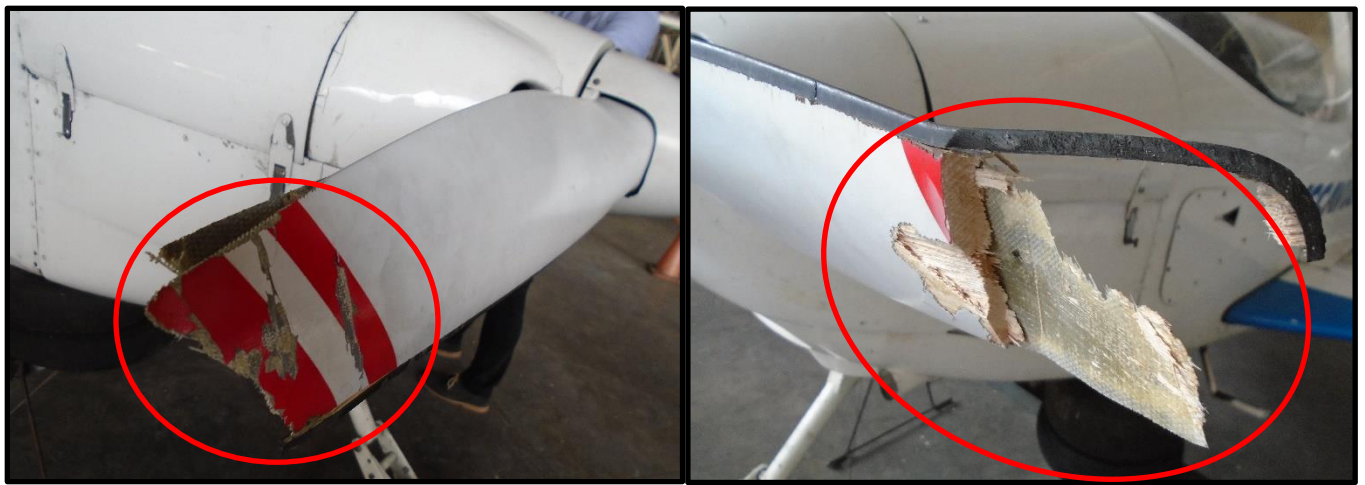
Figure 1 – Damage on the aircraft's propeller.

Upon touchdown, the aircraft experienced two (2) successive bounced landings before coming to a full stop. The aircraft came to rest at the right-hand side of runway 17 at coordinates 16° 03' 17" N, 120° 34' 54" E, and approximately located 177 meters from its touched-down point. The aircraft incurred a broken nose landing gear assembly and damaged propeller tips and bolt.

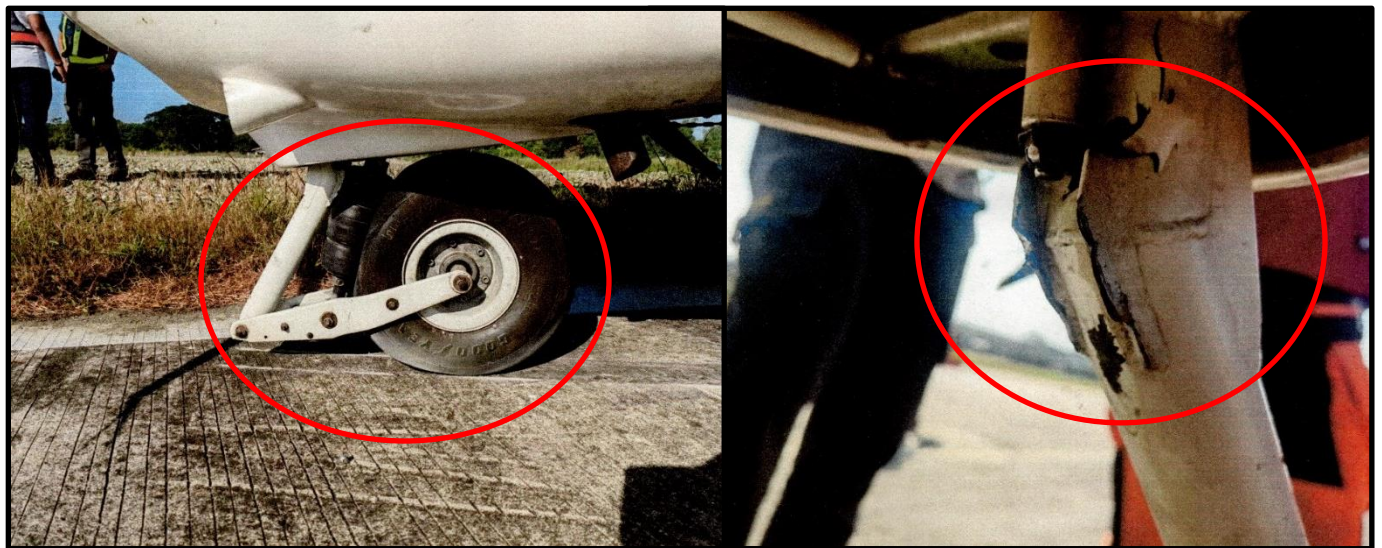
Figure 2 – Broken nose landing gear assembly.

As for the statement of his FI who monitored her flight, he observed that after the student initiated the flare, he noticed that the nose landing gear was slowly dropping, which likely caused a three-point landing. This landing attitude increased the likelihood of the aircraft bouncing upon touchdown. Additionally, the flare appeared to be too shallow, which may have further contributed to the rough landing. As the aircraft bounced, the student was unable to recover in time, resulting in multiple bounces that ultimately led to the collapse of the nose landing gear.

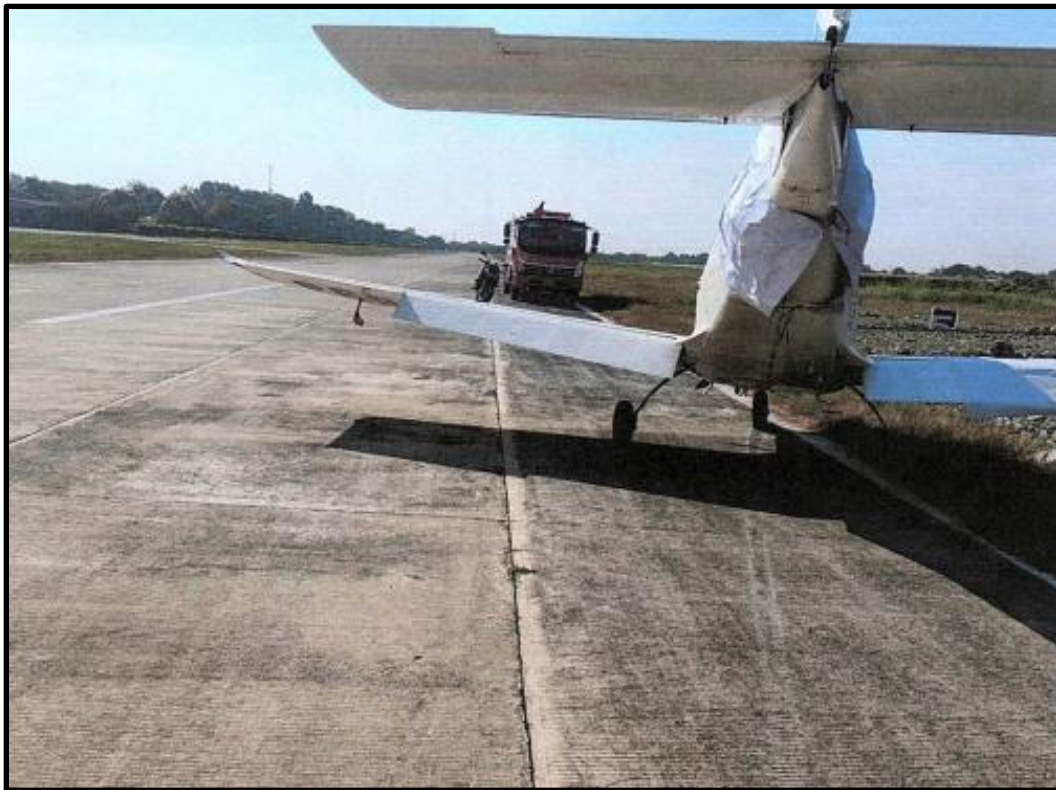
Figure 3 – The aircraft at its final stopping point.

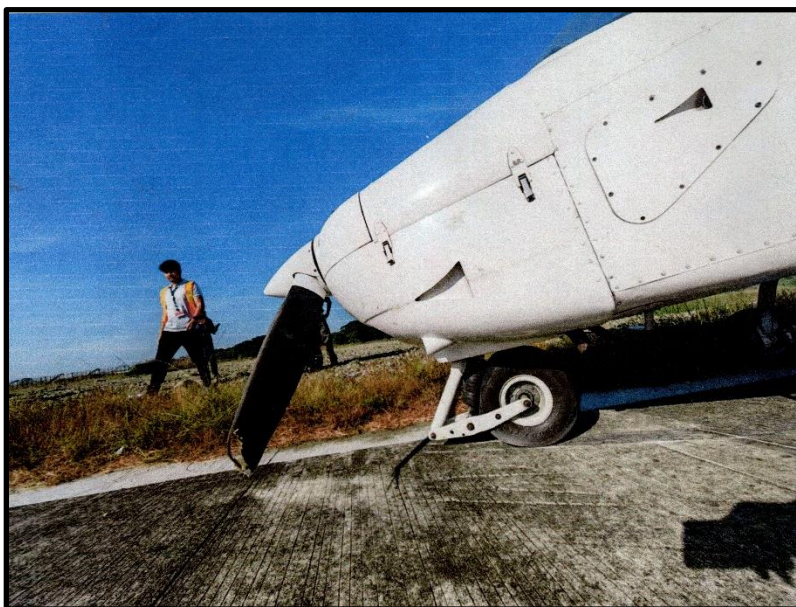
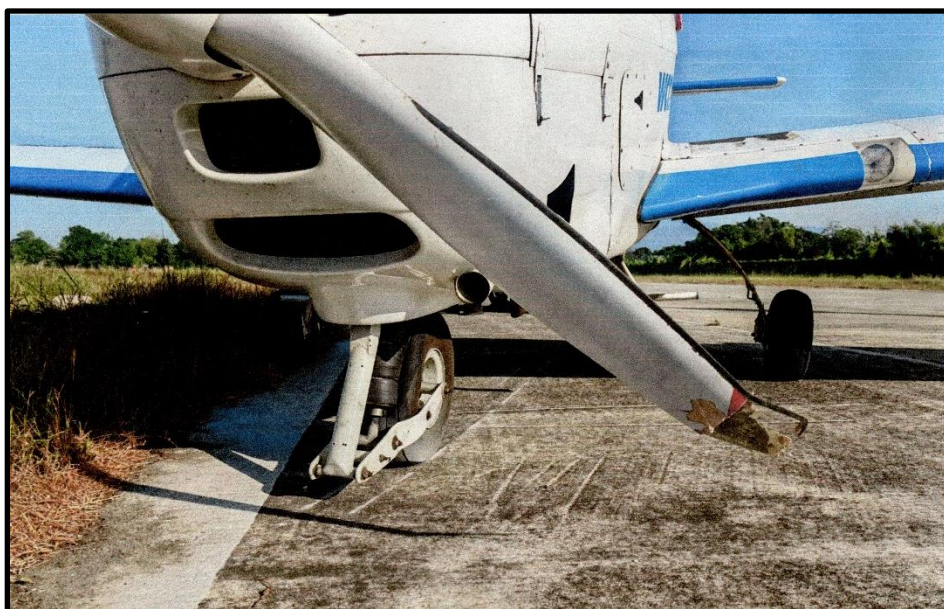
Figures 4 and 5 – The aircraft with its collapsed nose landing gear.
