# AIRCRAFT ACCIDENT INVESTIGATION AND INQUIRY BOARD

## FINAL REPORT

RP-R5380  
ALLIED AG-CAT, G-164A

**TITLE:** Accident involving an Allied Ag-Cat G-164A type of aircraft with Registry Number RP-R5380 operated by Aerowurkz Aerial Spraying Services, experienced forced landing due to engine failure within the vicinity of Barangay Sayon, Surigao Del Norte, Philippines, on September 24, 2019/0752H.

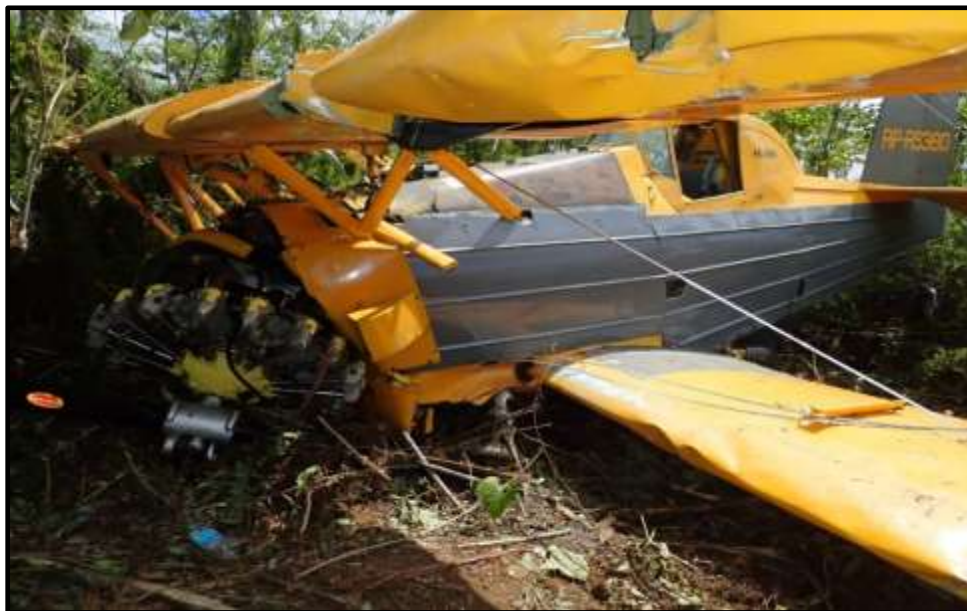
in contact with the ground about 1.5 kilometers before the runway end of Tagbina airstrip. The aircraft sustained substantial damage on both wings and the nose section due to impact. The pilot got out of the aircraft safely with no injuries. Witnesses on the ground stated that white smoke was visible coming out of the engine while it was descending.

Figure 1 - The aircraft at its final resting point.

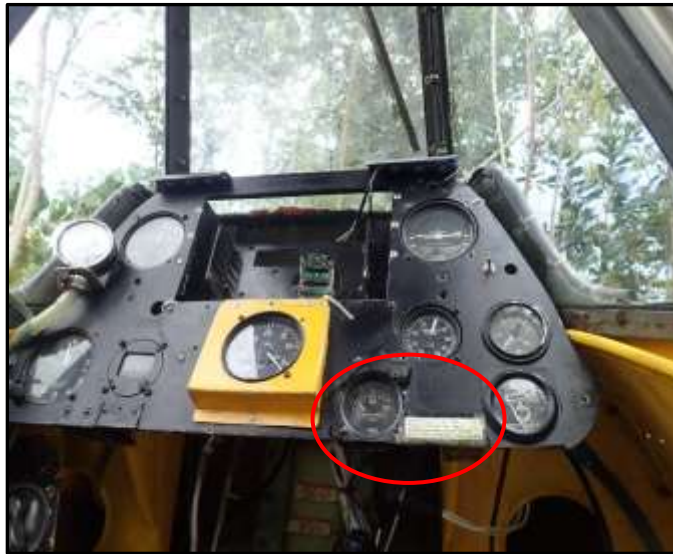
The pilot made a straight-out departure for take-off going to the spray area. Upon airborne, after reaching 200 feet AGL, he noticed the smell of burning oil. Surprisingly, there was smoke coming from the engine and starting to make its way into the cockpit. The pilot instantaneously observed the engine tachometer reading decrease, followed by an unusual engine vibration. The pilot immediately dumped his chemical load and tried to return to the airstrip but to no avail. While maneuvering, he admitted that he was too far and low from the airstrip, and after setting vital aircraft switches to the “off” position, he opted to force land the aircraft on its path. RP-R5380 has a Cylinder Head Temperature (CHT) gauge installed inside the aircraft (Figure 3). Through the CHT gauge, the pilot can monitor and take necessary preventive measures in case there is an abnormal cylinder head temperature and excessive manifold pressure.

Figure 3 – RP-R5830 Cylinder Head Temperature (CHT) gauge with placard.

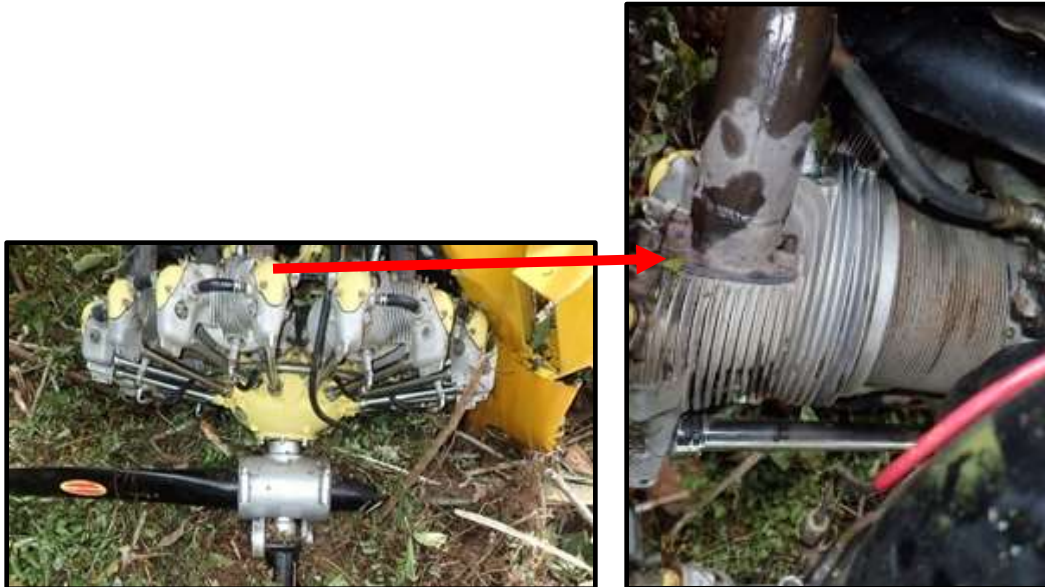
On-site investigators revealed that engine oil was coming out from one of the engine cylinders. The engine oil is scattered from a certain trajectory, which can be found in some isolated areas of the engine only (Figure 4). It is possible that this condition was a pre-impact event that occurred before ground impact. The aircraft propeller shows a bend of one of its blades pointing towards the fuselage, and this is due to ground impact. As per the witness statement, white smoke was visible coming out of the engine while it was descending.

Figure 4 – Visible oil coming from the cylinder.

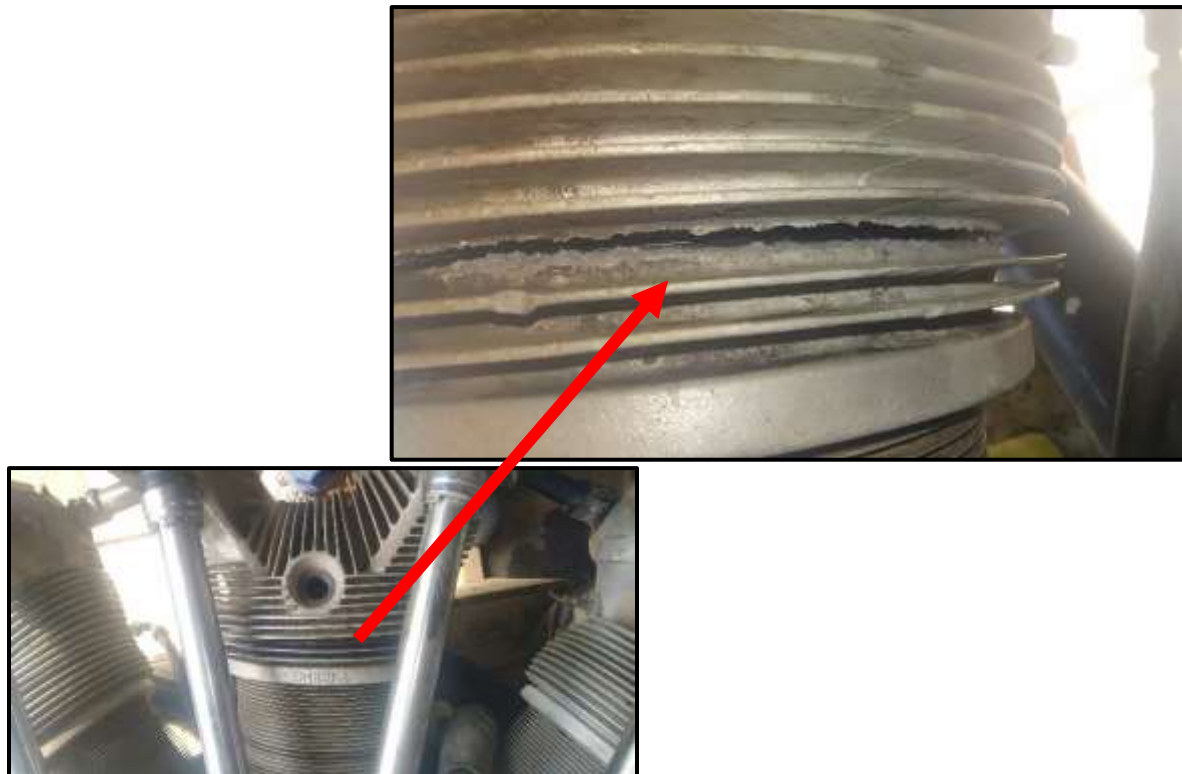
The engine teardown inspection revealed a crack in cylinder #4. This undetected crack progressed, which induced mechanical failure and/or malfunction of the engine. This occurrence is frequently known as “blown cylinder” or “cracked cylinder” from the aircraft engine that would have precluded normal operation. Aircraft piston-engine cylinders have basic failure modes. They involve the intake and exhaust valves, general cracking at various locations on the cylinder head, and head/barrel separation (Figure 5).

Figure 5 – Crack on cylinder #4.

- a. The failure of engine cylinder #4 resulting to loss of engine power. (Material Failure).

- a. Low compression, fatigue crack between the spark-plug port and intake/exhaust port.
- b. Non-inclusion in the pre- and post-flight visual inspection of the cylinder head cooling fins for discoloration or casting marks as an indication that a crack is developing.

- 4.1.1** To ensure that the operator includes in their schedule maintenance inspection manual the thorough inspection of aircraft piston-engine cylinders and the condition of its components (R-985 AN14B engine).
- 4.1.2** To ensure that the operator strictly adheres to Service Bulletin No. 1785 dated November 1977, ultrasonic and visual inspection of the cylinder head.

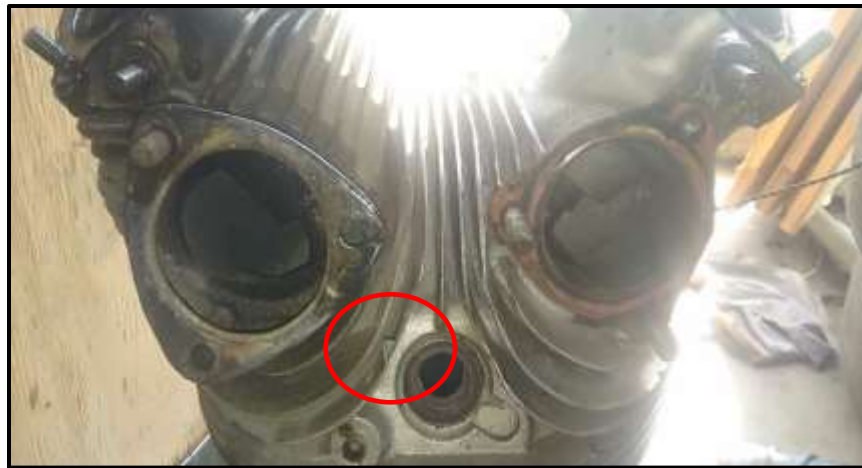
Cracking is perhaps the most pernicious type of cylinder failure. A crack occurs in the combustion chamber, specifically between a spark plug port and a valve. At a minimum, cracks result in low compression. At worst, they portend potentially catastrophic failure of the cylinder and/or engine, including the possibility of fire. Exhaust stains often lead to the location of many cracks, which should not be the case. There was evidence of shearing off and cracks in the corners of the intake/exhaust near the spark plug area on the engine of RP-R5380.

Figure 6: Visible crack where the oil was coming out.

The crack near the spark plugs on engine cylinder number #4 (Figure 6). The tear-down inspection revealed that the crack split open between the cooling fins. The separation was apparently due to pre-ignition or detonation stresses, which no longer allowed the pushrods to operate the valves. This resulted in a forced landing due to engine failure during the initial climb after take-off. Pre-ignition is the ignition of the air-fuel charge while the piston is still compressing the charge. A cracked spark plugs tip, carbon or lead deposits in the combustion chamber, or a burned exhaust valve can act as a glow plug, causing the ignition source to ignite the charge prematurely. Detonation is an explosion of the fuel-air mixture inside the cylinder. It occurs after the compression stroke, either near or after the top dead center. During detonation, the fuel/air charge explodes rather than burning smoothly. Because of this explosion, the charge exerts a much higher force on the piston and cylinder, leading to increased noise, vibration, and cylinder head temperatures.
