AIRCRAFT ACCIDENT INVESTIGATION AND INQUIRY BOARD

FINAL REPORT

RP-C2078
CESSNA 207A

***PLACE OF OCCURRENCE: CAUAYAN PRINCIPAL AIRPORT (RPUY), CAUAYAN, ISABELA,
PHILIPPINES***

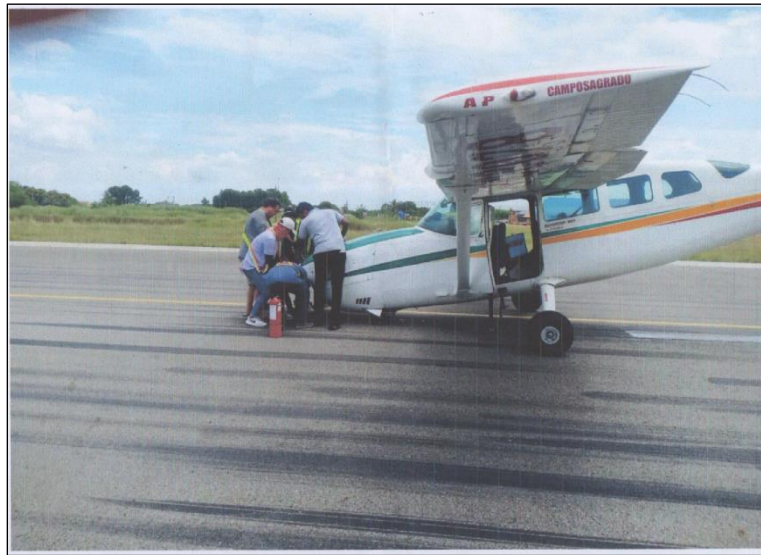
Figure 1 - RP-C2078 at its final resting point.

The pilot touched down at about five hundred (500) meters from the threshold of runway 12. During the landing roll, about seven hundred fifty (750) meters from the touchdown point, the aircraft nose landing gear separated from its assembly and underwent a subsequent propeller strike. The aircraft continued to roll for another eighty (80) meters. The aircraft made a normal landing at the centerline, and no fire was visible until it came to a full stop on the right side of the runway. The Cauayan airport Crash Fire Rescue (CFR) services arrived on scene to assist and secure the aircraft. The pilot and passengers safely got out of the disabled aircraft.

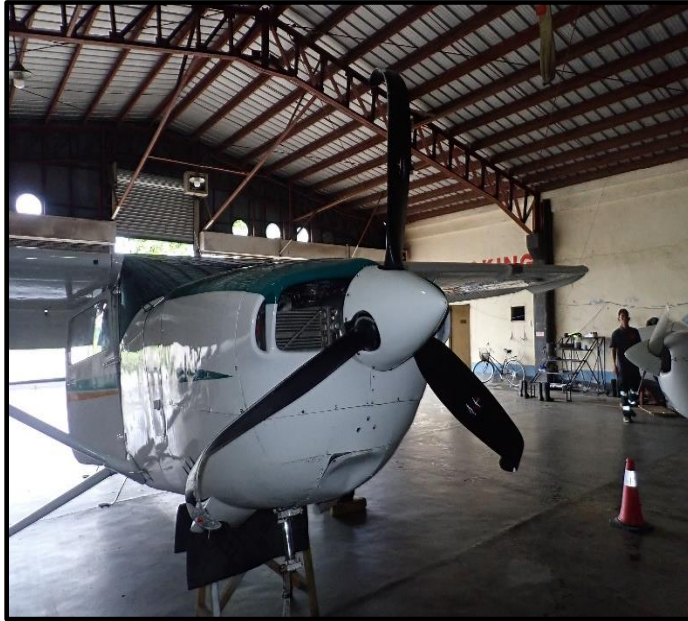
During the landing roll, about seven hundred fifty (750) meters from the touchdown point, the aircraft nose landing gear separated from its assembly, and a subsequent propeller strike happened (Figure 2).

Figure 2 - Propeller damage.

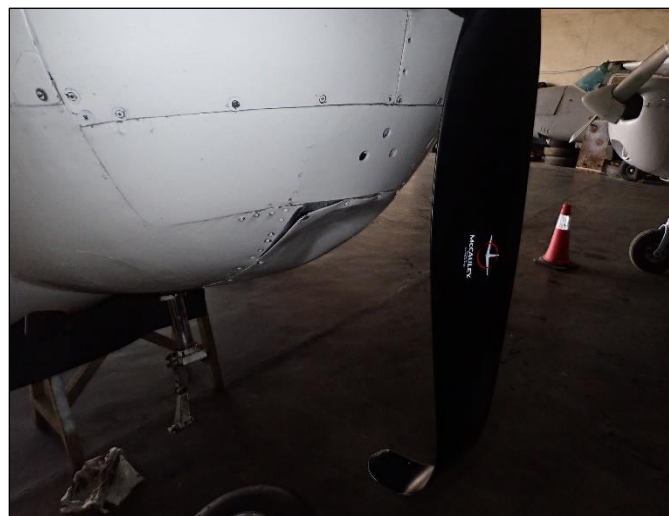
The aircraft's nose landing gear detached from its assembly, proceeded forward along the fuselage, and collided with the lower nose engine cowling, causing damage to the structure (Figure 3). Eyewitnesses' accounts stated that the aircraft landed normally at the runway centerline, going to the right. The NLG was located approximately fifteen (15) meters to the left of the grassy section of the runway from the aircraft's final position.

Figure 3 - Lower nose engine cowling damage.

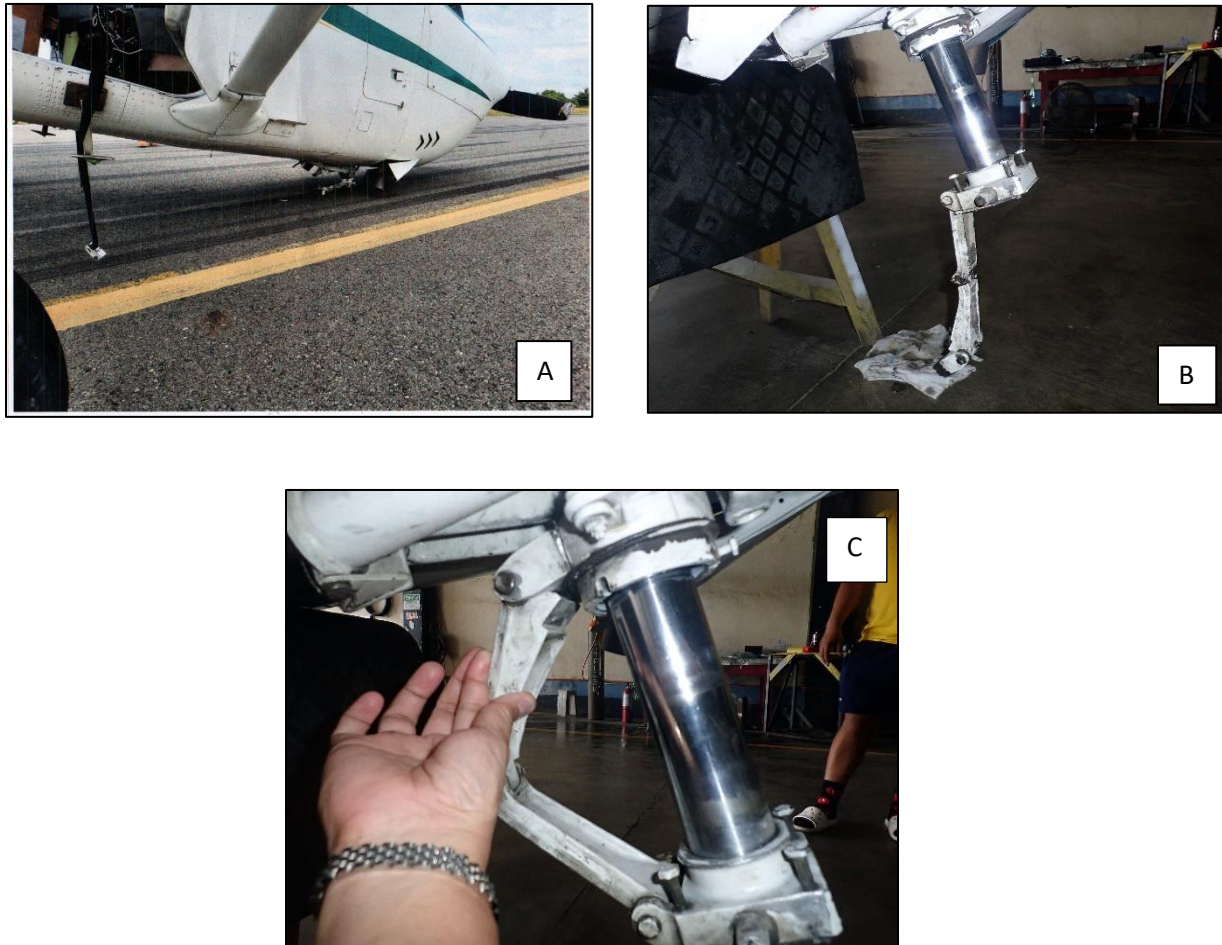
During the landing roll, the aircraft nose landing gear separated from its assembly, resulting in a subsequent propeller strike (Figure 4A). The aircraft NLG upper torque link assembly was broken (Figure 4B). The NLG upper torque link assembly was supposed to support the shock strut and nose wheel steering but was damaged (Figure 4C). The stress from the landing roll caused the NLG wheel to separate from its assembly (Figure 4D).

Figure 4 (A-D) Nose landing gear damage.

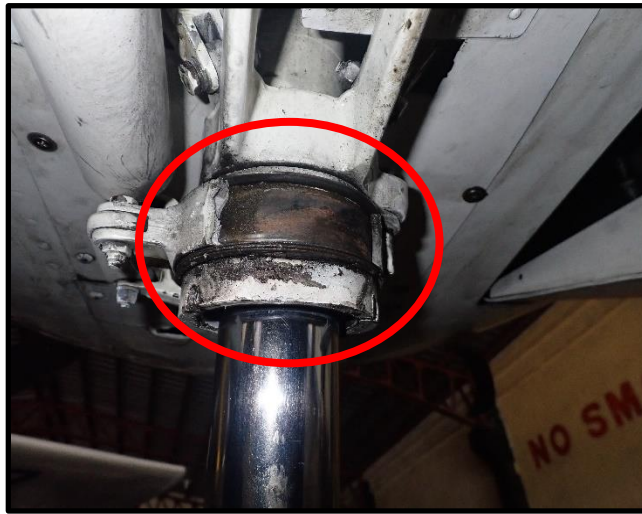
Due to repeated hammering with every takeoff and landing of the NLG shock strut, the nose gear incurs so much stress and strain that it just doesn't have a chance to last as expected. Excessive wear can cause the strut to overextend. It also often wears unevenly, resulting in inconsistent alignment of the nose wheel in flight, which then causes extra drag and yaw. The extra yaw of the NLG can require increased rudder trim, which causes even more drag. A runway sweep was conducted by the Cauayan CFR unit after the occurrence, and they stated that no part or component of the aircraft nose landing gear upper torque link assembly was found. The ground staff at Maconacon Airstrip also searched for the missing part or component of the aircraft nose landing gear upper torque link assembly, but they were unable to find it.

Figure 5 - Nose landing gear upper torque link assembly damage.

The investigation revealed that the operator uses three (3) aircraft, with the RP-C2078 serving as the primary workhorse for the company. The aircraft nose landing gear component mainly received overstress, forming an undetected fatigue crack while operating in the rugged airstrip of Maconacon, Isabela. The maintenance inspection criteria required an inspection/examination every 200 flying hours; however, there remains a persistent risk of not discovering fatigue cracks in a timely manner. That type

- a. The failure of the upper torque link assembly resulted in the collapse of the nose landing gear.

- a. The operator's inadequate maintenance program failed to detect the progressive fatigue crack on the aircraft's NLG torque link component.
- b. Non- adherence to Manufacturer Tech Note No. 001, Revision 004, dated April 15, 2010, on the affected aircraft.

- a. To ensure that the operator comply with the Manufacturer Tech Note No. 001, Revision 004, issued on April 15, 2010, concerning the affected aircraft.
- b. To ensure that the operator pilots and maintenance personnel fulfill their pre-flight and post-flight inspection responsibilities on every scheduled flight.
