# AIRCRAFT ACCIDENT INVESTIGATION AND INQUIRY BOARD

## FINAL REPORT

RP-C119  
PA-23-250

**TITLE:** Accident involving a Piper Aztec PA-23-250 Registry Number RP-C119 owned and operated by Skyline Aviation88 ditched into the sea following a right-hand (RH) engine failure on August 31, 2019, at around 1330H at about 2 kilometers from Isla Kampanario, Brgy. Papaya, Nasugbu, Batangas.

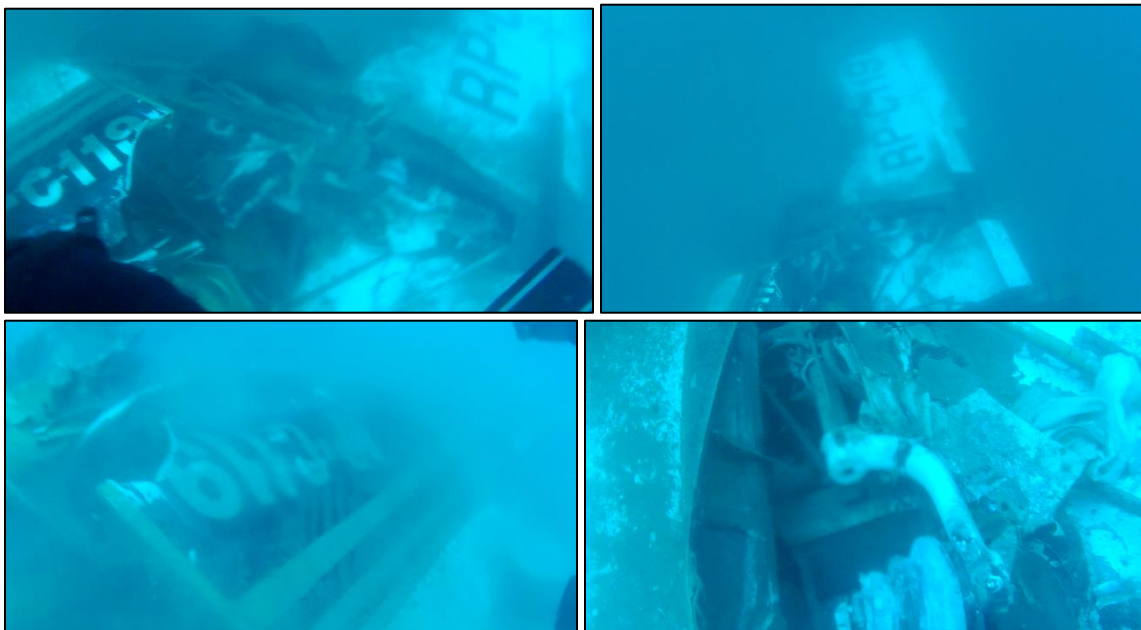
Figure 3: Various underwater photos of the wreckage

depth of 40 meters. The aircraft wreckage was in the vicinity. The PCG personnel took underwater video and pictures (Figure 3). At 0940H, the activity ended.

Several attempts to retrieve the aircraft yielded negative results because of the location's depth, which was around 40 meters. The water's condition and poor visibility due to the frequent rains caused by the southwest monsoon complicate the retrieval process. The presence of marine life and the potential harm to the ecosystem were carefully considered, as the wreckage lies within corals.
