AIRCRAFT ACCIDENT INVESTIGATION AND INQUIRY BOARD

FINAL REPORT

RP-C1741
CESSNA 152P

TITLE: Incident involving a Cessna 172P type aircraft with Registry Number RP-C1741 and operated by All Asia Aviation Academy that had a ground collision with a parked aircraft while on taxi at Iba Community Airport, Iba, Zambales, Philippines, on January 19, 2019, at 1145H/0345UTC.

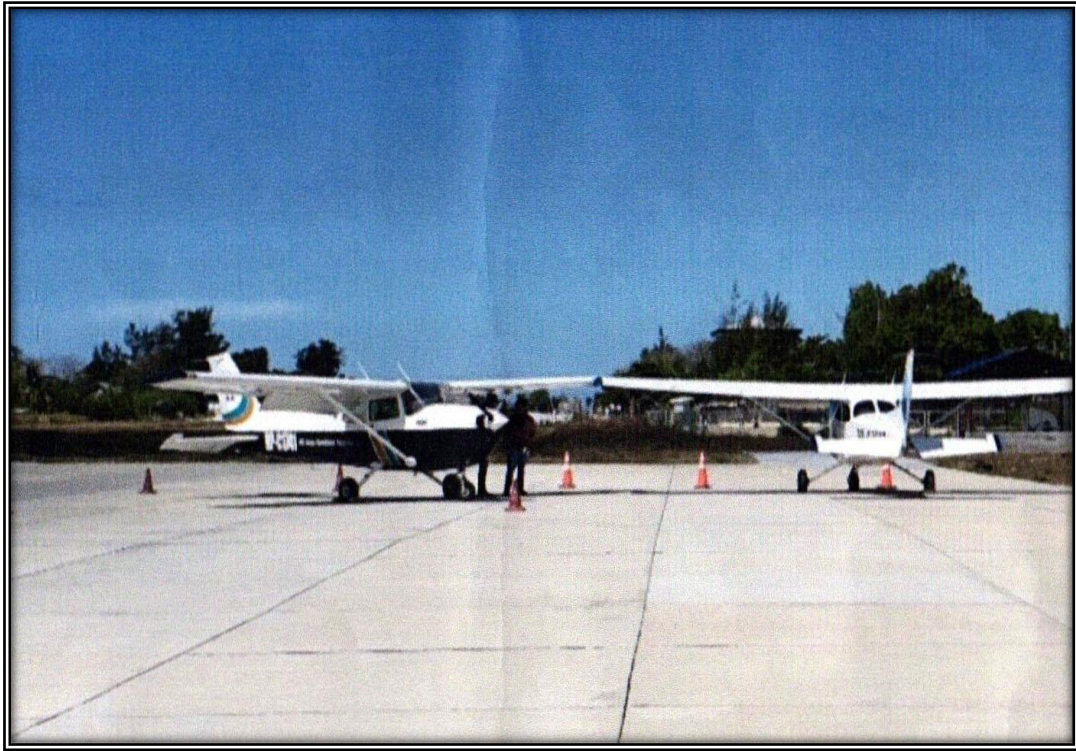
On January 19, 2019, at about 1145H/0345UTC, a Cessna 172P type aircraft with Registry Number RP-C1741 sustained minor damage after a ground collision with a parked aircraft while on taxi at Iba National Airport. On board was a student pilot (SP) on a solo training flight while taxiing after a full-stop landing when the incident happened. The SP allegedly said he was not aware of the ground collision until airport personnel caught his attention, signaling him to stop. The aircraft made a full stop on the ramp approximately 20 meters in front of the Crash Fire Rescue (CFR) building at coordinates 15°32'51.98"N, 119°09'69.844"E, and a heading of 090 degrees.

Figure 1 - RP-C1741 final position.

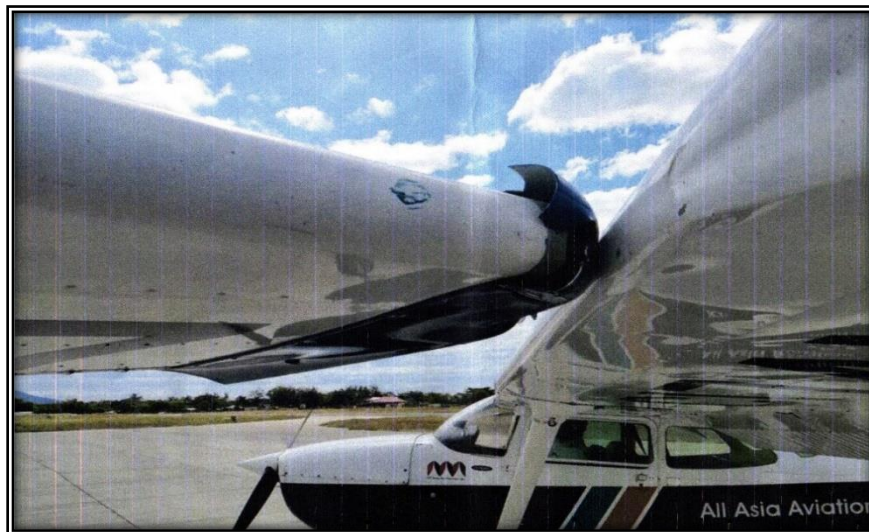
Upon entering the ramp area, the pilot did not notice that his aircraft's left wing had come into contact with another parked aircraft's left wing. The RP-C1741 left wing leading edge sustained a dent that measured approximately 20 inches by 4 inches. The aircraft made a full stop on the ramp approximately 20 meters in front of the Crash Fire Rescue (CFR) building at coordinates 15° 325198N, 119° 969844E, and a heading of 90 degrees.

Figure 2 - The aircraft wing collided with another aircraft parked at the ramp.

- a. The aircraft has a valid Certificate of Registration and Certificate of Airworthiness, respectively.
- b. The aircraft was released for flight with no discrepancies recorded on the day of the occurrence.
- c. The aircraft sustained impact damage to its left-wing leading-edge assembly and left-wing wingtip fairing.

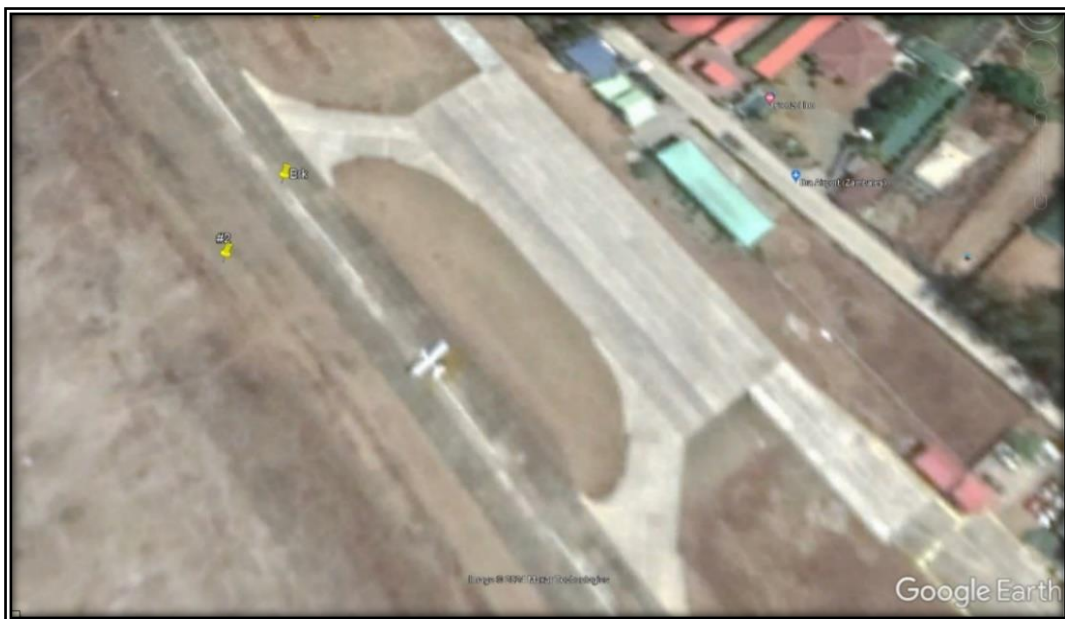
All Asia Aviation Academy was operating the Cessna 172P in this aircraft incident. It had a ground collision with another parked aircraft on the ramp while on taxi operation at Iba National Airport (RPUI), Iba Zambales. The investigation revealed that the SP was taxiing the aircraft towards the parking ramp after a full-stop landing. He also said that he did not notice that the left wing of his aircraft came into contact with the left wing of another aircraft parked on the ramp. The investigation also revealed that the ramp and apron area was undergoing renovations when the incident occurred. The aerodrome operator has developed a program of work that includes providing visual markings for aircraft movement on the ramp. The airport manager stated that the work program was in progress and the said visual markings will follow soon (Figure 3).

Figure 3 - The apron & ramp area during the incident without line marking.

- b.** The ramp apron of the aerodrome does not provide continuous taxiway marking.

The primary requirements for safe taxiing are positive control, the ability to identify potential hazards in time to avoid them, and to stop or turn where and when desired without undue reliance on the brakes. Pilots should proceed at a cautious speed at a rate where the movement of the aircraft is dependent on the throttle. That is, slow enough so that when the throttle is closed, the aircraft can be stopped promptly. Although the aerodrome has no line marking in place, the pilot's primary responsibility is to see and avoid other aircraft, as well as to help them see and avoid his aircraft. When taxiing, the pilot's eyes should be looking outside to the sides as well as in front. The pilot must be aware to ensure that the entire area is clear of any obstructions. If at any time there is doubt, the pilot should stop the aircraft. It is encouraged further that the operator includes in their safety program topics to improve pilots' "see-and-avoid" capabilities. Meanwhile, a follow-up of the visual markings of the ramp on the said airport shows that the aerodrome operator initiated the completion of the taxiway line markings as a safety corrective action.

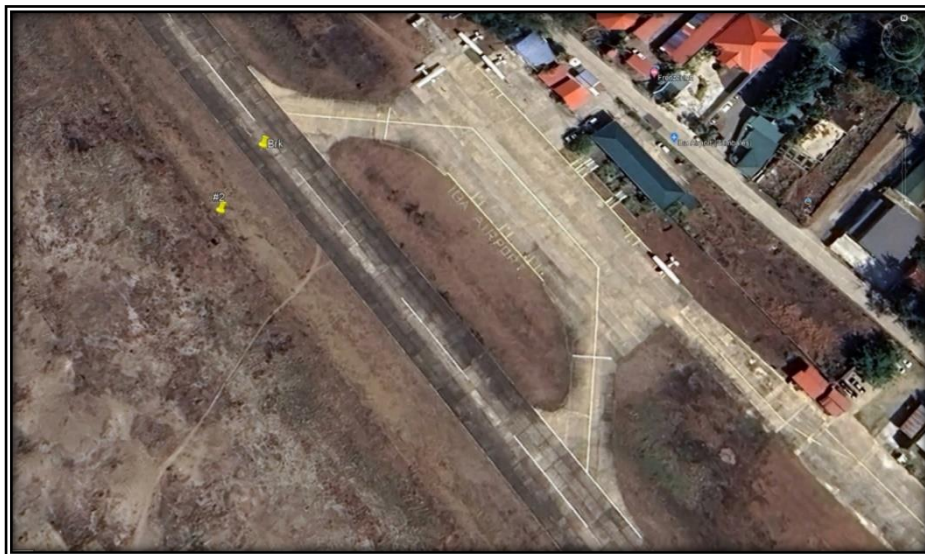
Figure 4 -The apron & ramp area with line marking.

5.1 Following the occurrence, the aerodrome operator initiated the following safety corrective action:

- a.** Provision for the taxiway line markings was started on April 2019 and completed pavement markings on January 2020.
