# **AIRCRAFT ACCIDENT INVESTIGATION AND INQUIRY BOARD**

## **FINAL REPORT**

**RP-C3604**  
**CESSNA 152**

**TITLE:** An accident involving a Cessna 152 aircraft with Registry Number RP-C3604 owned and operated by OMNI Aviation Corporation with Student Pilot on board that went missing heading Sabang Beach, Baler, Aurora bound for OMNI Aerodrome at around 1500H on July 28, 2019.

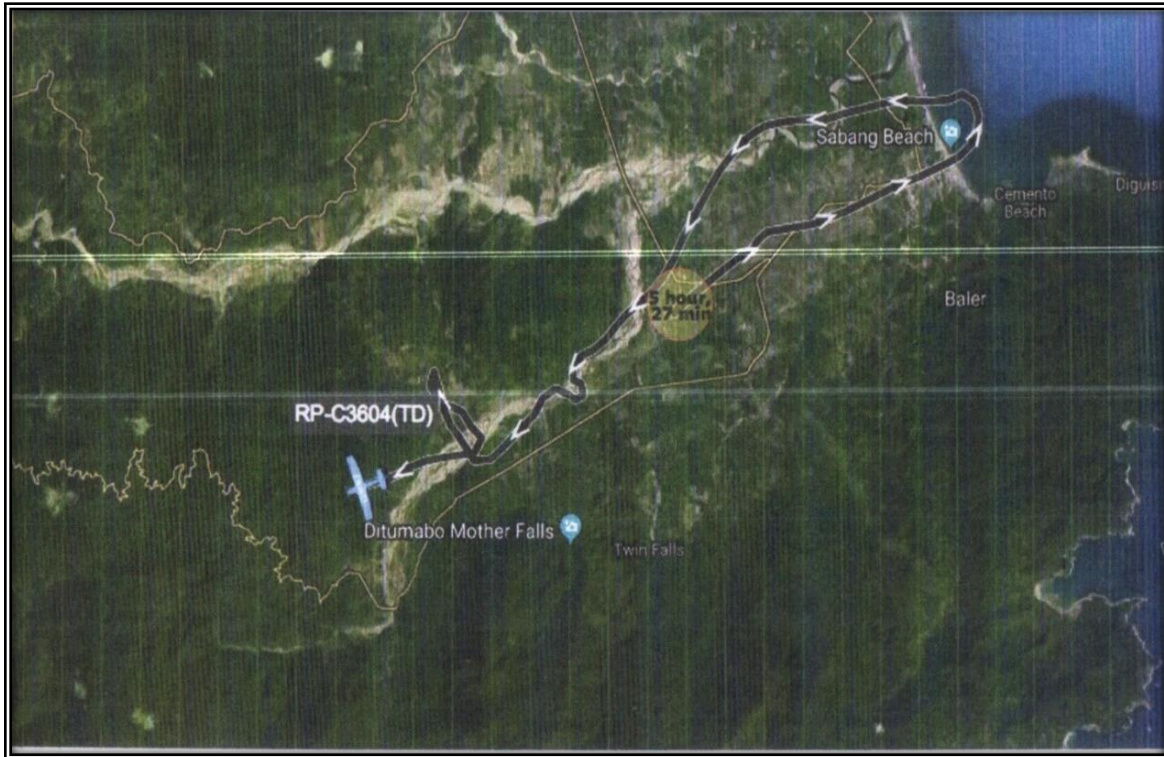
The aircraft's built-in GPS system tracked the aircraft's movement from the moment it took off from Baler Airport in Aurora at around 1500H, heading towards Sabang Beach, and turned to an approximate heading of 250 degrees. It showed that the aircraft climbed up to an approximate altitude of 3,800 feet, still heading 250. The GPS signal ceased at approximately 1527H, and PARCC detected the ELT signal at approximately 1533H. Immediately thereafter, search and rescue operations were dispatched up to 2100H on July 28, 2019. Different units conducted an extensive search and rescue operation for three (3) weeks, before suspending it on July 28, 2020. The aircraft and the lone student pilot occupant on board are still missing at this time.

Figure 1 - Aircraft flight path upon departure at Baler Airport.
