AIRCRAFT ACCIDENT INVESTIGATION AND INQUIRY BOARD

FINAL REPORT

RP-C5907 BOMBARDIER, DHC-8-402 (Q400)

***PLACE OF OCCURRENCE: CATARMAN AIRPORT,
POBLACION, CATARMAN, PHILIPPINES***

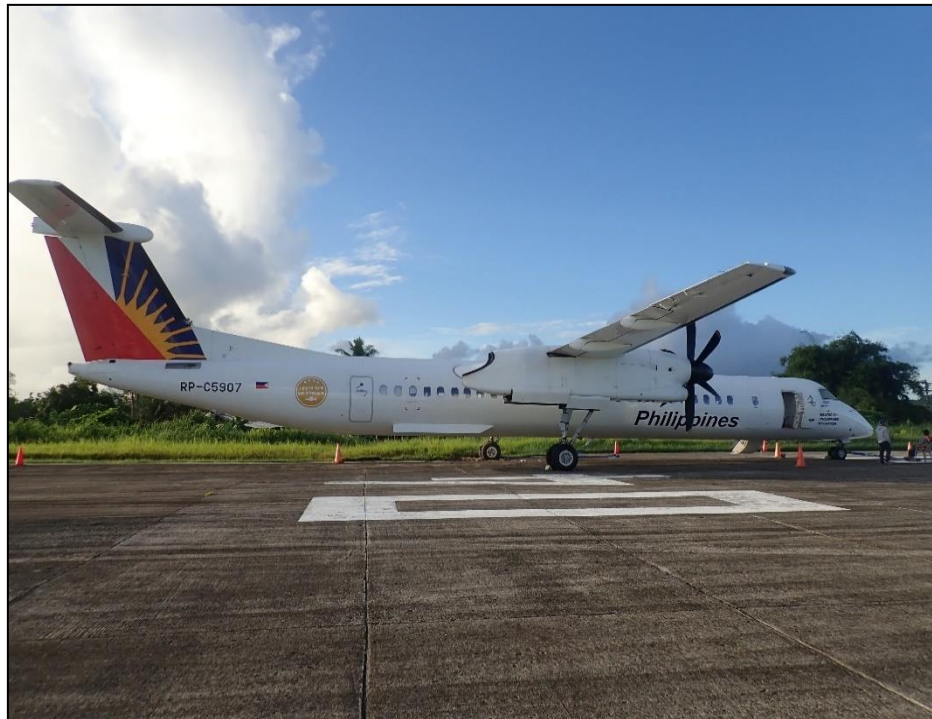
Figure 1 - RP-C5907 at its final resting point.

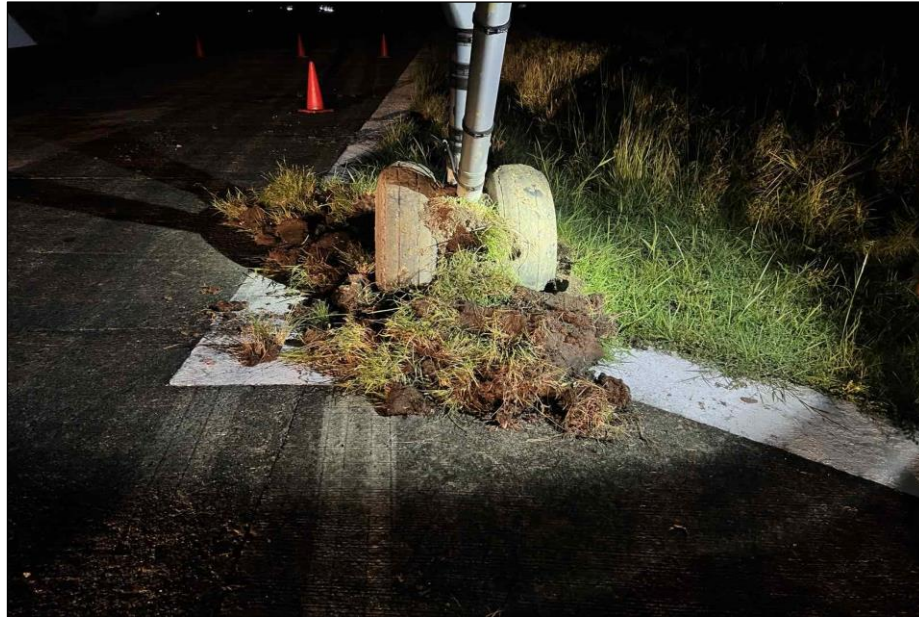
The left MLG exited the runway edge and got stuck on grassy soft ground at the right-angled corner of the runway turn-around pad that was about twenty (20) meters from the threshold of RWY 04. The PIC noticed that the aircraft could not move forward. The PIC decided to contact his supervisor for advice and informed the duty air traffic

Figure 2 - The left main landing gear lodged on the soft ground.

After completion of the inspection task sent by the technical representatives, work was done on the affected landing gear. A new set of wheels was installed as part of the scheduled task as per the aircraft maintenance manual and was then released for a ferry flight to Manila on June 27, 2022, for further assessment.

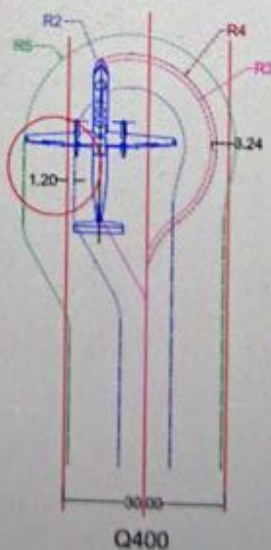
NOTE: Although Q400 can execute a turn using this turning procedure, it must be observed that the clearance between the Outer MLG and runway edge is only 1.2m.
