# AIRCRAFT ACCIDENT INVESTIGATION AND INQUIRY BOARD

## FINAL REPORT

RP-R3027  
AG CAT G-164A

**TITLE:** Serious incident involving an Agcat G-164A type of aircraft with Registry Number RP-R3027 operated by Mindanao Rainbow Agricultural Development Services, Inc (MRADS) that made a runway excursion after an aborted take-off at Agrotech Integrated Farm Airstrip, Monkayo Davao De Oro on September 24, 2019 at about 0610H.

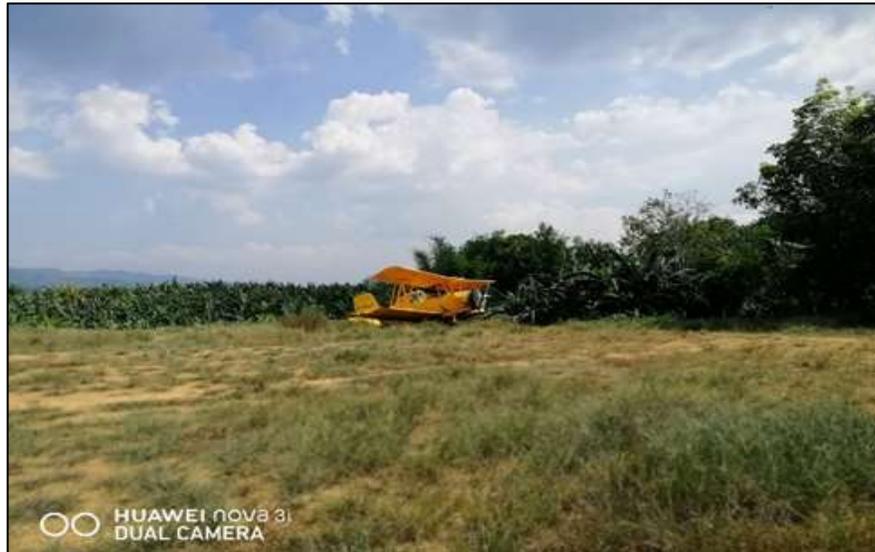
continued to roll for about 200 meters before exiting the end of runway 25. The aircraft came to a complete stop at the left end of the runway, with a last heading of 189 degrees and coordinates of 7 47 18.20 N, 126 4 49.20 E.

Figure 1 - Final position of RP-R3027 at the end of RWY 25.

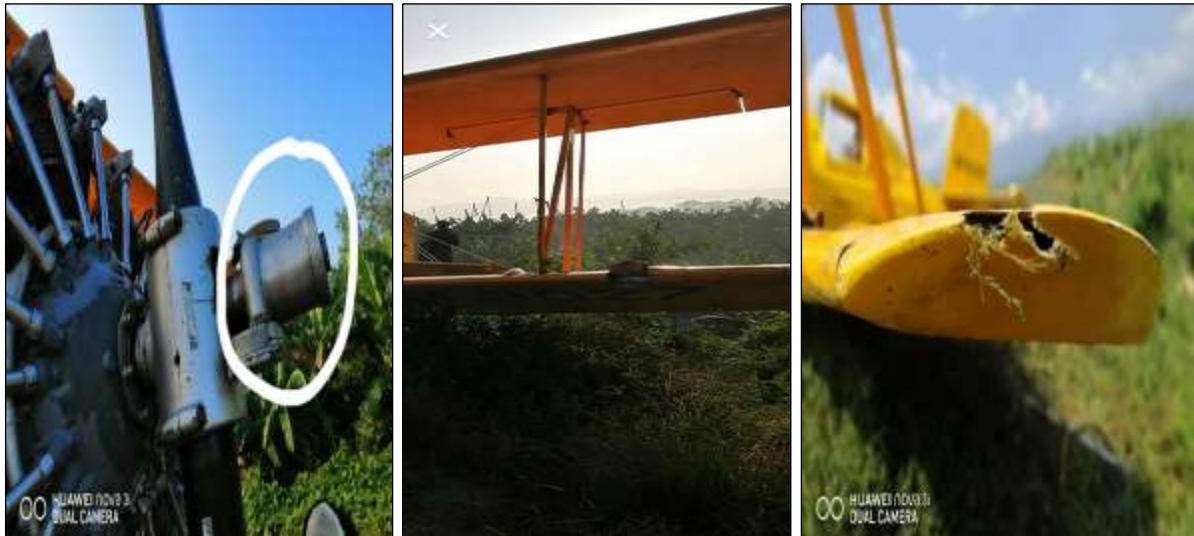
The aircraft sustained damage to the wing tip, lower left-wing leading edge, tail wheel spring, and broken propeller counterweight bracket.

Figure 2 - Damages sustain by RP-R3027.

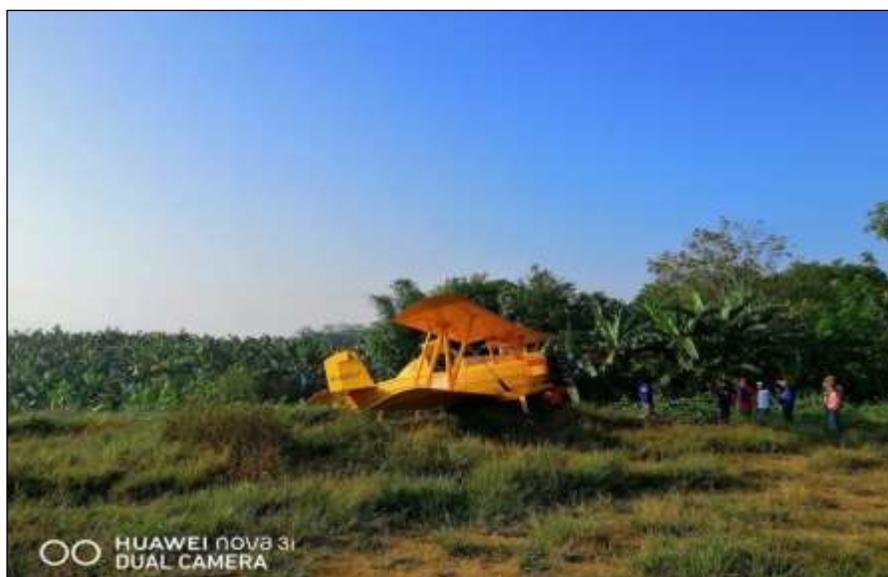
The aircraft veered to the left side of the runway, colliding with marker 0, and continued to roll for about 200 meters before exiting at the end of runway 25. The aircraft came to a complete stop at the left end of the runway, with a last heading of 189 degrees and coordinates of 7 47 18.20 N, 126 4 49.20 E.

Figure 3 - RP-R3027 final position after colliding runway marker "0".

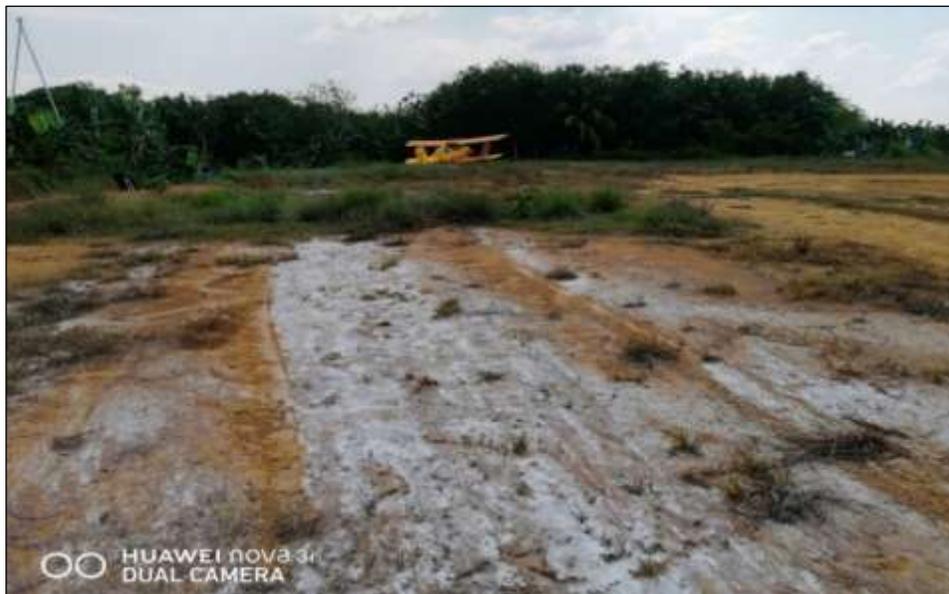
The RP-R3027 aircraft was scheduled to perform aerial spraying activities at Agrotech Farms, Barangay Union, Monkayo, Davao de Oro, on September 24, 2019. During the second load at around 0610H, when the aircraft was taking off at runway 25 with full engine power and an airspeed of about 70 knots, the pilot abruptly experienced a power loss. At this point, the pilot decided to abort the take-off, but failed to control the aircraft, resulting in a runway excursion

Figure 4 - RP-R3027 Final position after the incident.

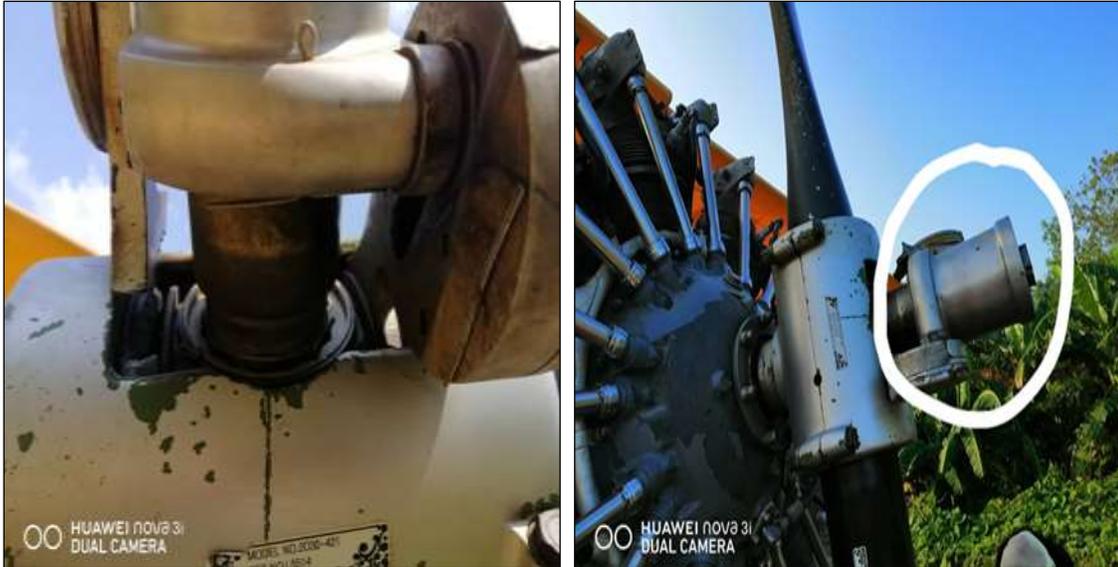
Fatigue appears to be the cause of the propeller counterweight bracket's failure. Despite the unique circumstances, a thorough inspection of the propeller counterweight bracket and its accessories is necessary. The 50-hour, 100-hour, and annual inspections provide limited information about the necessary inspections for propeller counterweight brackets and accessories.

Figure 6 - Showing the broken counterweight bracket.

- a. The failure of the propeller counterweight bracket.

- 4.1 To ensure that the operator, Mindanao Rainbow Agricultural Development Services Inc., includes in their pre-flight and post-flight inspection checklists the inspection of the propeller counterweight bracket and accessories for wear, tear, and fatigue.
- 4.2 To ensure that the operator, Mindanao Rainbow Agricultural Development Services Inc., adheres to the propeller inspections in the Hamilton Standard Propellers Handbook, particularly on counterweight brackets and accessories.
