## AIRCRAFT ACCIDENT INVESTIGATION AND INQUIRY BOARD

### **FINAL REPORT**

**RP-C1174**  
**TEXTRON AVIATION INC. CESSNA U206F**

**TITLE:** An accident involving a Textron Aviation, Inc. C-U206 type of aircraft with Registry Number RP-C1174 had a Controlled Flight Into Terrain (CFIT) accident at the mountainous area of Barangay Ditarum, Divilacan, Isabela, Philippines on January 24, 2023, at around 1455H.

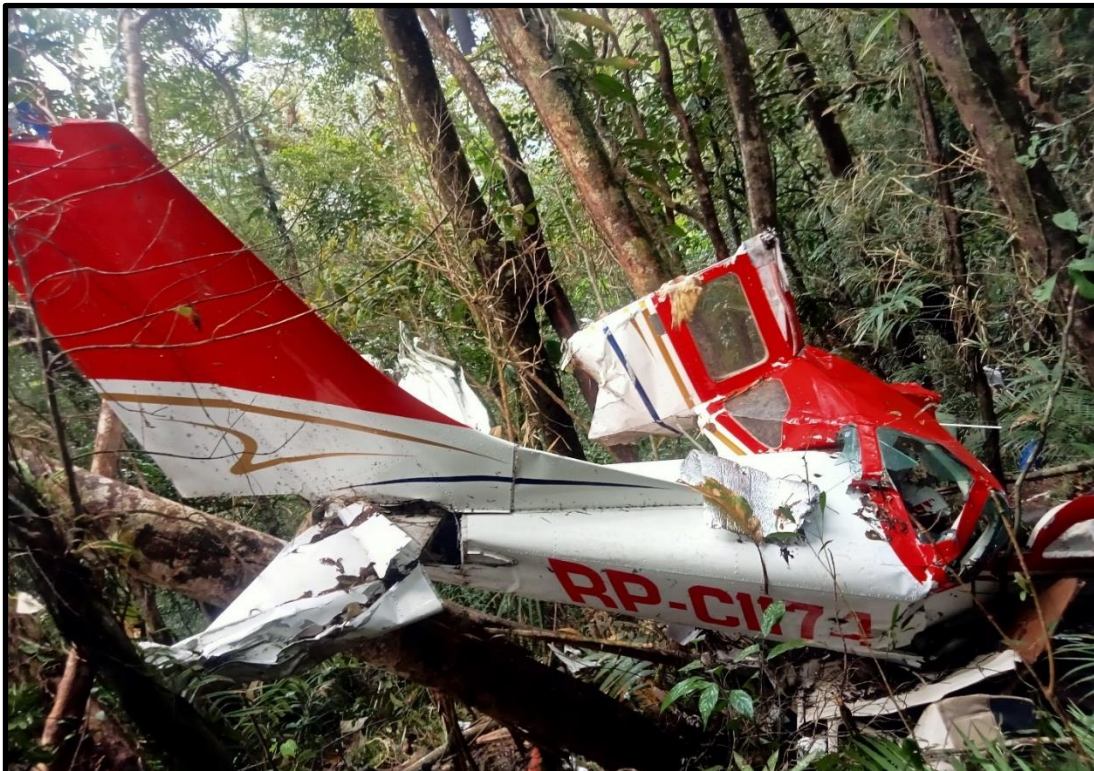
1. Only the empennage section of the aircraft remained relatively intact and was found lodged in between trees in a down-sloping position.
2. The engine was located in the lower part of the mountain, some distance away from the main fuselage.
3. Observed crumpled and detached sections of the wings and horizontal stabilizers;
4. A broken section of the propeller tip was found at the site.
5. Passenger seats were discovered among the wreckage located below the hill and farther away from the main fuselage.
6. The nose landing gear was noted to be detached from the aircraft.

Figure 1 – RP-C1174 at the accident site.

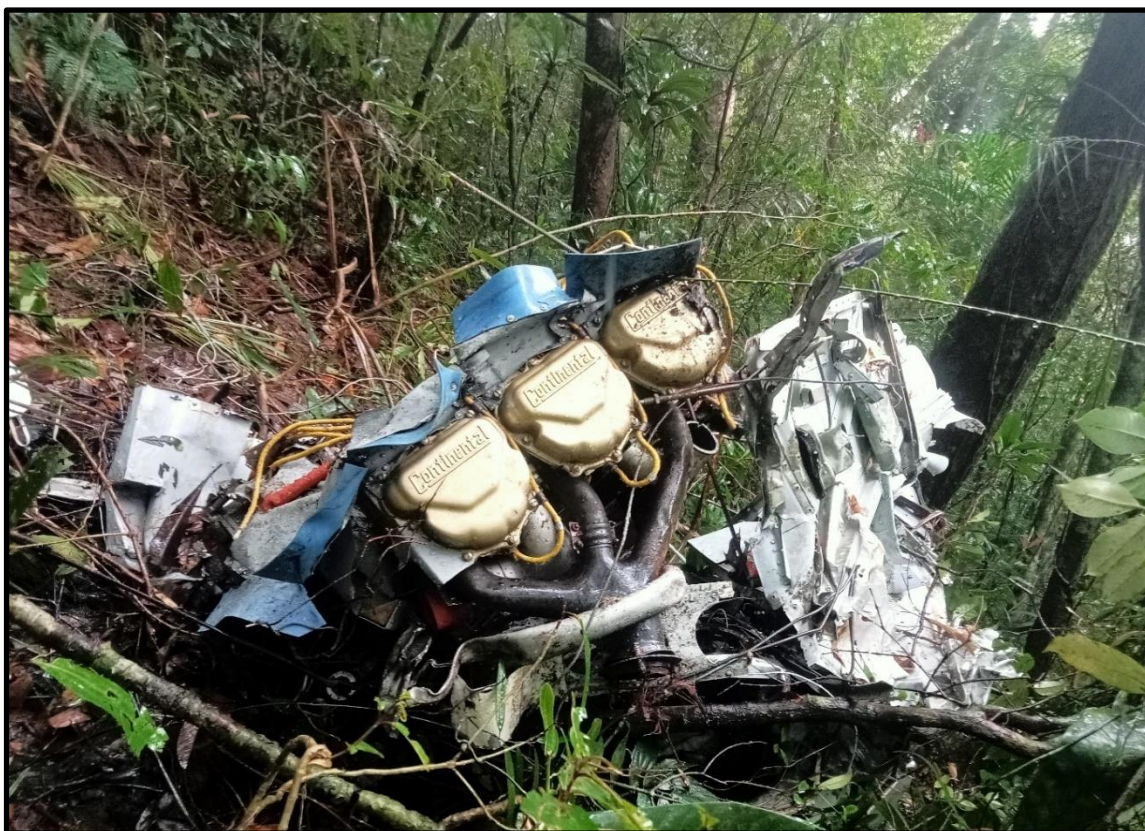
Figure 2 – Aircraft engine located some distance away from the fuselage.

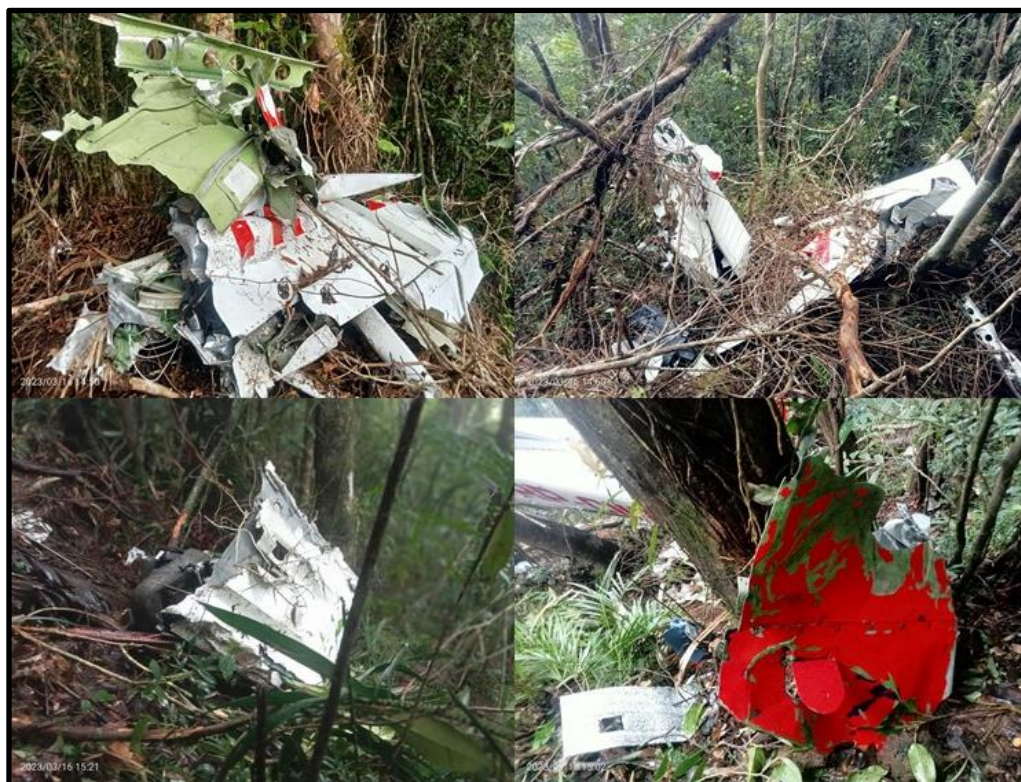
Figure 3 – Aircraft parts scattered within the crash site

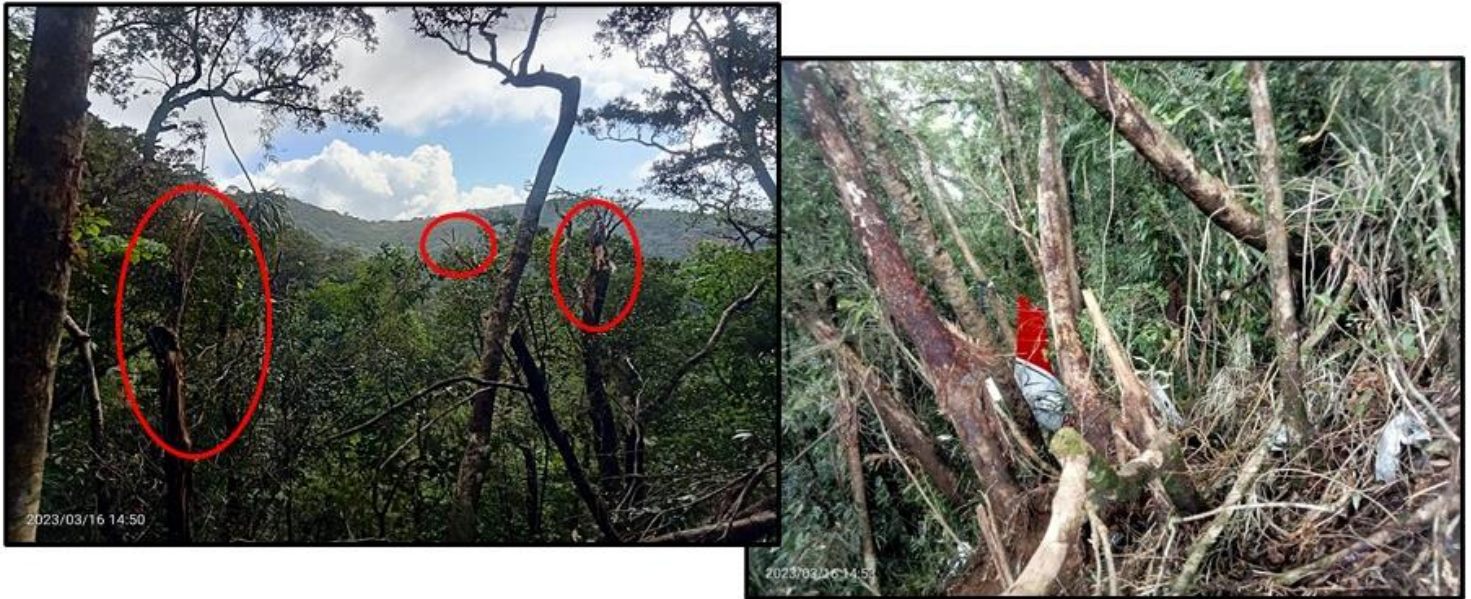
Figure 4 – Branches of tress hit by the aircraft during its descent.

extremely high impact forces, causing the fragmentation and breakup of the aircraft structure. The combination of the aircraft's velocity and the robustness of the trees likely resulted in the latter. Analysis of the wreckage pattern and the distribution of debris from aircraft components clearly indicates that the aircraft encountered these sturdy trees during its descent.

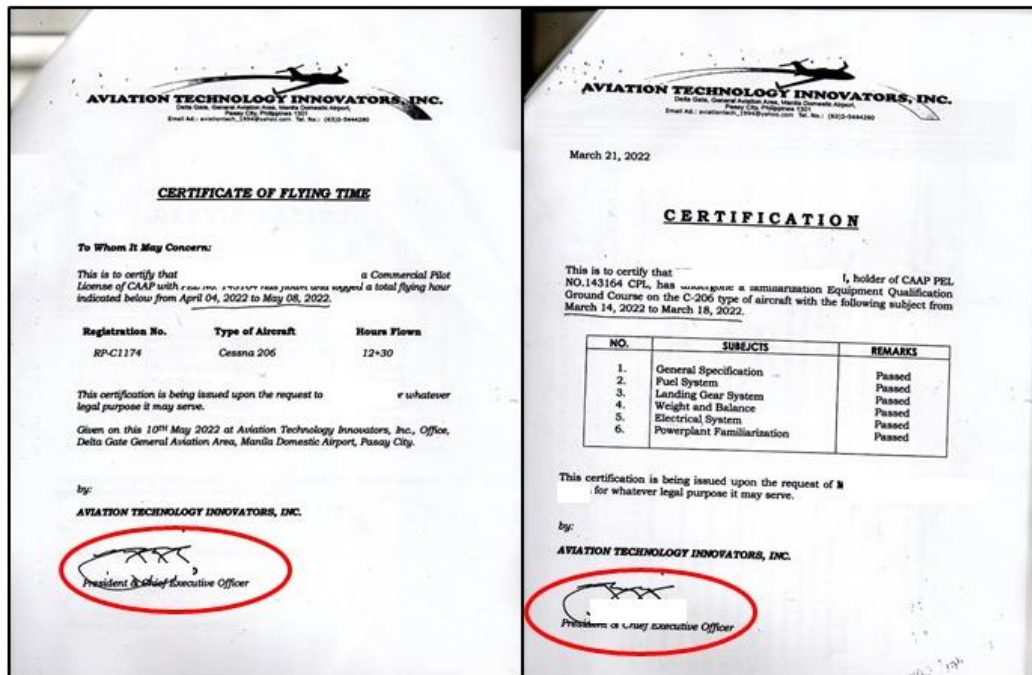
With the above results of the interview and validation of records, a conclusion can be drawn that falsified documents were indeed submitted to CAAP in connection with the pilot's application for an additional rating on the Cessna 206.

Figure 5 – Documents submitted by the involved pilot during his application for additional aircraft type rating which was allegedly issued by ATII.

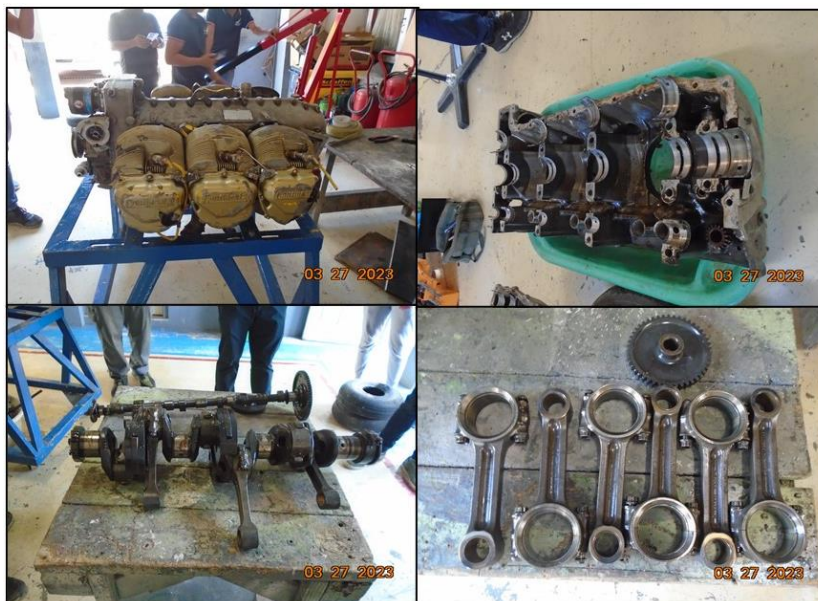
Figure 9 – Pictures of the engine during the teardown inspection last March 27, 2023.

- 3.1.2** The aircraft has valid Certificates of Airworthiness and Registration.
- 3.1.3** The aircraft was released for flight without any recorded maintenance issues. Likewise, teardown inspection of the engine disclosed that all engine components that were found to be defective or structurally damaged during disassembly appear to have been damaged due to impact.
