AIRCRAFT ACCIDENT INVESTIGATION AND INQUIRY BOARD

FINAL REPORT

RP-C 1234
PIPER AIRCRAFT INC., PA-32-300

TITLE: Accident involving a Piper Aircraft Inc., PA-32-300 type of aircraft with Registry Number RP-C1234 owned and operated by Fliteline Airways Philippines Inc. that experienced controlled flight into-terrain within the vicinity of Barangay Casala, San Mariano, Isabela, Philippines, on November 30, 2023 at about 1040H (local).

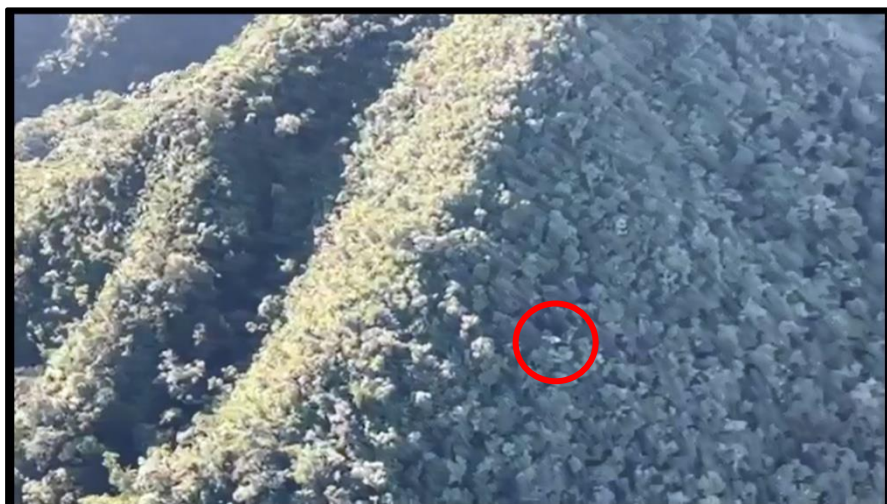
Figure 1 – The aircraft at its final resting point at about 3,800ft ASL.

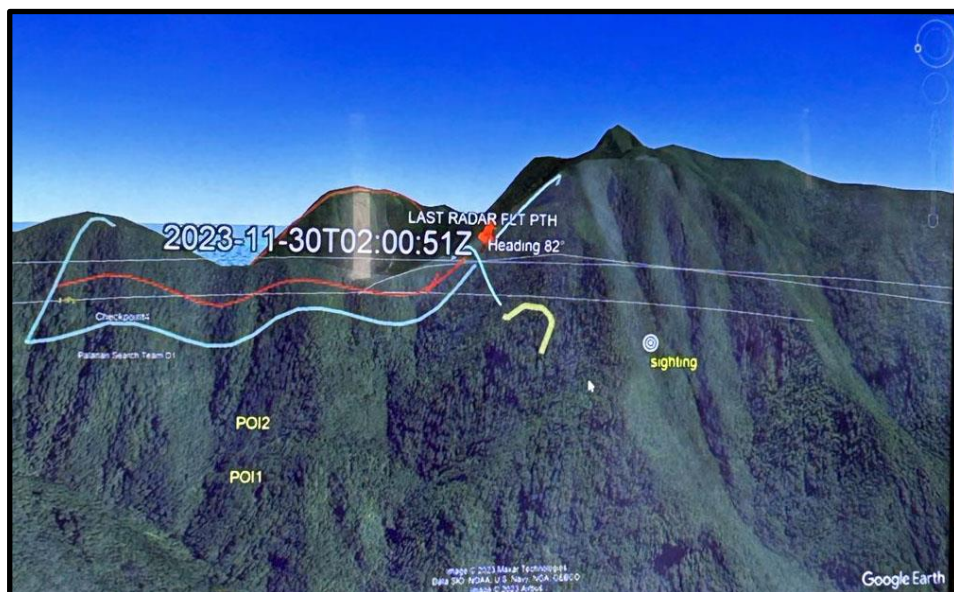
The evidence of the aircraft's initial impact point was on the west side of the mountain at 16.87170104N 122.25588149E, with the aircraft's final heading being north (Figure 3). The main wreckage is composed of the nose/crew section, cockpit instrument panel, engine, propeller, and left wing, with thermal damage on its tip-tank. Also found was the empennage with its vertical and horizontal stabilizers.

Figure 3 – The aircraft initial impact point sighting.

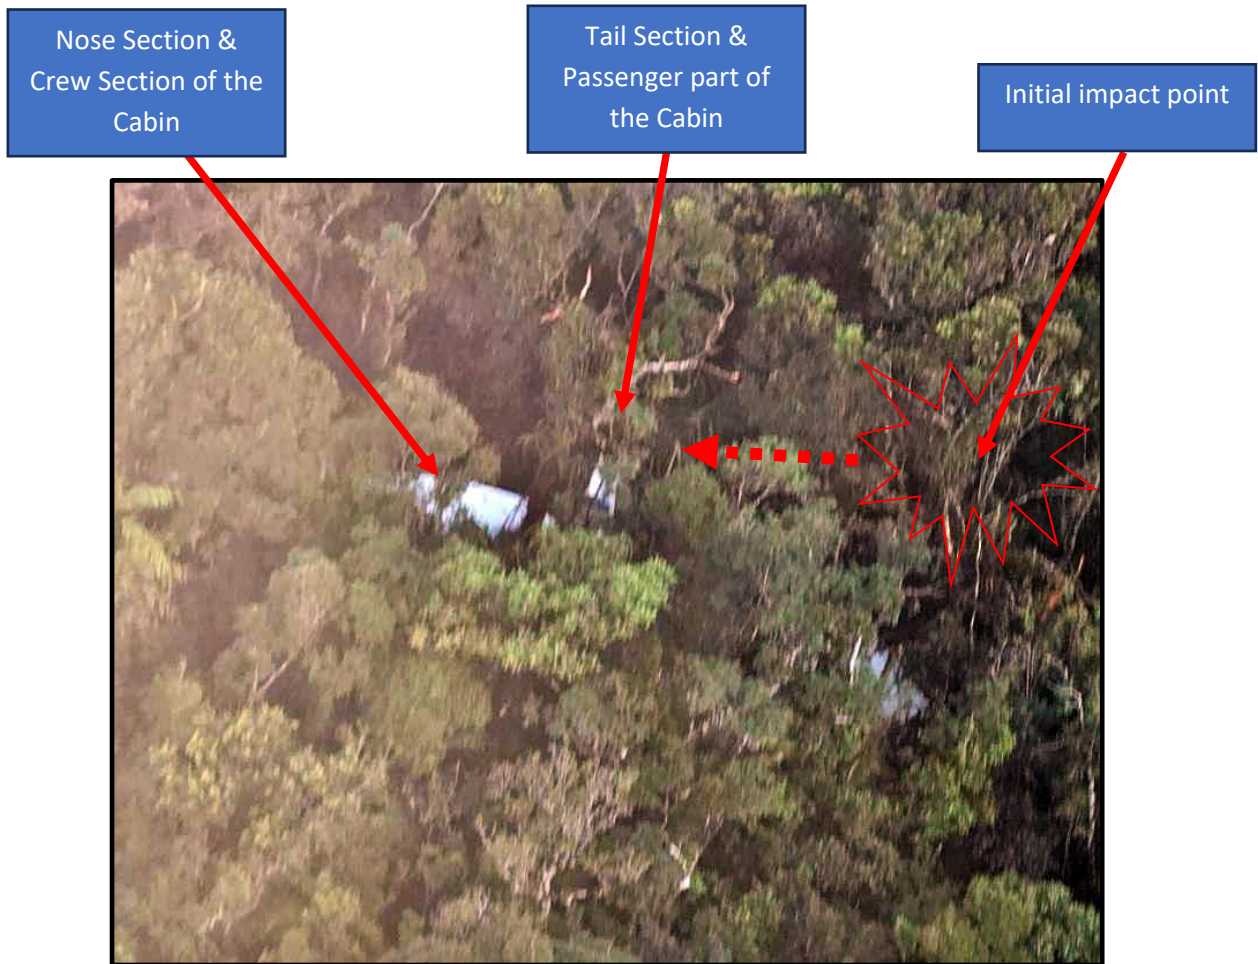
The initial impact was at an approximate elevation of 3,800 feet MSL on a very steep side of a mountain slope. The aircraft's right wing initially came into contact with a tree, severing it from the fuselage while in a turning climb maneuver to the left. The direction of impact also shows that the left wing also collided with a tree and got separated from the fuselage moments before its full stop. Moreover, both aircraft vertical stabilizers came into contact with two (2) trees, arresting the passenger/tail section and splitting the fuselage nose/crew section between the wings. The propeller indicates rotational movement upon impact. The aircraft was perched on thick vegetation covering the mountainside (Figure 4).

Figure 4 – The main wreckage.

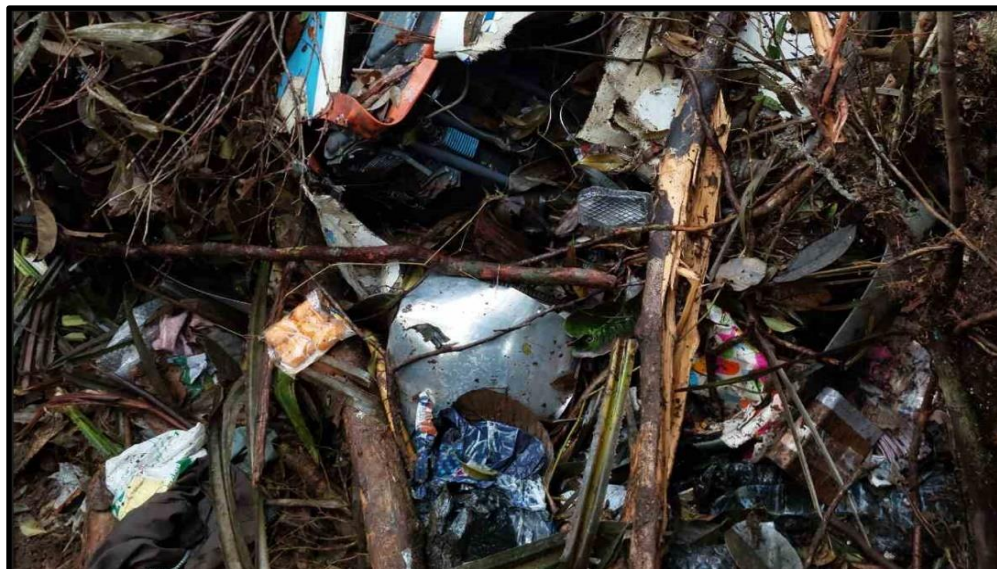
Most of the significant components of the aircraft were located within the main wreckage area, which was about one hundred (100) feet in diameter. A pictographic examination of the propellers exhibited substantial damage. (Figure 5).

Figure 5 – The propeller.

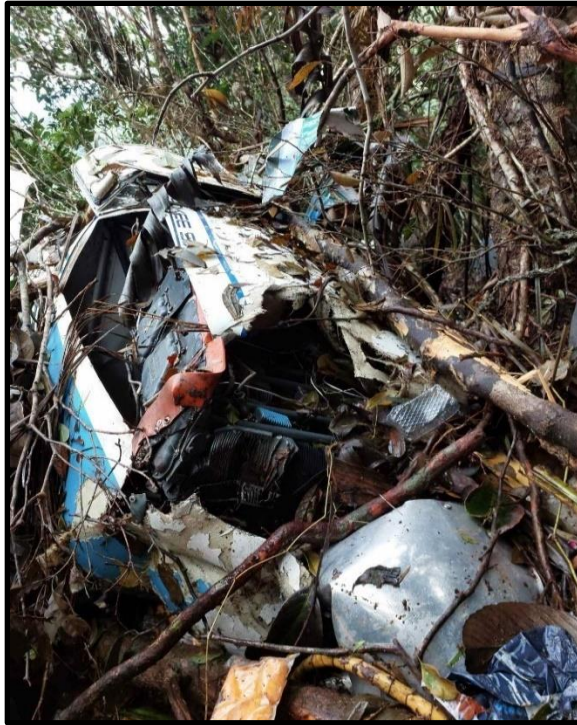
The engine (Figure 6) and its nomenclatures were intact and found within the nose section of the aircraft.

Figure 6 – The engine.

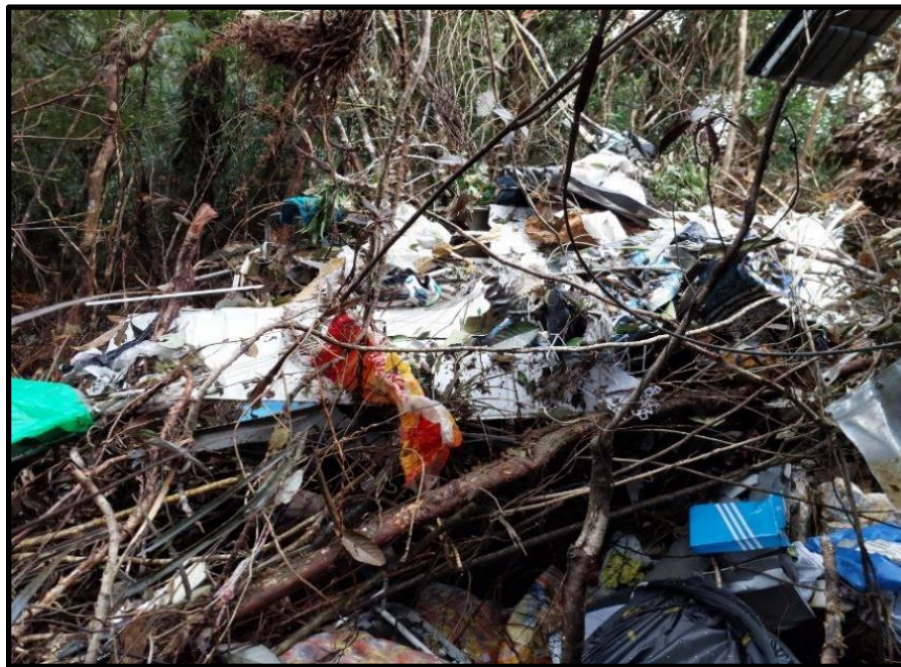
The left wing (Figure 7) was just below the left side of the passenger part of the cabin, caught on the tree roots of the ridge. Its wing tip tank was detached, driven forward by the momentum of the impact, and caught fire (Figure 8).

Figure 7 – The left wing.

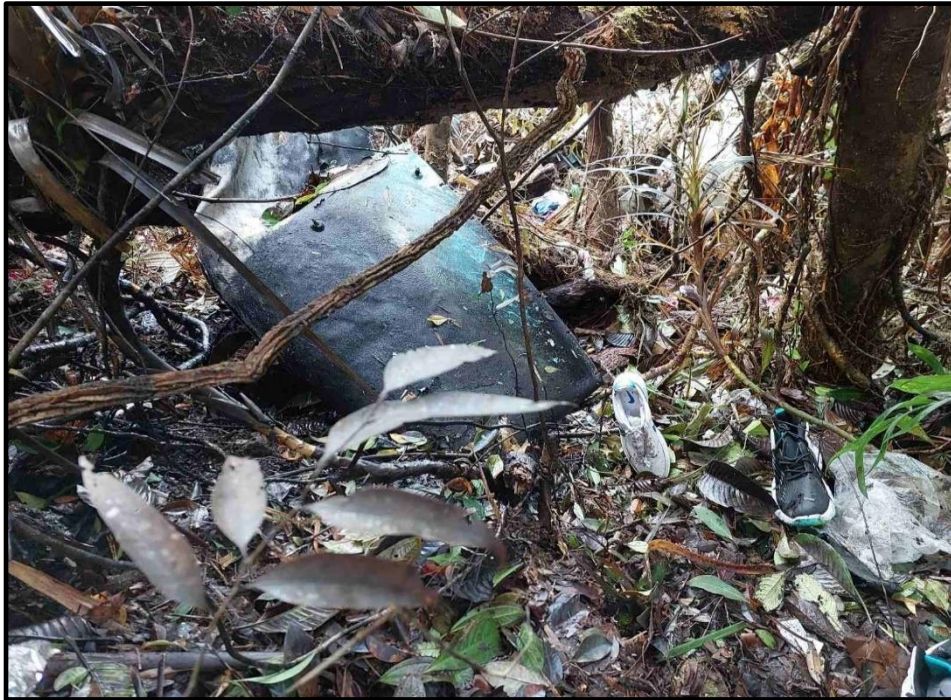
Figure 8 – The left-wing tip tank.

Post-crash fire was limited to most part of the Left-wing tip tank after the ground impact.

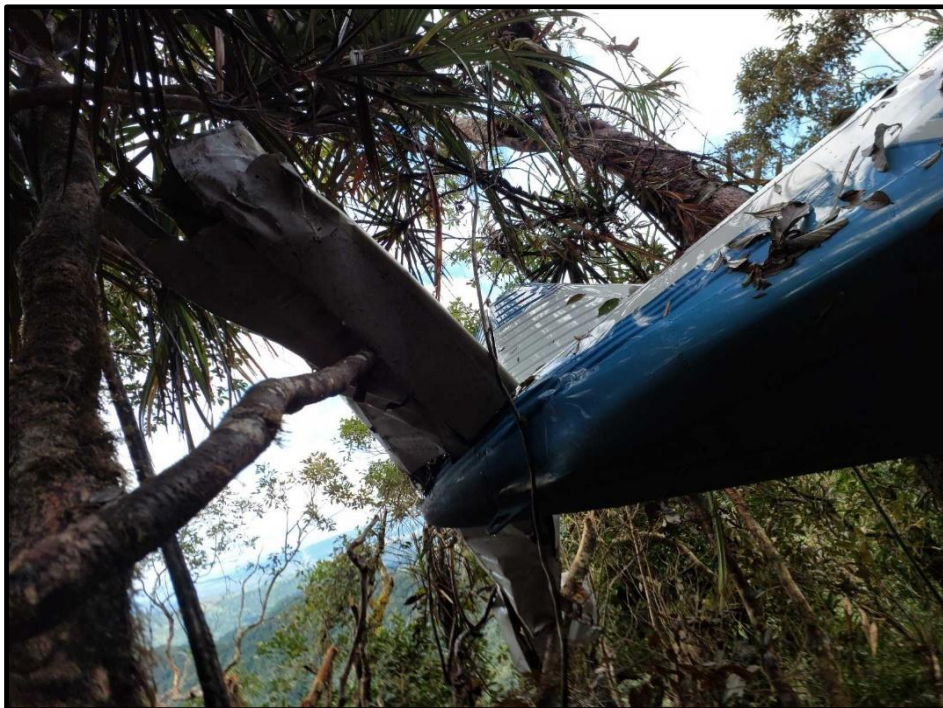
The empennage with its vertical and horizontal stabilizers caught on the trees (Figure 9).

Figure 9 – The empennage.

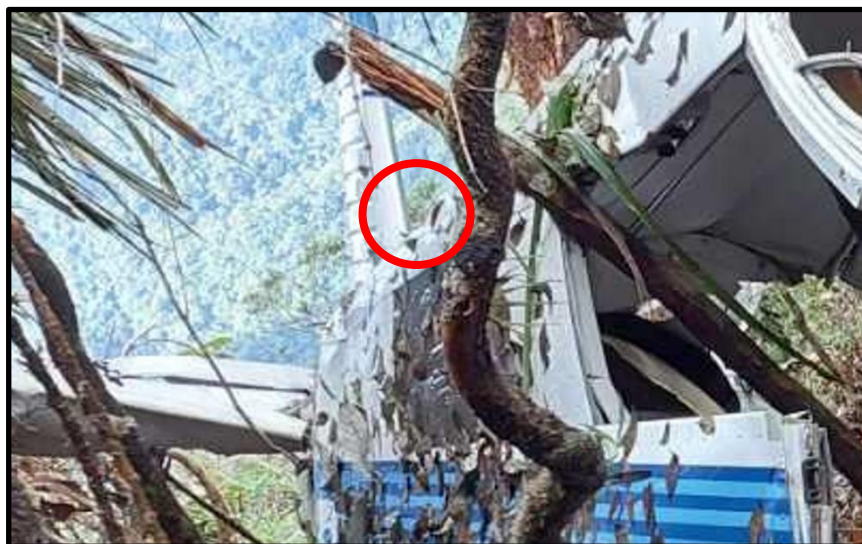
The ELT was not recovered during retrieval operations on December 9, 2023. There was no distress signal received by any Emergency Locator Transmitter (ELT) monitoring center worldwide. Pictures of the wreckage show no indication of the ELT antennae (Figure 10). This was probably detached due to the high magnitude of the force impact. The separation of the antennae from the ELT unit explained why no distress signal was transmitted.

Figure 10 – Missing ELT antennae.

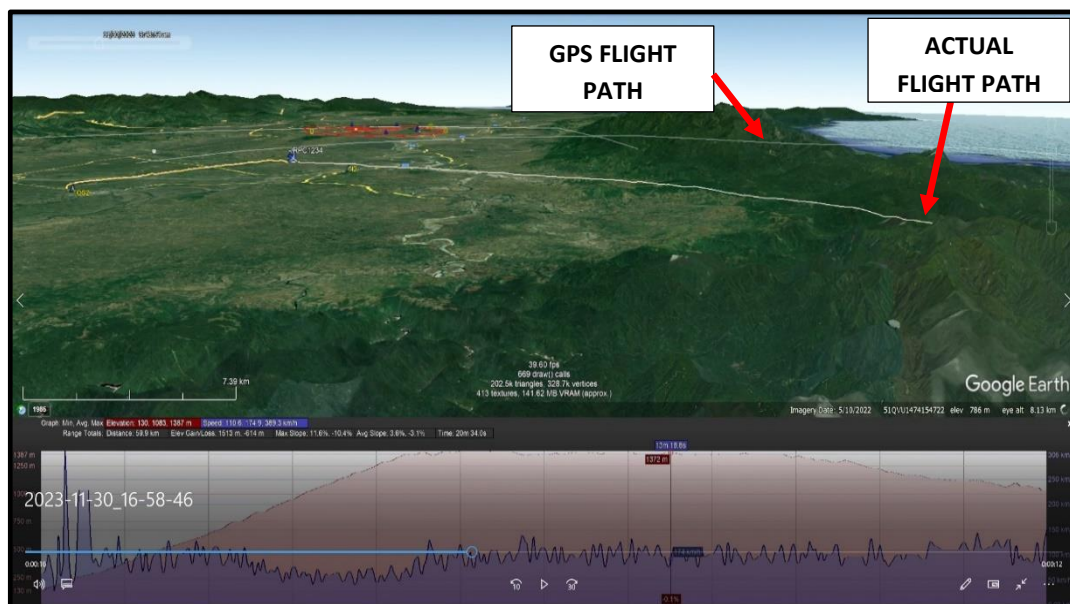
With the aircraft limited to VFR operation, the pilot must operate the aircraft with visual to the ground and visually avoid obstructions and other aircraft. Visual flight rules (VFR) are a set of regulations under which a pilot operates an aircraft in weather conditions that are generally clear enough to allow the pilot to see where the aircraft is going. Under VFR, if flying at an altitude below 10,000 ft, pilots shall maintain 5,000 ft of visibility, 1,000 ft above the highest terrain, and below clouds, respectively. This is to be able to see outside the cockpit, control the aircraft's altitude, and avoid obstacles as well as other aircraft. Given the details about the prevailing weather at the time of the accident and the terrain features along this route, it is evident that these factors played a substantial role in the occurrence of this accident.

Figure 13 - The flight paths.

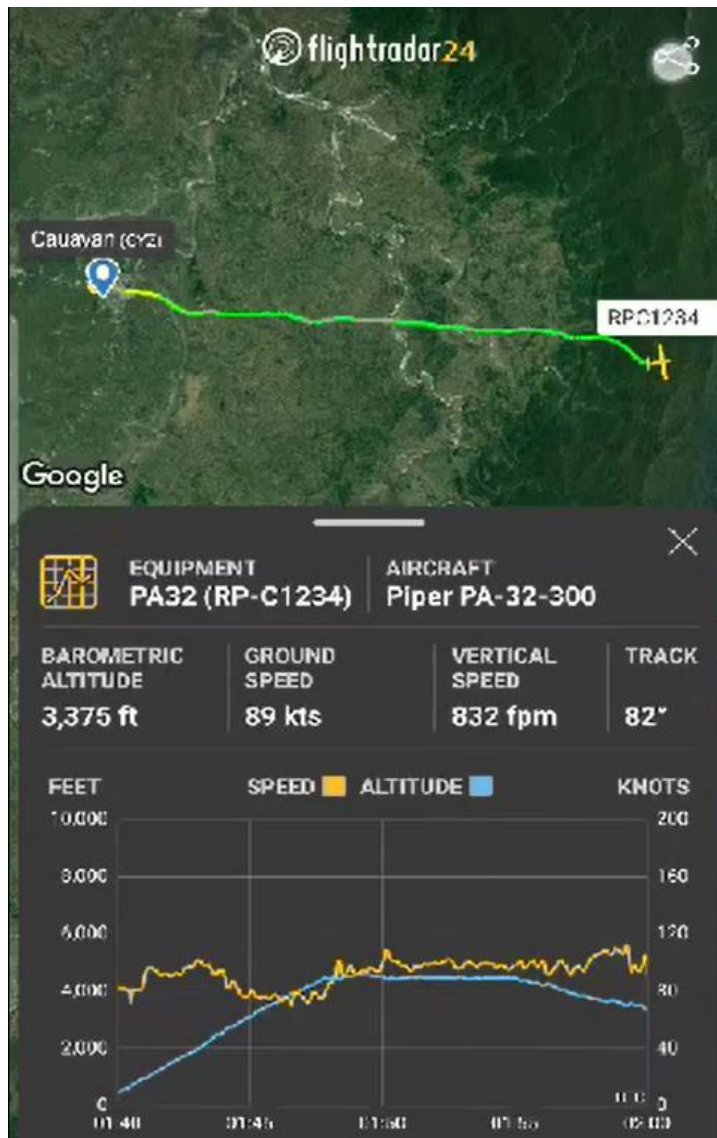
The degraded awareness of the surrounding terrain made it difficult for the pilot to recognize potential hazards and take corrective action in a timely manner. Shown below is the navigational flight route plotted by the application for a more familiar representation (Figure 14).

Figure 14 - Navigational flight route plotted on Google Earth.

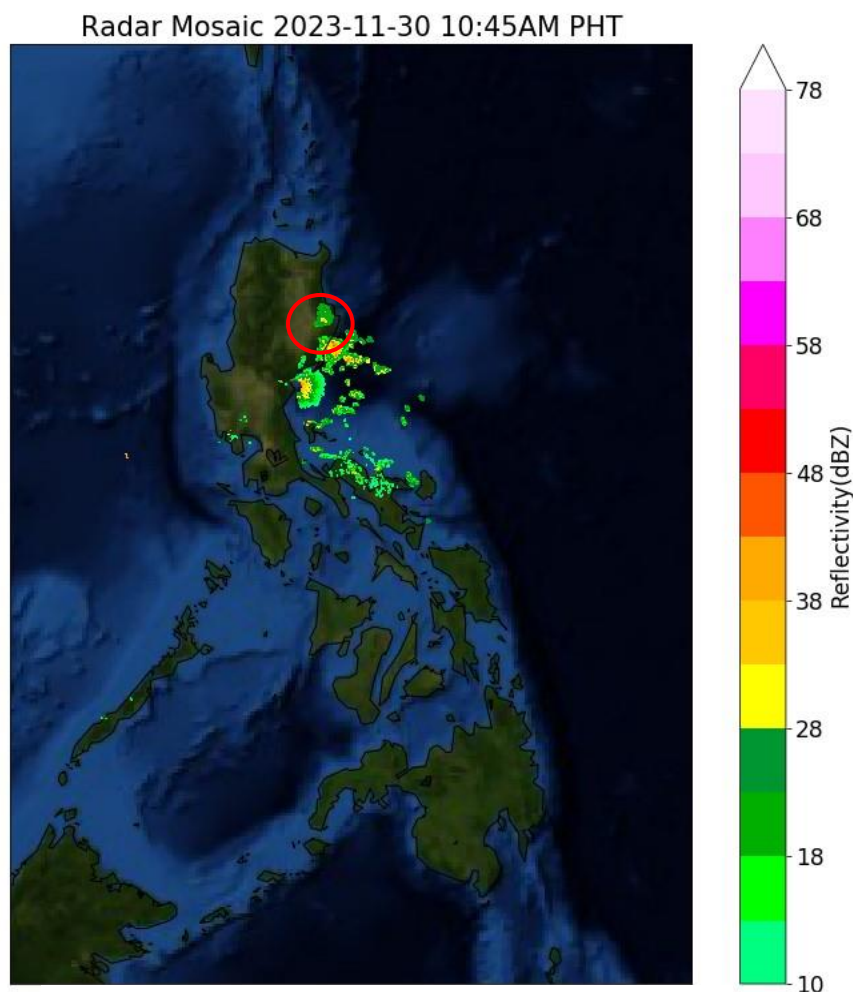
The weather captured by DOST-PAGASA RADAR satellite station revealed that during the time of the occurrence at about 1040H, there was a large area of cloud concentration with rain over the vicinity of San Mariano, Isabela, approximately 15 NM from Cauayan, Isabela, and Sierra Madre Mountain. (Figure 15).

Figure 15 - RADAR satellite image from DOST-PAGASA.
