### **FINAL REPORT**

**RP-C 1889**  
**TECNAM P2002JF**

**TITLE:** An accident incident involving a Tecnam P2002JF type of aircraft with Registry Number RP-1889, operated by WCC Aviation Company Inc. had a forced landing event at Brgy. Baybay, Sual, Pangasinan, Philippines, on September 06, 2022, at around 1104H.

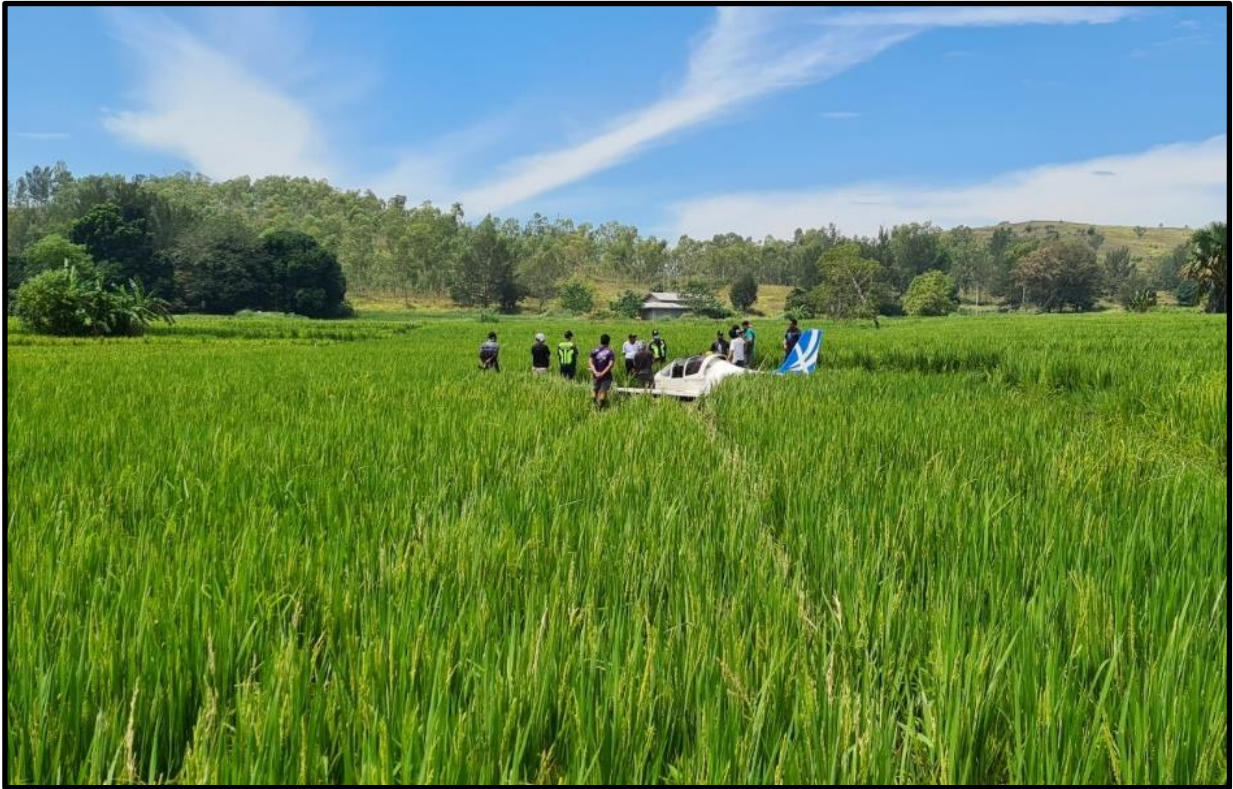
Upon impact, the aircraft sustained damages on its lower fuselage, wings, and engine cowling area. Likewise, the aircraft propeller was noted to have been broken after contacting the ground.

Figure 1 – RP-C1889 at the middle of the rice field

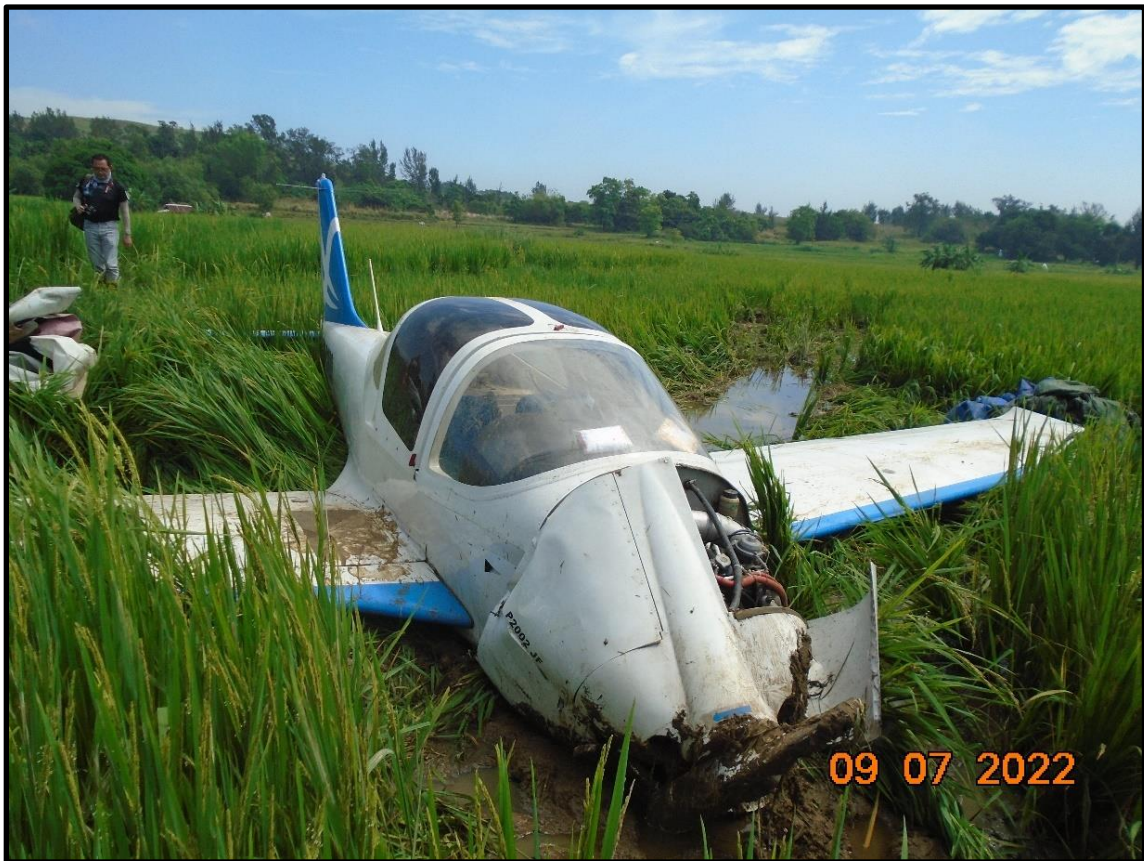
Figure 2 – RP-C1889 at its final stopping point

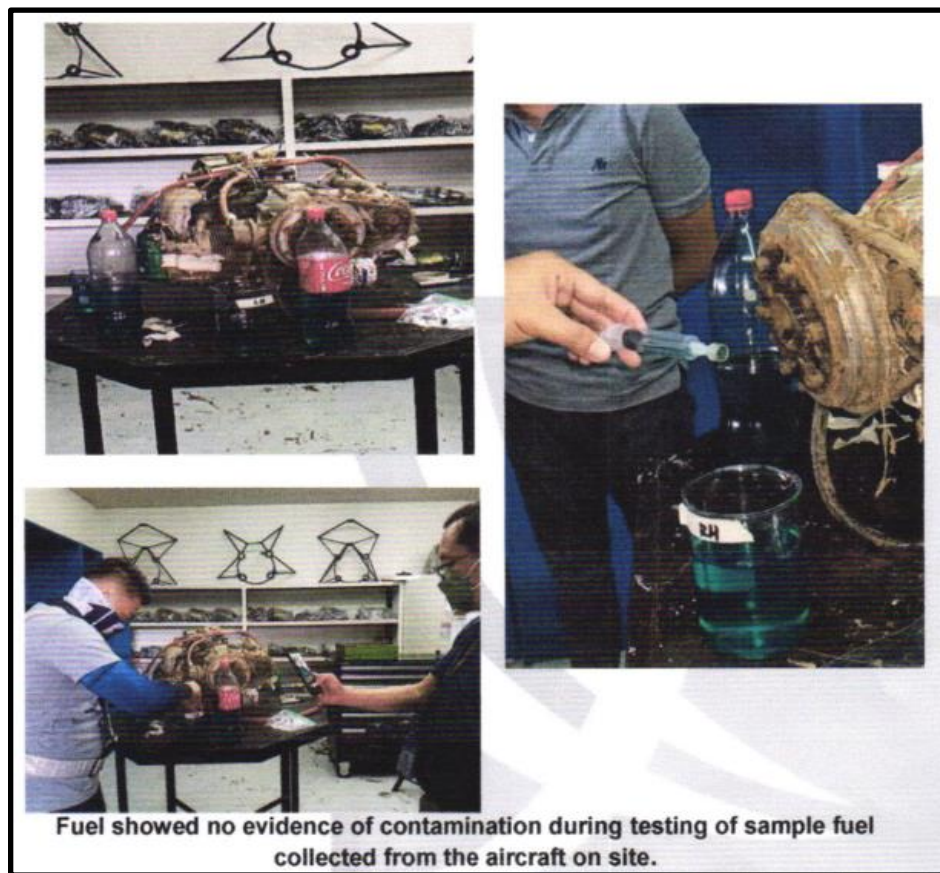
1. Magnetic chip detector was removed from the oil sump and visually examined for any metal chips and no significant amount of metal chips was noted.
2. Fuel pump filter was removed and visually examined for contaminants that may cause clogging and no contaminants were noted.
3. Approximately one (1) liter of MOGAS was removed from each aircraft fuel tank (RH & LH) and tested utilizing an aviation approved fuel tester (Shell water detector capsule) to determine presence of water on the samples. The test showed negative result for any contamination on both samples.
4. Functional test of the engine ignition system (spark check) was conducted to the involved aircraft engine utilizing an electric starter direct cranking to determine the serviceability of the magneto (CDI). Sparks were noted in all spark plugs during this test and in correct firing order.

Figure 3 – Fuel testing for possible contaminants

- 3.1.5 There were no signs of any blocking particles on the engine oil sump as well as contaminants on the fuel which might have affected the engine performance.

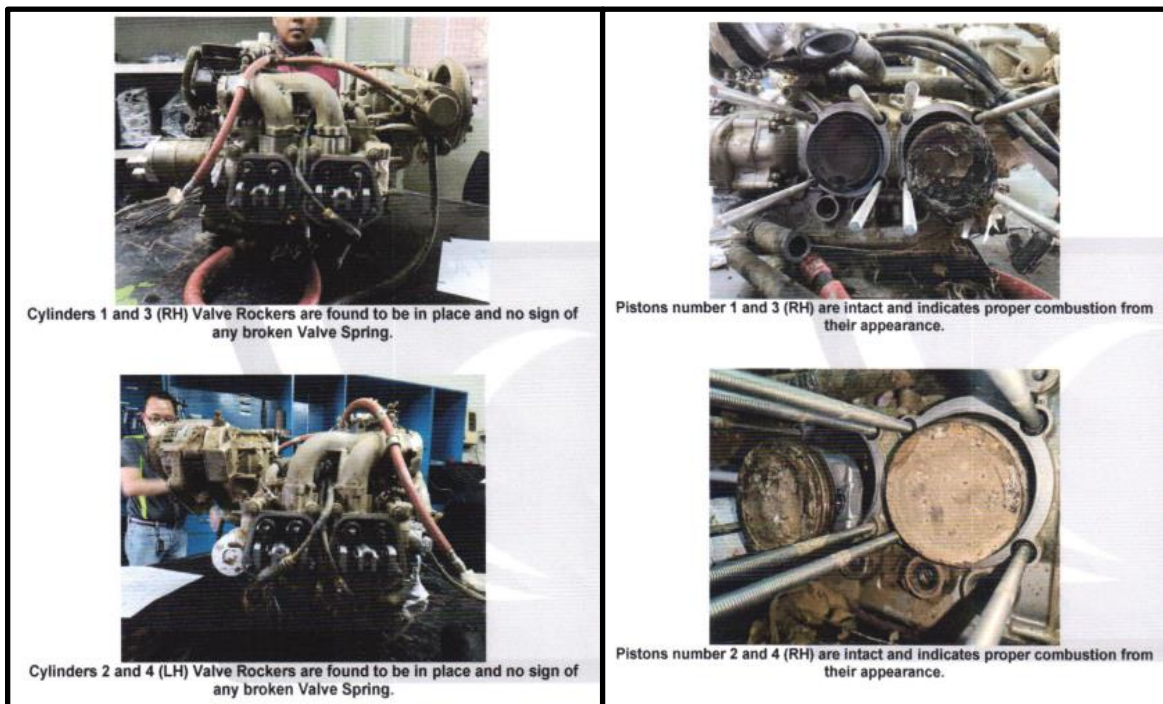
- a. Cylinders 1 and 3 (RH) including cylinders 2 and 4 (LH) valve rockers are found to be in place and no sign of any broken valve spring.
    - b. Pistons number 1 and 3 (RH) including pistons 2 and 4 (LH) are intact and indicates proper combustion from their appearance.

- d. Cylinders 1,2,3 and 4 were determined to be in good condition and without any sign of scoring or deep scratches on cylinder walls.
  - B. No metal shaving nor any debris found on the oil filter element upon examination.

Figure 4 – Engine cylinders and pistons during the top overhaul inspection

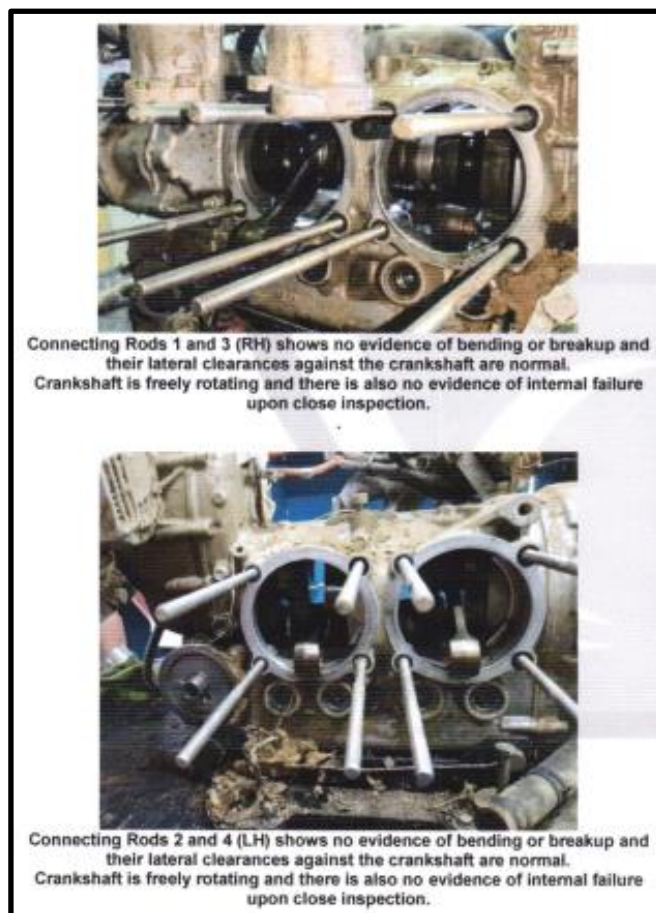
- c. Connecting rods 1 and 3 (RH) including connecting rods 2 and 4 (LH) shows no evidence of bending or break-up and their lateral clearances against the crankshaft are normal. Crankshaft is also freely rotating and there is also no evidence of internal failure.

Figure 5 – Engine connecting rods during the top overhaul inspection
