AIRCRAFT ACCIDENT INVESTIGATION AND INQUIRY BOARD

FINAL REPORT

RP-C2080
TEXTRON AVIATION INC., CE340A

TITLE: An accident involving a Textron Aviation Inc., CE340A type of aircraft with Registry Number RP-C2080 owned and operated by Energy Development Corporation that encountered Controlled Flight Into Terrain at the South West side slope of Mt. Mayon Volcano within the municipality of Camalig, Albay, Philippines, on February 18, 2023 at about 0650H/2250 UTC.

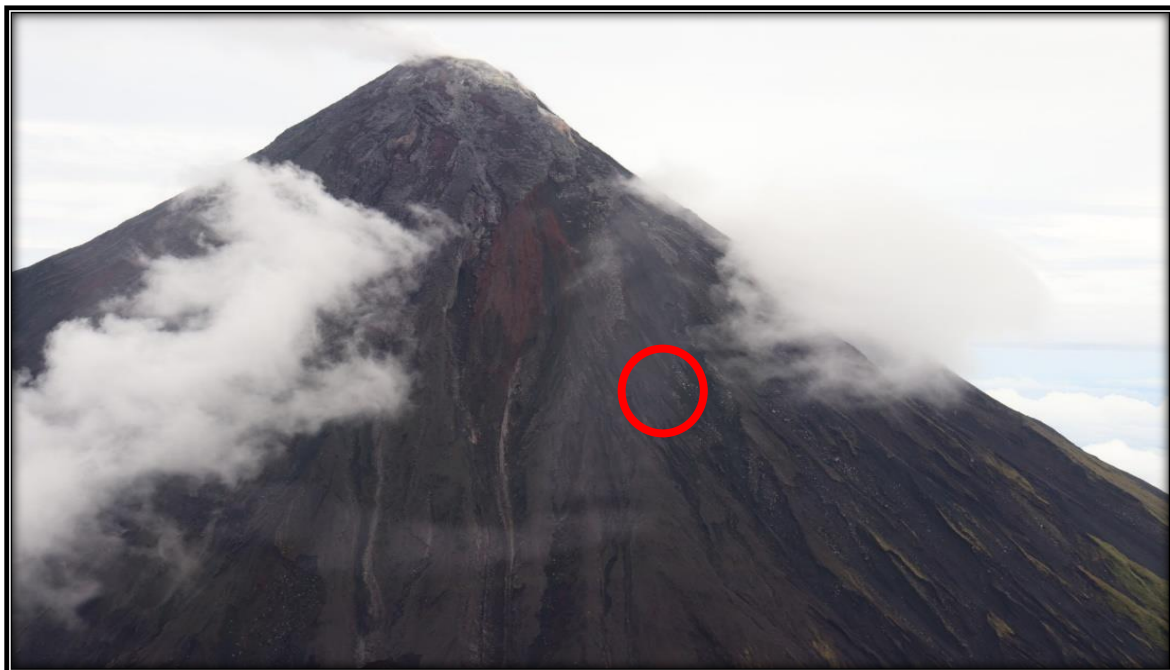
On the next day, February 19, 2023, the operator launched their own search operation using an AW139 helicopter, which was able to locate the missing aircraft at about 6,300 feet on the south-west slope of Mt. Mayon Volcano with grid coordinates of 13°14'56.45 N and 123°40'57.79 E (Figure 1).

Figure 1 – The aircraft at its final resting point at about 6,300ft.

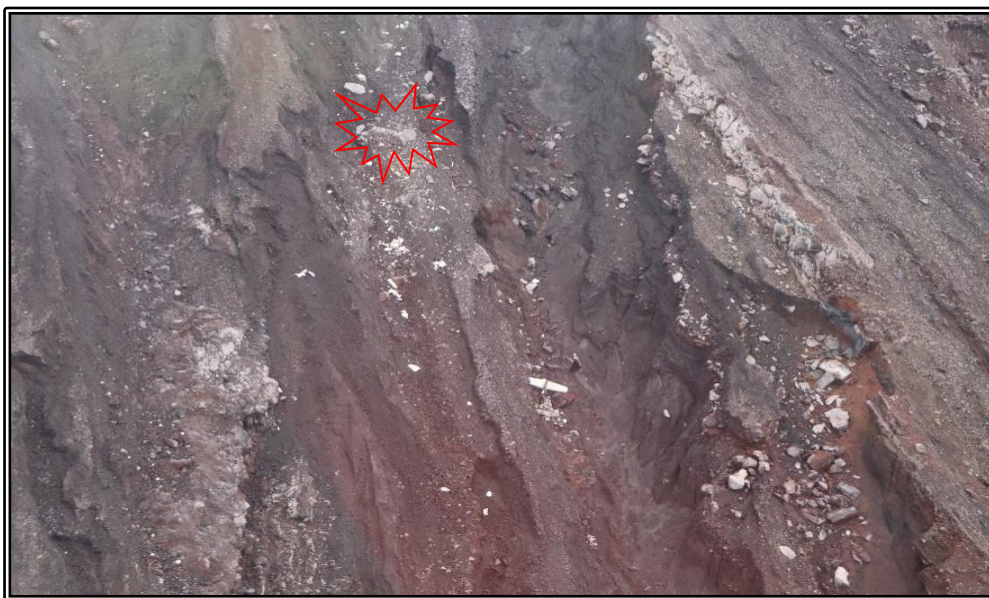
The evidence of the aircraft's initial impact point (Figure 3) is on the south-west side of the mountain and includes impact marks and pieces of aircraft debris. The initial impact site was at an approximate elevation of about 6,300 feet MSL with a 60-degree slope. The aircraft came into contact with its belly against the huge lava rock, forming a ridge. There was no crater observed as a result of the impact. The aircraft disintegrated, and it fell in different fractions down the lava channel.

Figure 3 – The aircraft initial impact point.

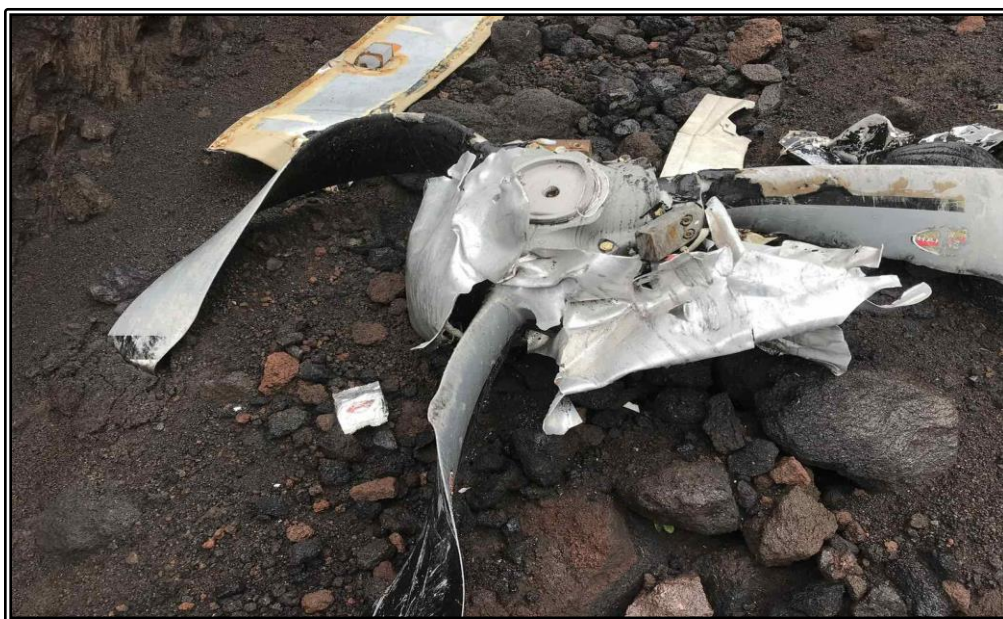
All significant components of the aircraft were located within the main wreckage area, which was about one hundred (100) feet in diameter. A pictographic examination of the propellers exhibited substantial damage. (Figure 4).

Figure 4 – The left propeller.

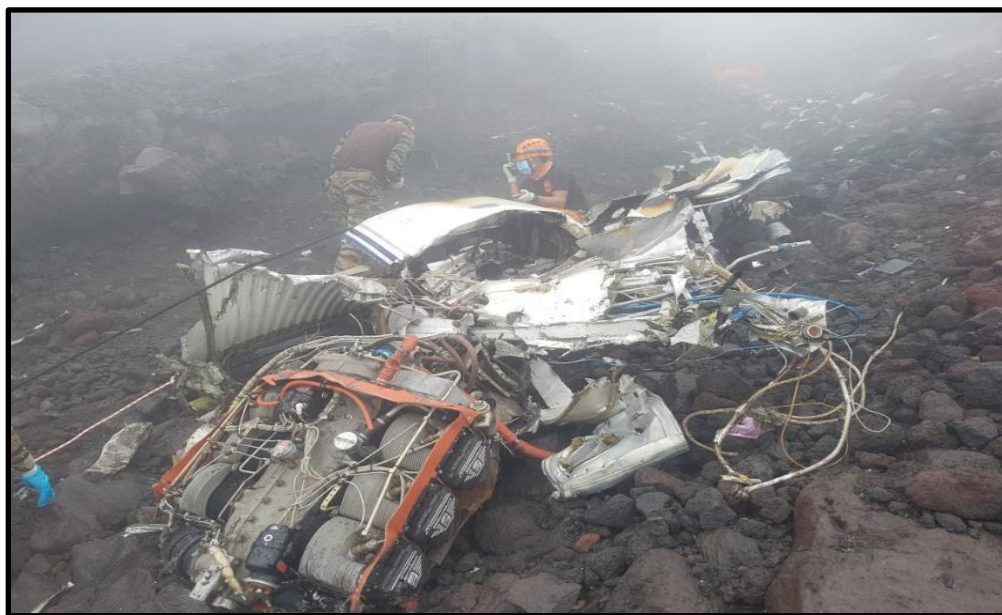
The initial point of impact consisted of highly fragmented cabin and cockpit debris. The right engine (Figure 5) and its nomenclatures were found lying on the left side of the ridge. Some parts of the right wing were found approximately fifty (50) feet below (downhill) from the initial impact point.

Figure 5 – The right engine.

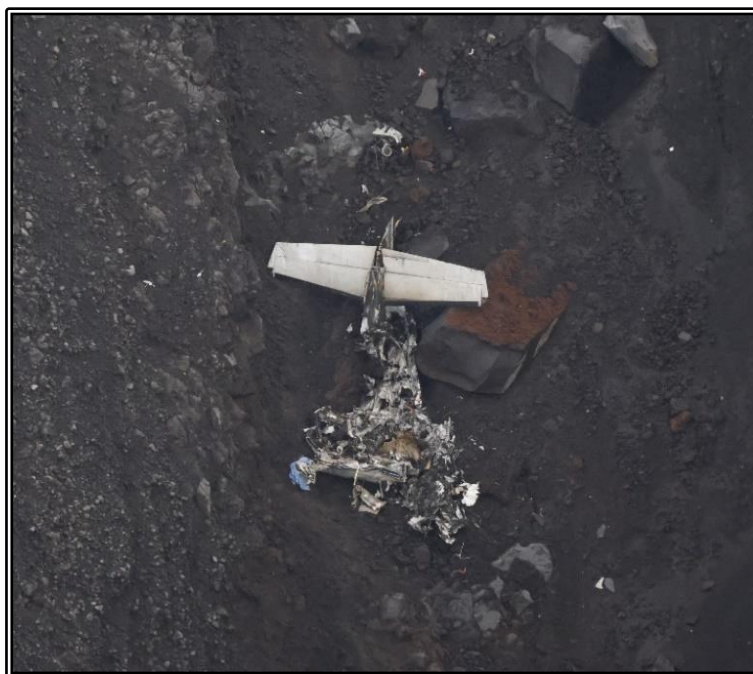
The main wreckage (Figure 6) was about one hundred (100) feet below the initial impact point and on the right side of the ridge. It is composed of the fuselage, empennage, and parts of the left engine and left wing. The cabin, nose section, avionics component boxes, and cockpit instrument panel were found obliterated with thermal damage. The empennage exhibited rotational curling damage signatures on its vertical and horizontal stabilizers.

Figure 6 – The main wreckage.

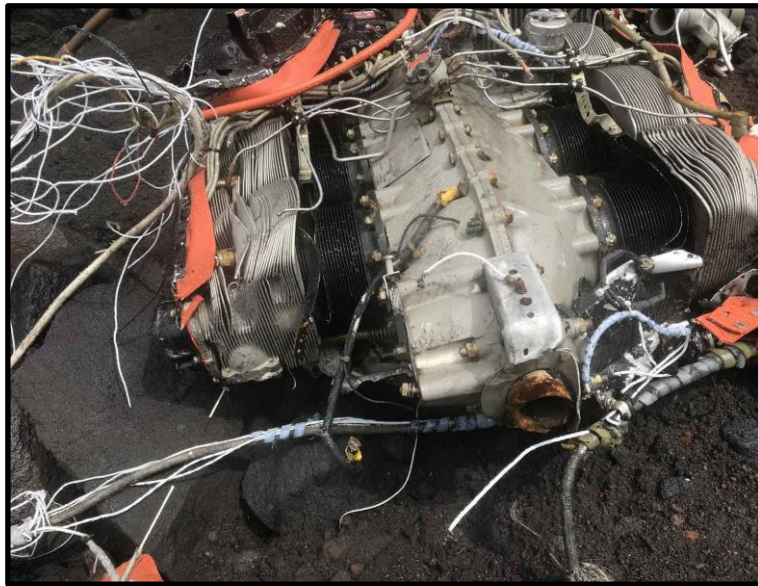
from their panel mounts. Flight controls were fragmented and fire-damaged. The left engine was found lying about fifty (50) feet below the main wreckage (Figure 7).

Figure 7. The left engine.

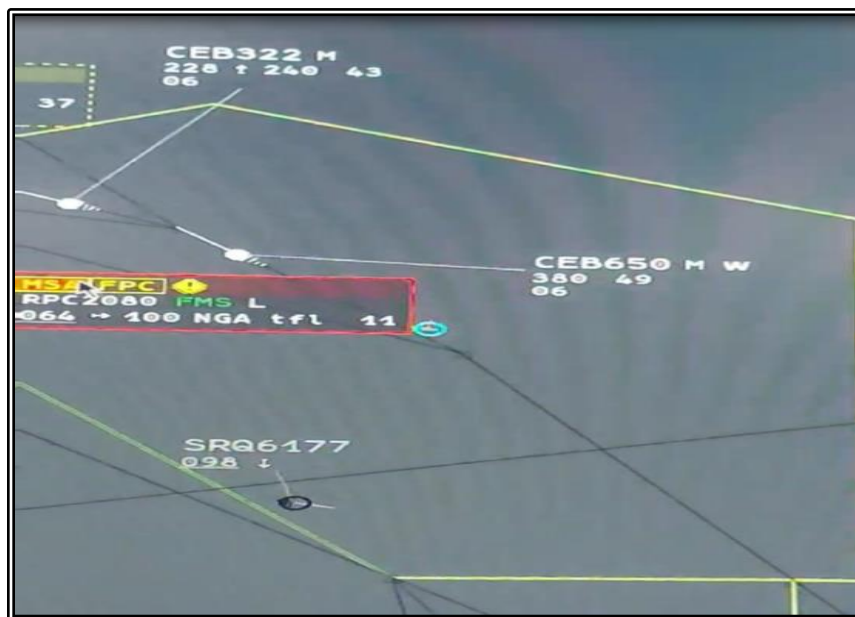
Figure 10: RADAR depicting the aircraft at an altitude 6,400 AMSL.

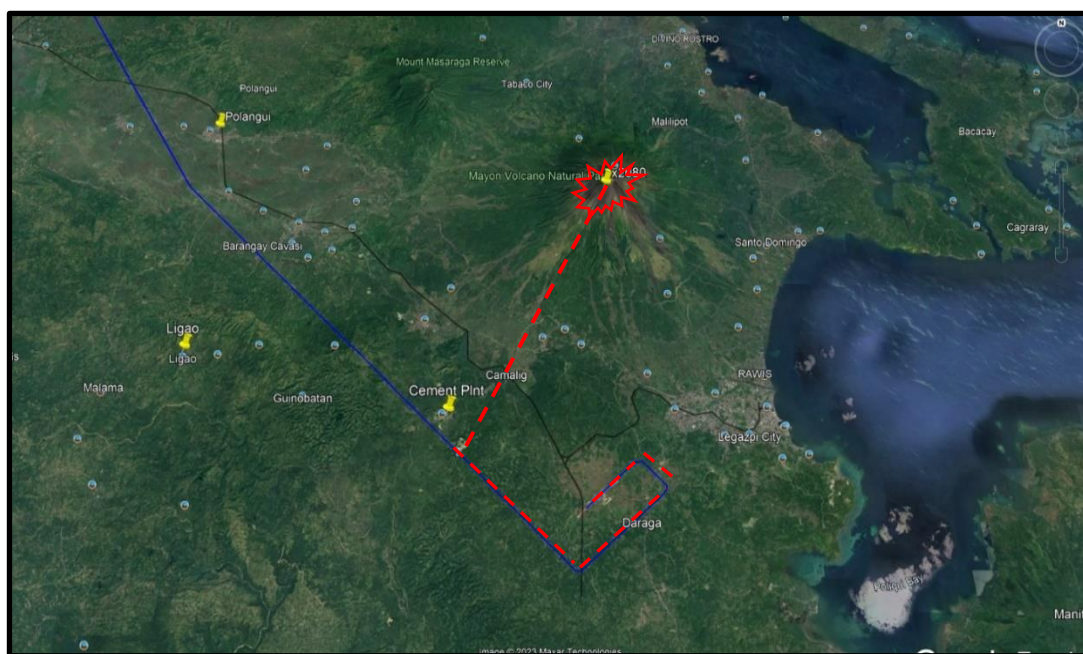
Figure 11: Navigational flight route plotted on Google Earth.

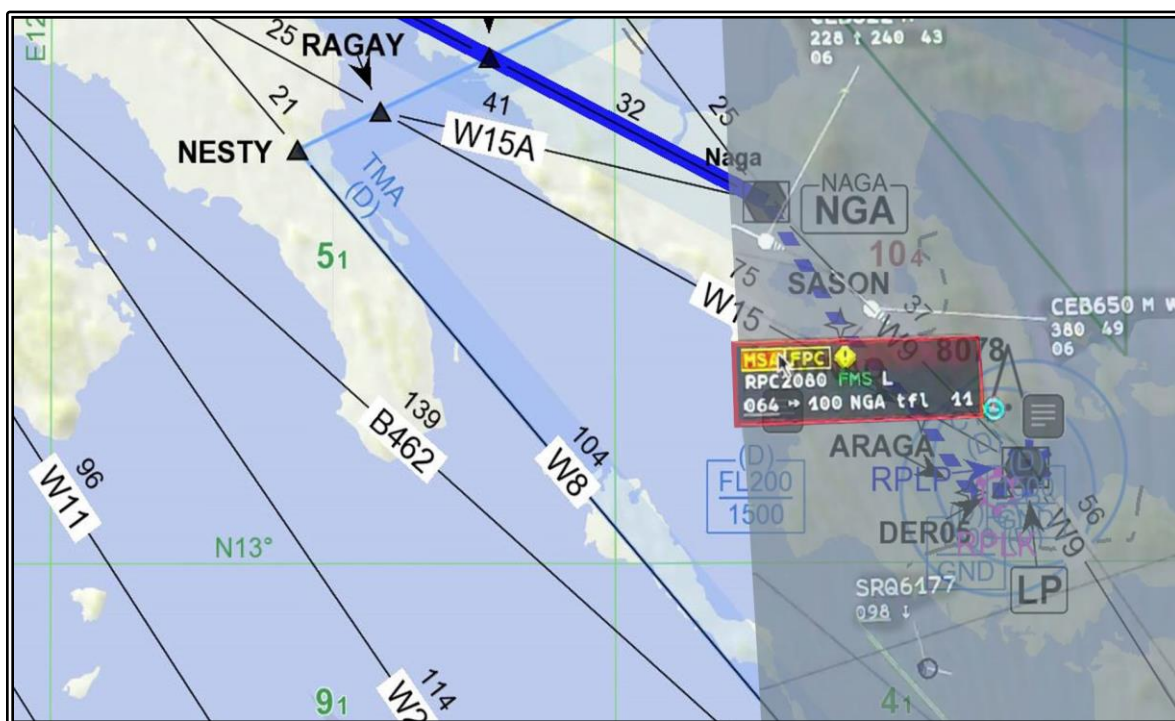
The flight was then charted and the radar overlay was added to represent that RP-C2080 came into contact with Mt. Mayon (Figure 12).

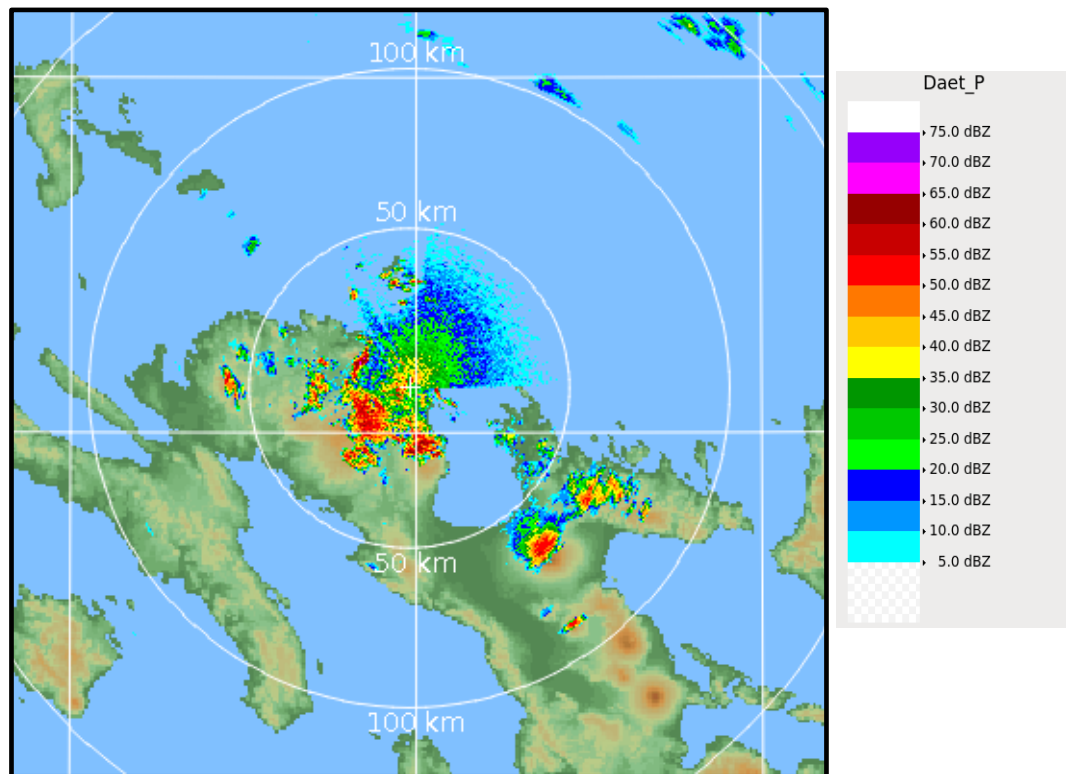
The weather captured by DOST-PAGASA, RADAR satellite, and Daet station revealed that during the time of the occurrence at about 0600H, there was a large area of cloud concentration over Mt. Mayon Volcano. (Figure 15).

Figure 15: RADAR satellite image from DOST-PAGASA.
