AIRCRAFT ACCIDENT INVESTIGATION AND INQUIRY BOARD

FINAL REPORT

RP-C5230
TWIN COMMANDER LLC 685

TITLE: An accident involving a Twin Commander LLC 685 type of aircraft with Registry Number RP-C5230 owned and operated by Sentinel Logistics Enterprise had a ditching occurrence at the waters of Brgy. Sto. Rosario, Iba, Zambales, Philippines, on March 17, 2022, at around 0730H.

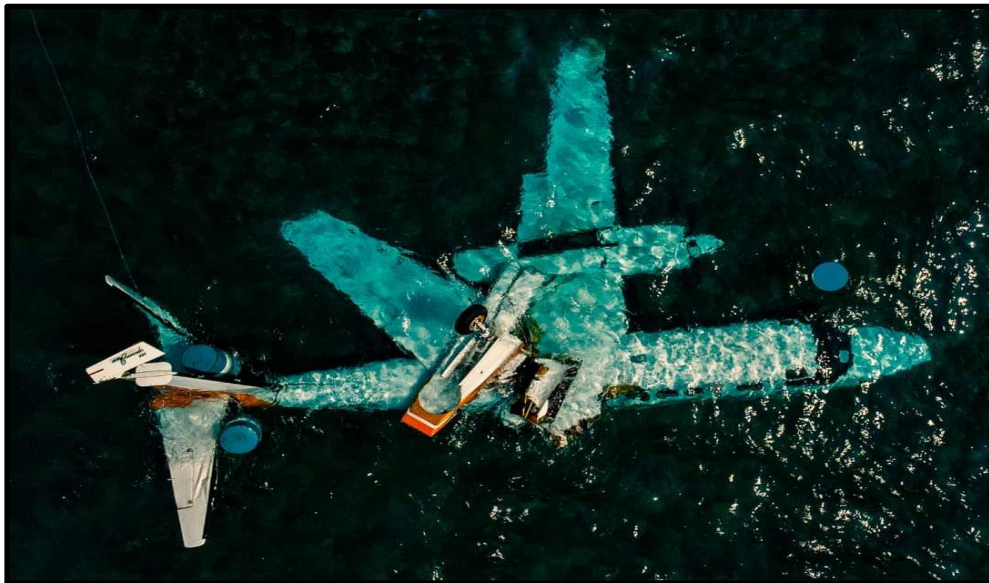
The aircraft last position after ditching was at coordinates 15°20'06.6" N, 119°57'35.5" E and about 1 kilometer from the threshold of Iba airport runway 14. Following the aircraft's impact, it eventually submerged under water at around 5-10 feet below. The aircraft was later recovered from the crash site through the effort of the LGU and PNP Maritime Unit. It was towed to the shoreline of Brgy. Bangantalinga, Iba, Zambales which is about 1.3 kilometers from the accident site for temporary safekeeping. Moreover, substantial damage on the aircraft fuselage, wings, tail section and engines were noted because of this water landing. Please see figures 1-3.

Figure 1 – RP-C5230 at the waters of Brgy. Sto. Rosario, Iba, Zambales

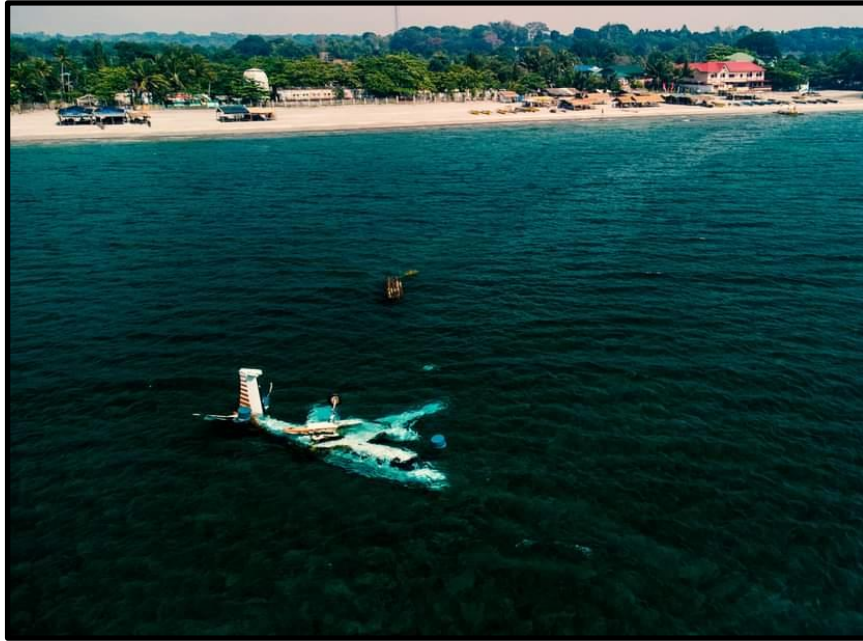
Figure 2 – RP-C5230 being towed near the shoreline

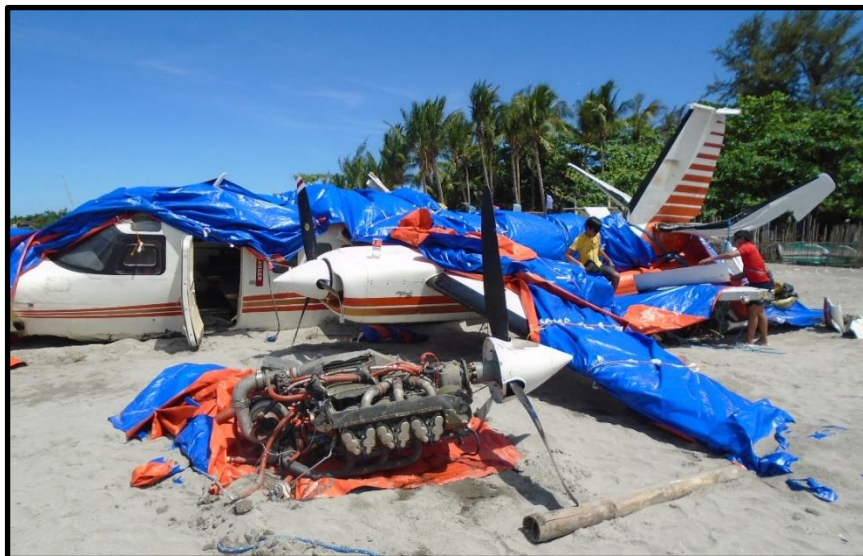
Figure 3 – The aircraft after it was recovered from the water

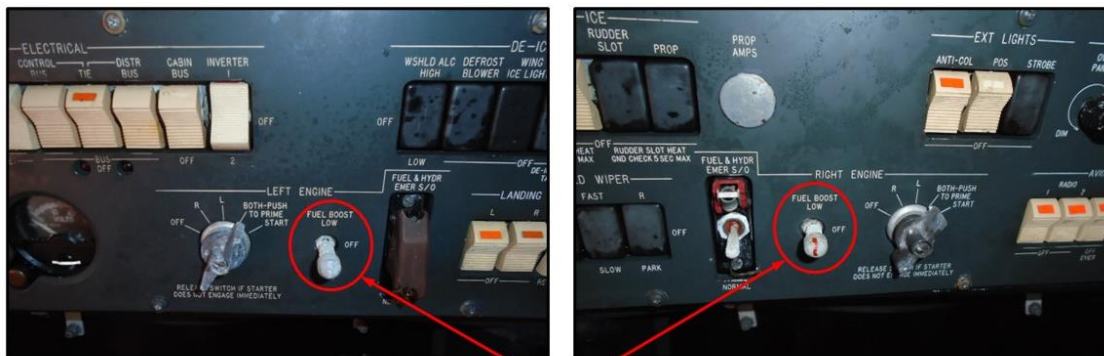
Fuel Boost Pump Switch

On the statements given during the investigation, it was alleged by the PIC that the aircraft initially experienced low engine power on the left engine followed by the right engine before ditching. Inspection by CAAP investigators of the cockpit during the site investigation, reveals that the fuel boost pump switches of both engines were at OFF position. (Figure 4).

Figure 4 – Fuel Boost Pump set to OFF

With both fuel boost pump at OFF position suggests that the pilot failed to follow what is in the checklist and is not familiar with the operation of the aircraft.

- a. Low engine power caused by the absence of fuel pressure supplied to the engine-driven fuel pump for vapor suppression.

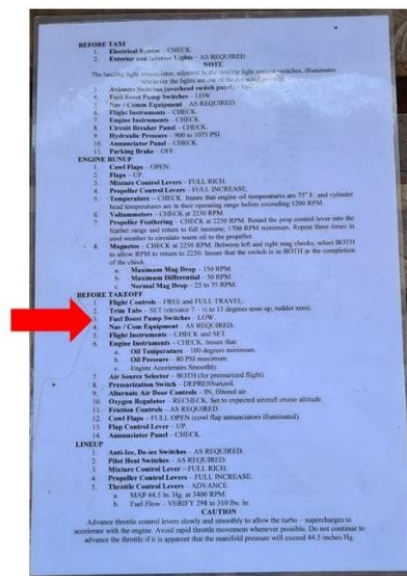
In addition to the above, the recovered aircraft pilot’s checklist (Figure 5) indicates the requirement for fuel boost pump switches settings on “BEFORE TAXI” and “BEFORE TAKE-OFF” are all required to be set to “LOW”.

Figure 5 – Aircraft Pilot Checklist
