Republic of the Philippines  
CIVIL AVIATION AUTHORITY OF THE PHILIPPINES

## AIRCRAFT ACCIDENT INVESTIGATION AND INQUIRY BOARD

### FINAL REPORT

RP-C6911  
HUGHES/MD369HS

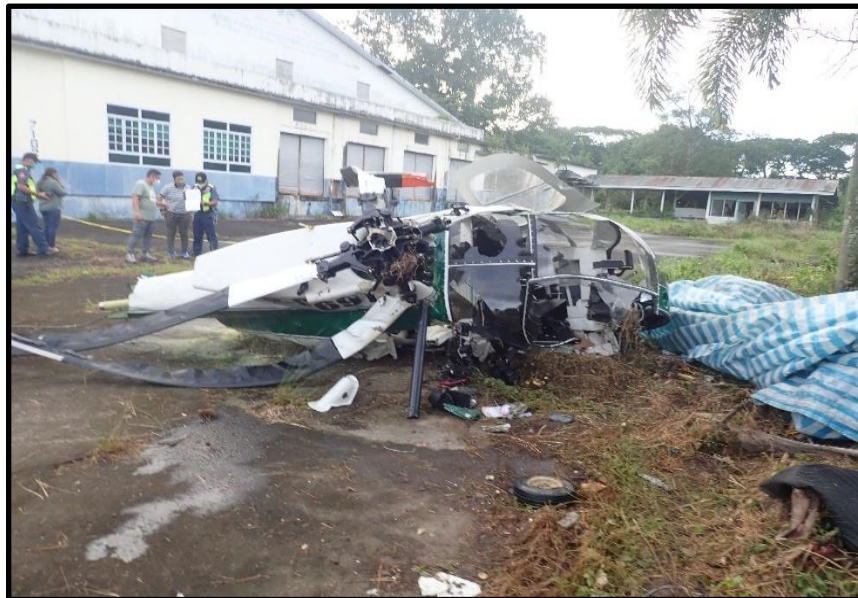
Figure 1. The aircraft at its final full-stop point.

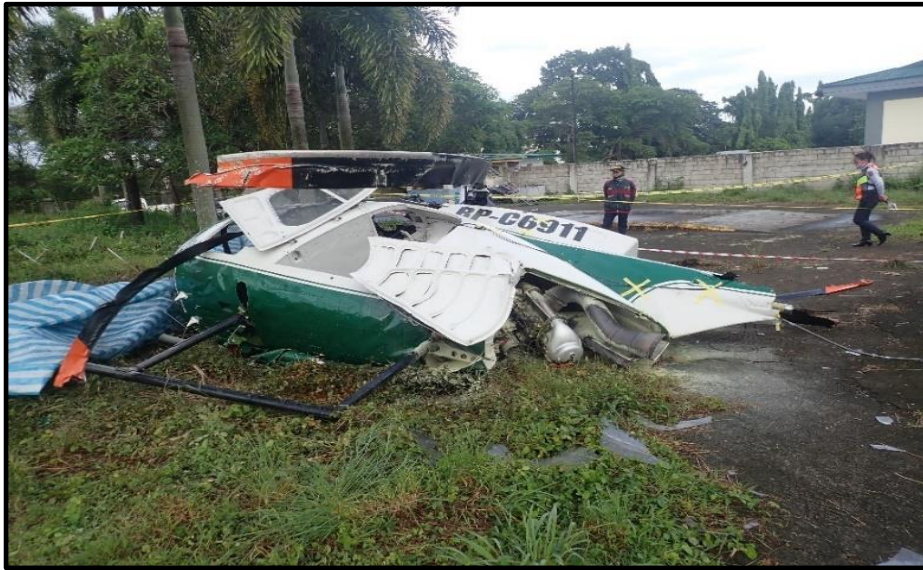
The aircraft, after the sudden lift-off to about 12 meters AGL and with a right bank, entered into a nose up/tail down unusual attitude with about (3X) rotation to the right on its longitudinal axis, then dropped down and hit ground (tail first). Then, it slid on ground on its right side, rotor hitting ground with northward momentum and finally settled on its right side. The aircraft was destroyed at its final full-stop position. Collective Friction was at low position as found on-site.

Figure 2: The aircraft was destroyed at the final full-stop point.

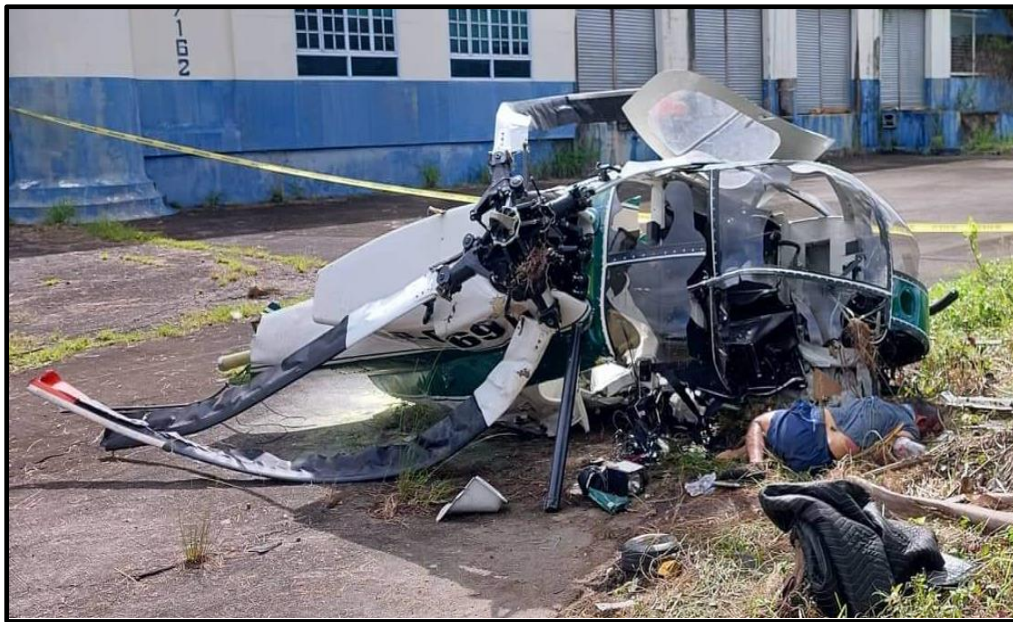
Fire and Rescue Unit (FRU) arrived on-site about 7 minutes from impact (1103H) and found the main wreckage without post-crash fire. The Team found the pilot's body on grass outside the aircraft wreckage just below the open right cockpit door (but did not act on pilot's body or did not bring to nearest hospital) and the pilot's seat restraint system (seat belt & shoulder harness) still set and unused (pilot was not restrained on pilot seat during the lift-off and crash).

Figure 3. The right side of the main wreckage at the final impact point with the pilot's body.

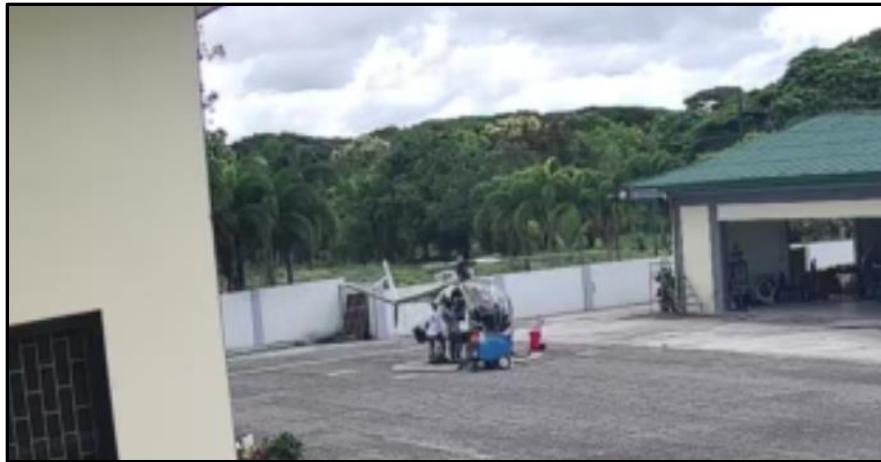
The Pilot was seated at the left cockpit seat with the assistance of two (2) Aircraft Maintenance Technicians (AMTs) positioned on the RH skid of the aircraft, were doing Rotor Track & Balance tests. The right-side aircraft doors were open (figure 4).

Figure 4. The helicopter at its run-up point.

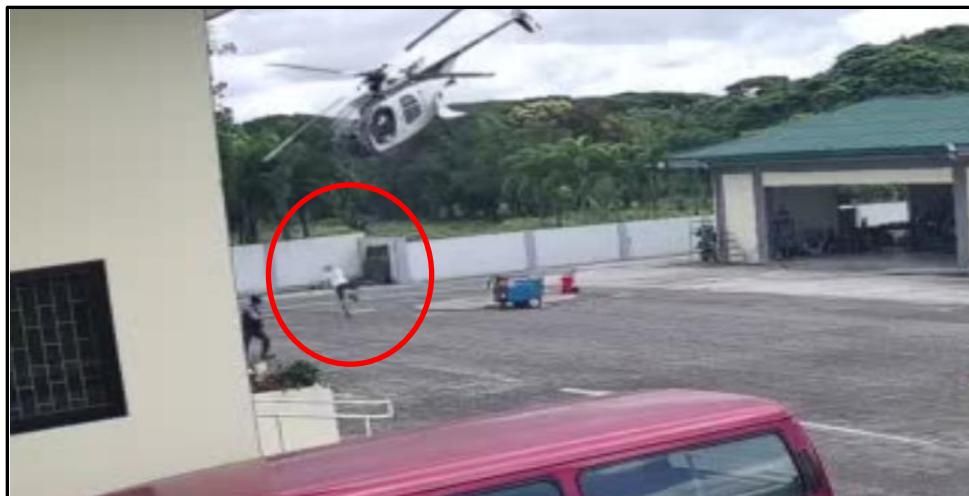
Suddenly, the aircraft lifted-off until about 12 meters high (on the process one AMT-1 fell down at about 5 feet high and AMT-2 fell down at about 10 feet high) and tilted to the right towards the rear (figure 5 and 6). Reaching the rear and facing north, it entered into a vertical nose-up (unusual) attitude with about 3 rotations on its longitudinal axis (tail down vertical) then dropped on the ground (tail first underbelly facing North) at the vacant lot across the perimeter wall and North of the lift-off point at company compound. With the momentum of ground impact towards the North, the right side of MR disc then hit the cemented ground (nose-oriented North) then finally the MR disc hit the cemented ground (fuselage was on right side down mode, nose heading about 060deg) as the last momentum to its final full-stop point about 15meters from initial (tail) impact point and about 35 meters from the lift-off point at company compound.

Figure 5. AMT-1 as he fell on the ground at 5ft high.

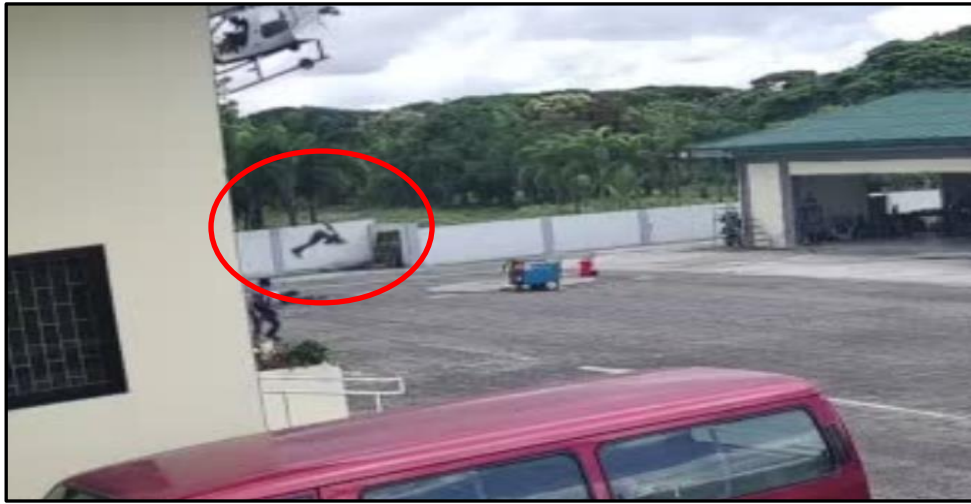
Figure 6. AMT-2 followed in the fall at 10ft high.

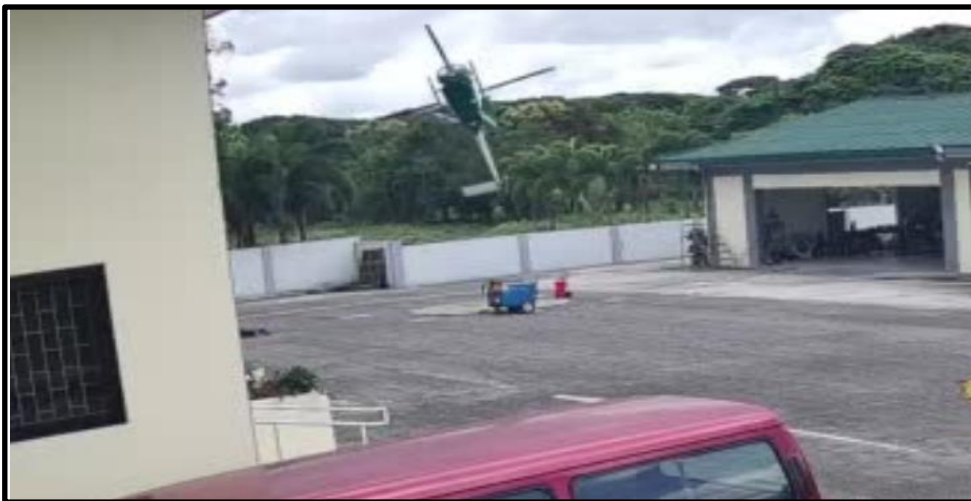
At its final full-stop point at the vacant lot across the wall of company compound, the aircraft was on its RH side at about 70deg angle (from upright position) with nose oriented towards about 045deg (figure 7).

Figure 7. Helicopter tail impacts the ground first.

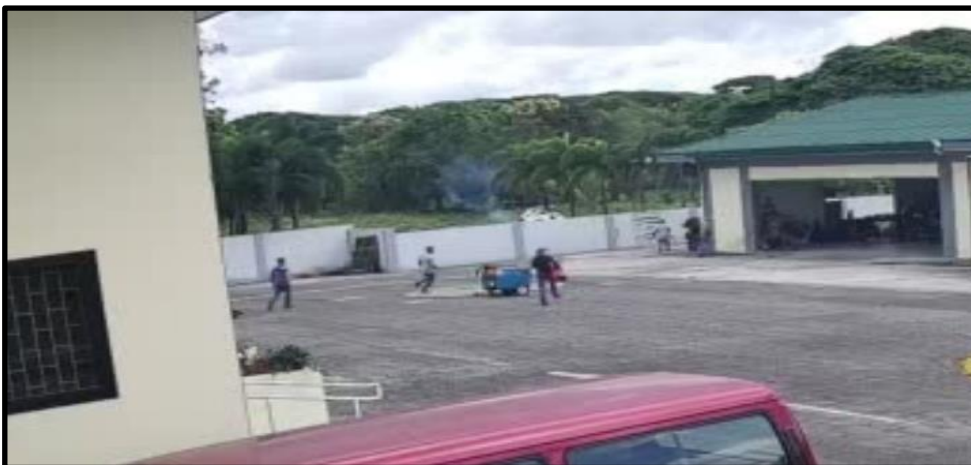
Figure 8. Helicopter crashed at the other side of the fence.

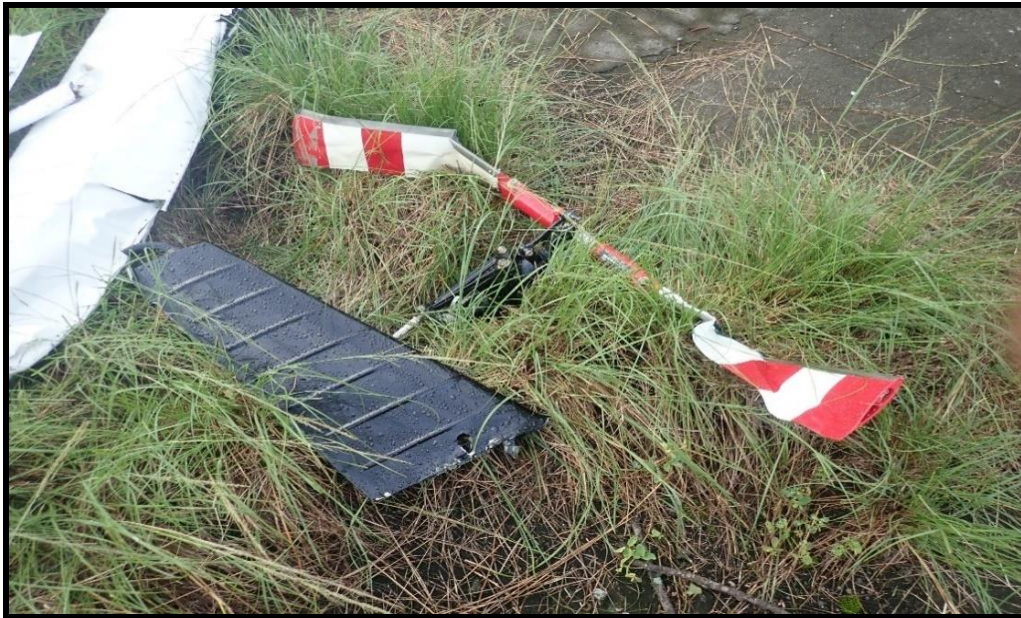
Figure 9. The detached Tail Rotor and other tail components at initial impact point.

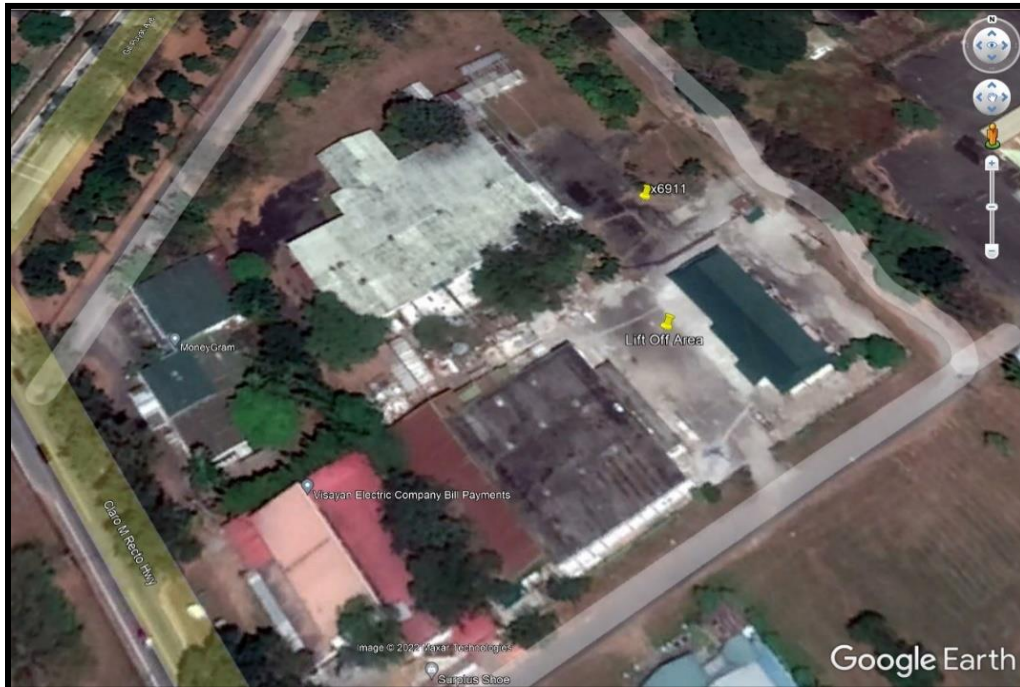
Figure 10. The helicopter lift-off and its final resting place is about 35 meters.
