## **AIRCRAFT ACCIDENT INVESTIGATION AND INQUIRY BOARD**

### **FINAL REPORT**

**RP-C8459**  
**SIKORSKY 269C-1**

**TITLE:** An accident involving a Sikorsky 269C-1 type of aircraft with Registry Number RP-C8459 owned and operated by Masters Flying School that had a tail skid strike accident during training at Brgy. San Roque, San Luis, Pampanga, Philippines, on March 30, 2022, at around 1300H.

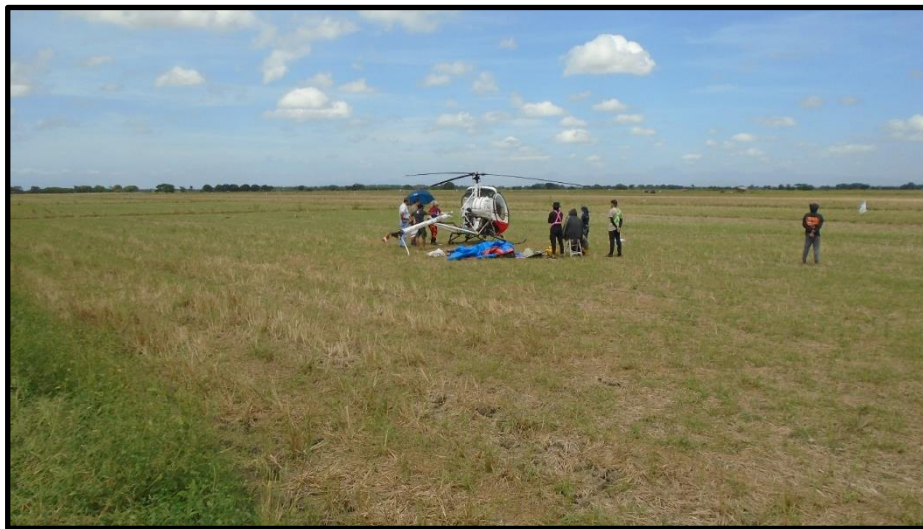
The accident site is in an open rice field located approximately 2 kilometers from the town proper and about 12 kilometers from Plaridel Airport (Figure 1). The aircraft last position was at coordinates 15°00'09.1" N, 120°49'35.9" E.

Figure 1 – RP-C8459 at the accident site

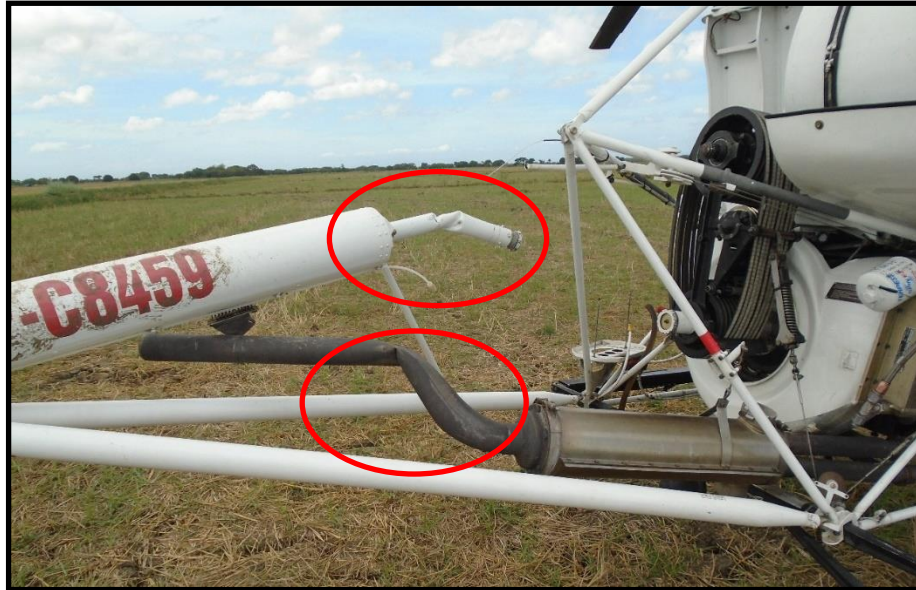
The aircraft was found to have sustained a broken tail boom and a damaged tail rotor (Figure 2 and 3). Likewise, part of its vertical stabilizer was found on the ground approximately five (5) meters North West from the nose of the aircraft. Ocular inspection also revealed markings on the soft ground indicating contact with the aircraft tail rotor.

Figure 2 – Damaged/broken tail boom and exhaust

Moreover, the FI said that while the aircraft was experiencing erratic or pendulum movement, he was shouting at the SP to hand over the controls. He further alleged that the SP could not understand what he is saying. This indicates that both FI and SP had a miscommunication with each other. The FI must be alert to what the SP is doing and not wait too long to take over the control if the situation warrants. Regardless of the situation, it is the detection, interpretation and response that influence the potential effect on safety. The objective of error management is the timely detection and prompt appropriate response in flight operations for the error to become operationally inconsequential. The mismanaged error while the aircraft was on hover resulted for the tail skid followed by the tail rotor to hit the ground.

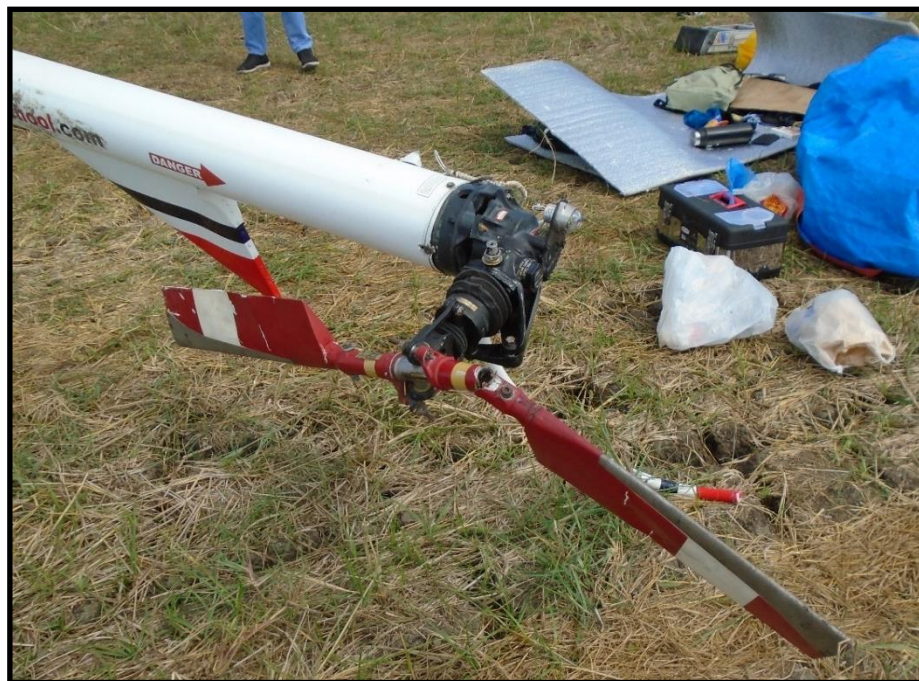
Figure 3 – Damaged tail rotor
