FINAL REPORT

RP-C8598
TEXTRON AVIATION INC. CESSNA 152

OPERATOR: ECHO AIR INTERNATIONAL AVIATION ACADEMY, INC.

DATE OF OCCURRENCE: AUGUST 1, 2023

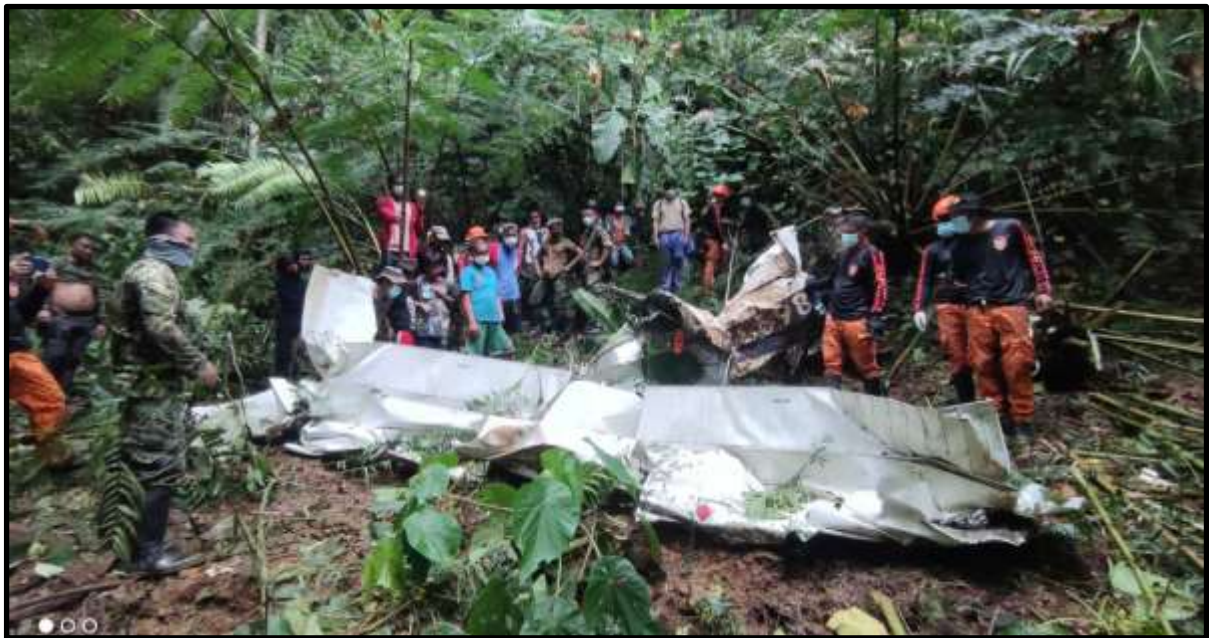
Figure 1: The aircraft at its final resting point.

The aircraft was destroyed upon impact with the ground.

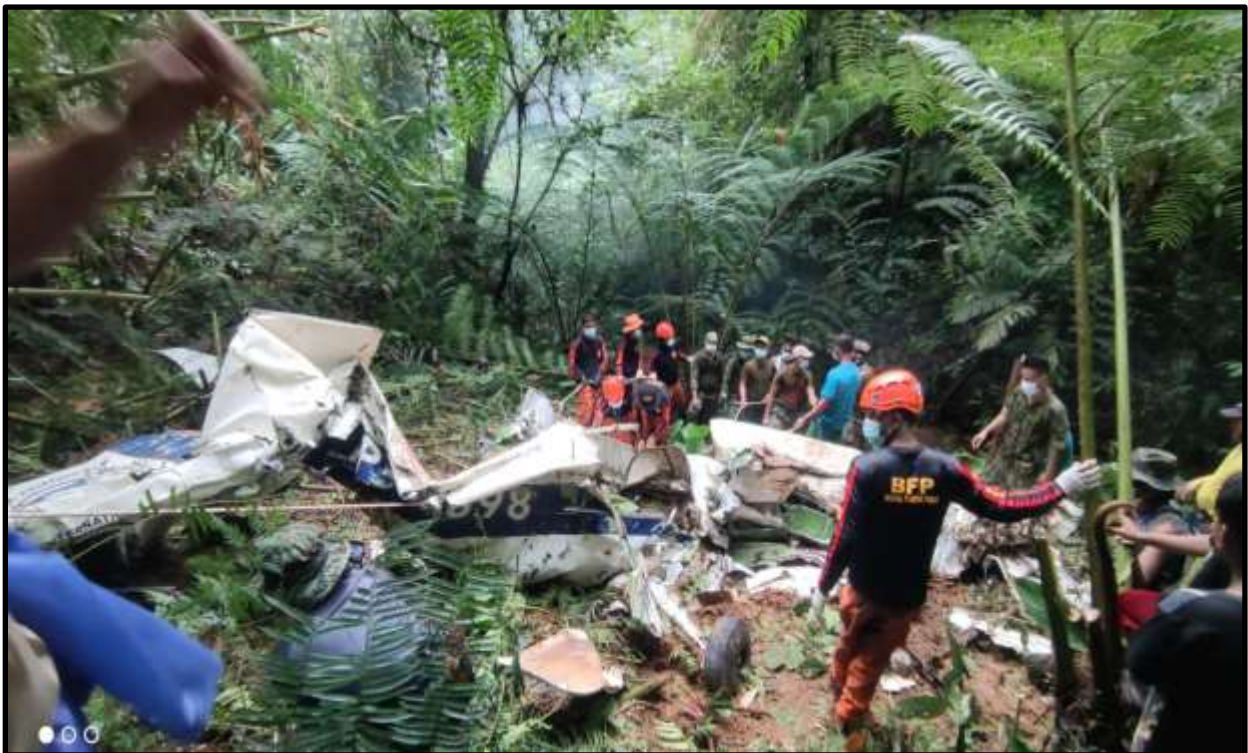
The aircraft wreckage (Figure 3) was found at coordinates 18° 15' 2.16" N, 121° 18' 9.24" E at an elevation of 660 feet ASL and with a general heading of 307° NW. The site was

- a.** The aircraft was completely destroyed after impact with the ground.
- b.** The engine and propeller were buried approximately 1 meter in the ground upon impact (Figure 4).
- c.** All significant components of the aircraft were located within the main wreckage area, approximately ten (10) meters in diameter.
- d.** The entire fuselage and wings sustained substantial damage, with the cockpit and flight controls highly fragmented. The instrument panel was destroyed, and most instruments were displaced from their panel mounts.

Figure 3 – The aircraft wreckage.

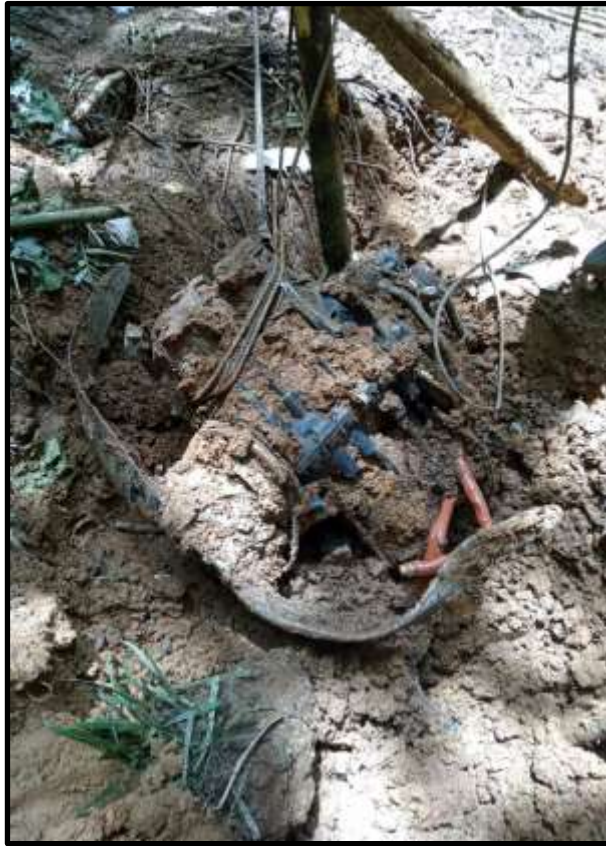
Figure 4 - The aircraft engine with its propeller buried in the ground.

The aircraft engine was recovered on August 5, 2023, and the teardown inspection was conducted on August 22, 2023, at an Aircraft Maintenance Organization (AMO) facility of Fliteline Aviation in Plaridel, Bulacan. The activity was supervised by a CAAP-AAIIB Investigator and maintenance personnel of the operator. On the completion of the inspection, the AMO stated that the engine was found to have no evidence of pre-impact mechanical malfunctions or anomalies that would have affected the aircraft's normal operation. Internal examination also showed that the other components of the engine were all in good condition. The engine teardown report also stated that the engine was delivering power at the moment of the accident. However, the examination could not conclude on the amount of power that was then delivered. In addition, the damage to the engine propeller indicates that it resulted from the impact of vegetation debris while it was still in motion at the time of the accident.

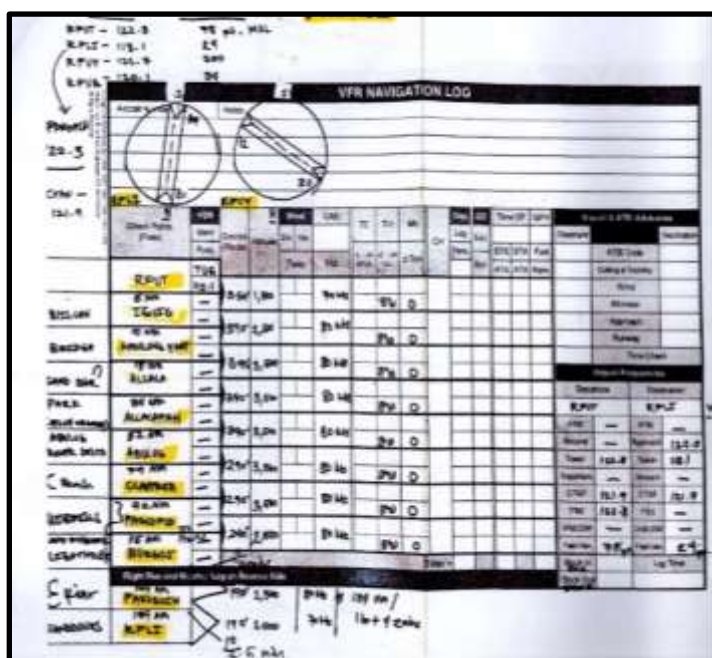
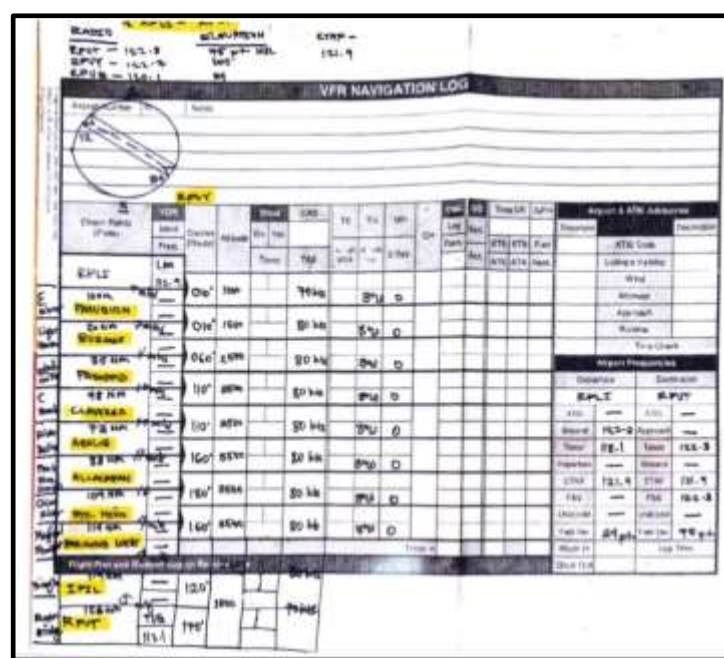
For the Tuguegarao/RPUT-Laoag/RPLI v.v. navigation flight training, there is an available navigation log prepared for this route (Figure 6). In addition to the navigation log, the route is also documented in Echo Air's Procedures Manual (1st Edition, issued February 21, 2020), Chapter III – Routes, Section VII – Training Routes and Areas, Item 2 – Training Routes, Letter B – Tuguegarao-Laoag (RPUT-RPLI). Likewise, interviews with other Echo Air's FIs confirmed the availability of such a navigation log being used for the said flight training.

On review of the available navigation log and the documented route under its Procedures Manual, inconsistencies were noted on both documents, particularly regarding the identified check points for that specific route. The check points indicated on the navigation log are different from the published route (Figure 7) in its manual. In addition, there is no specific documentation under their manual that a navigation log is specifically required during cross-country flight training.

Figure 6 – Navigation log for RPUT-RPLI-RPUT navigation training

- 3.1.5** The involved ATO's navigation log form is not consistent with the published route under its Procedure Manual.
- 3.1.6** The ATO has been found to be not fully compliant with the restrictions imposed by the CAAP FSIS on its approved RPUT-RPLI cross-country flight training.

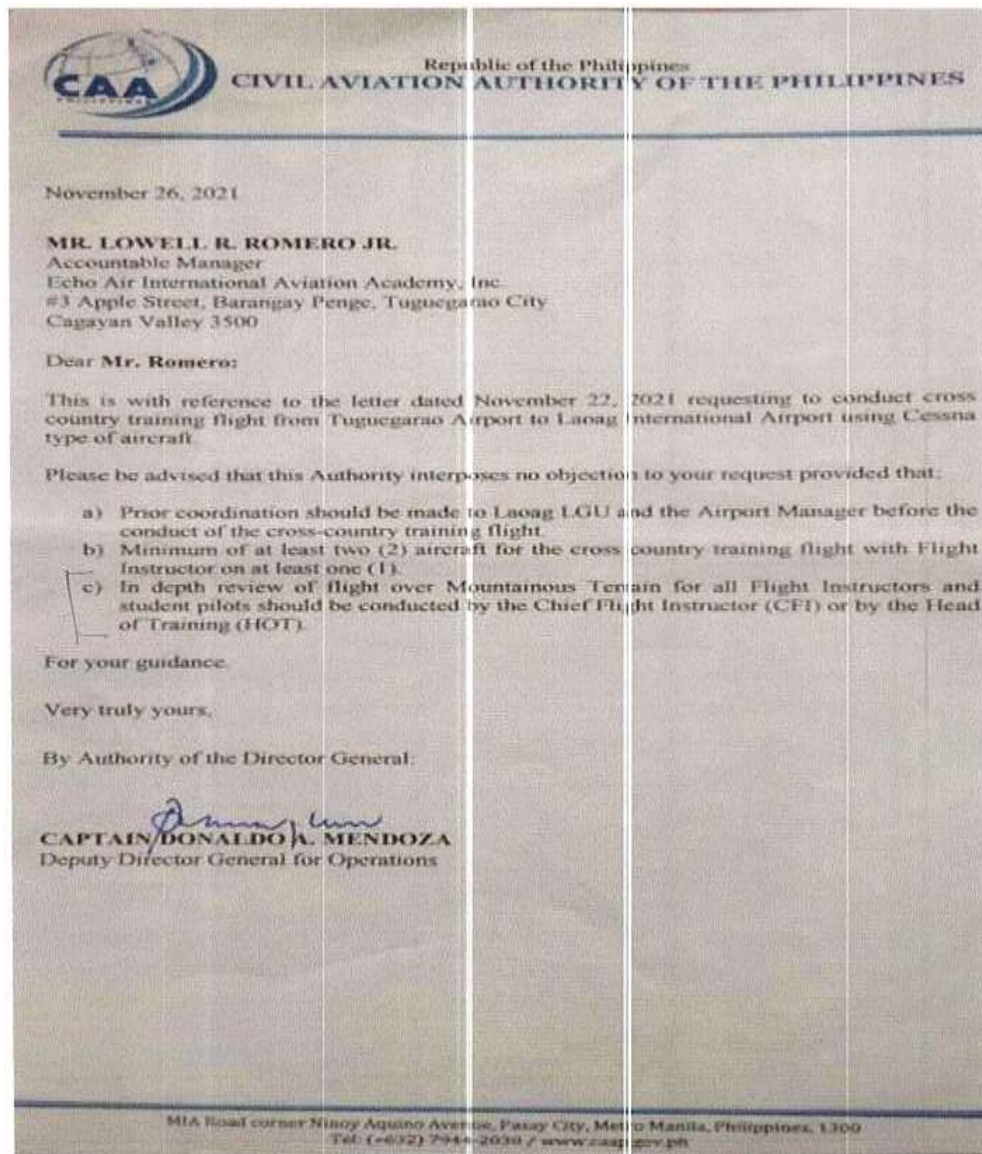
For this specific cross-country training route, RPUT-RPLI v.v., approval from CAAP Deputy Director General of Operations (Figure 9) was secured by Echo Air via a letter dated November 26, 2021. Under the said letter, the following conditions should be met for this training route:

- a.** Prior coordination should be made with Laoag LGU and the Airport Manager before the cross-country training flight.
- b.** Minimum of at least two (2) aircraft for the cross-country training flight with the instructor on at least one (1).
- c.** In-depth reviews of flight over mountainous terrain for all Flight Instructors and student pilots should be conducted by the Chief Flight Instructor (CFI) or by the Head of Training (HOT).

Figure 9 - CAAP letter of approval for RPUT-RPLI cross-country training.

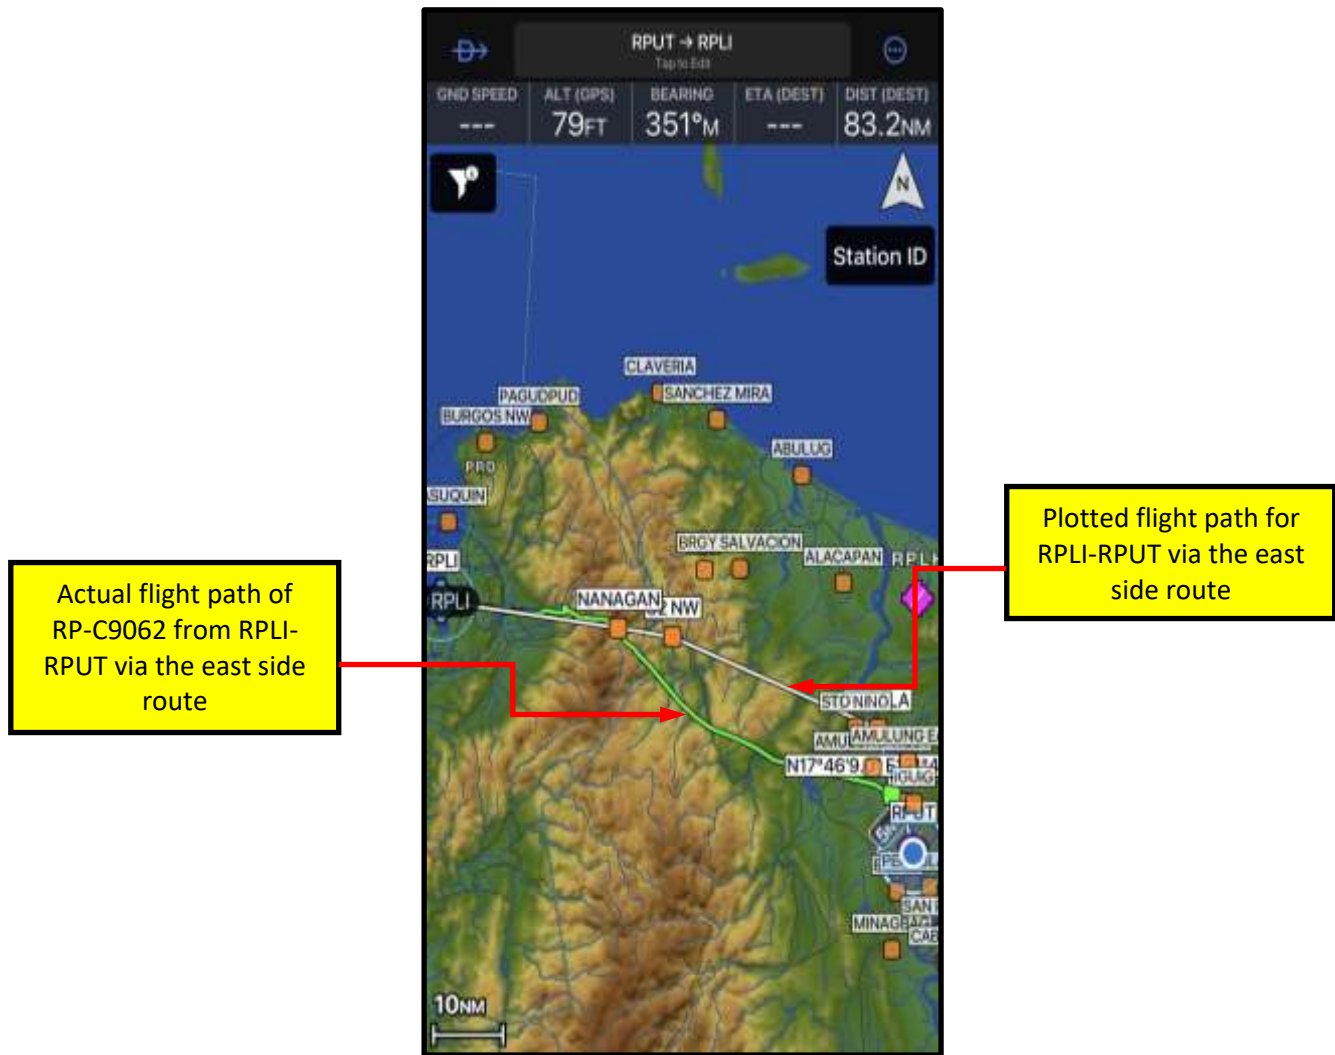
Upon their arrival at RPLI at about 1034H and 1112H, respectively, both flight crews of the two (2) aircraft, RP-C9062 and RP-C8598, had some snacks before departing again for their next flight. While having their snacks, the FI of RP-C9062 mentioned that they discussed the weather conditions along the shoreline, which was the one taken by RP-C8598. During their conversation, the deteriorating weather in the area was highlighted, including the fast build-up of Cumulonimbus clouds within RPLI. As they continued their discussion, the RP-C9062 FI proposed the idea that, for their departure from RPLI, they consider taking the east side route over the mountains (Figure 17) to navigate away from the deteriorating weather. This suggested route was also the route taken by RP-C9062 on its way to RPLI. Following this discussion, both FIs agreed to proceed with the proposed route via the east of the station, despite the RP-C8598 FI being unfamiliar with this new route.

Figure 17 - RPLI-RPUT flight route via the east side.

- a. The Flight Instructors' decision to continue the VFR flight in a deteriorating weather condition resulted in a loss of control inflight.
- b. The Flight Instructor's decision to deviate from the published training route.

- a. To ensure that the operator conducts additional training for their FI's on reduced visibility operation under adverse weather condition to include flight operations over mountainous areas.
- b. To ensure that the operator establishes a clear policy on VFR operations in deteriorating weather conditions.

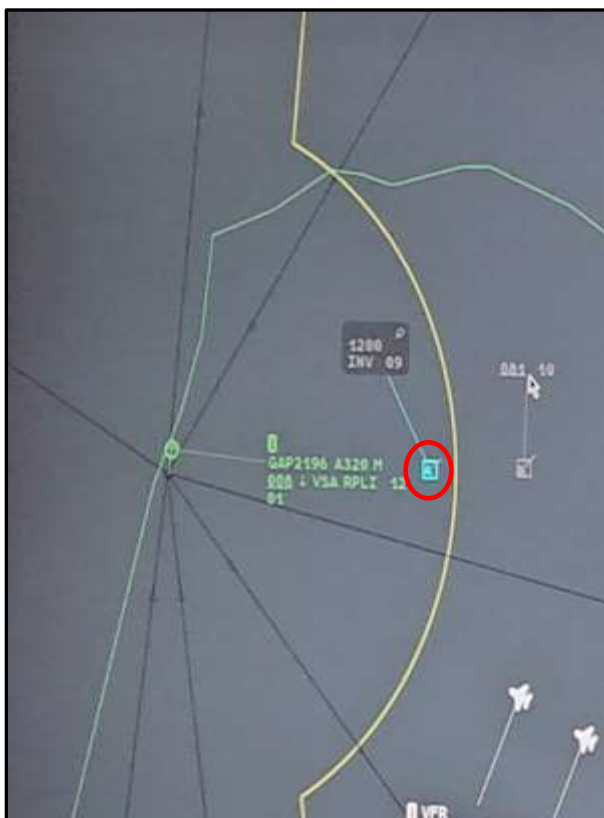
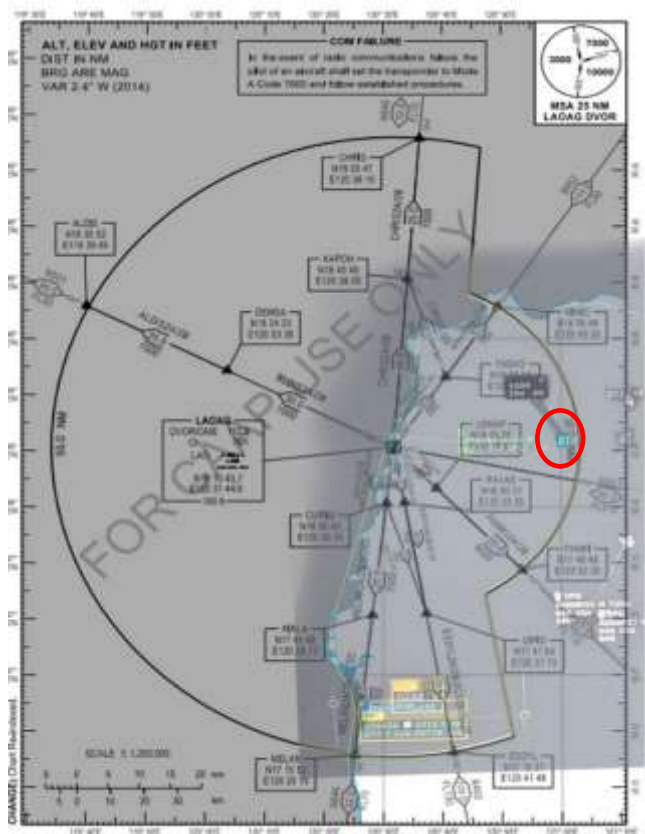
- a.** The radar track of RP-C8598 disappeared on the radar display at about 0446 UTC/1246H (Figure 19).
- b.** By overlaying the obtained radar track of RP-C8598 on the current RPLI FIR chart alongside the prevailing weather data at the time of the accident suggests that RP-C8598 may have inadvertently transitioned from visual meteorological conditions (VMC) into instrument meteorological conditions (IMC).
- c.** The Manila radar information confirmed that the flight deviated from its published Nav Log flight route out of RPLI to RPUT.

Figure 19 - The Flight route with radar track overlay

Based on this compiled information, it is highly probable that RP-C8598 was maintaining its intended flight path in a deteriorating weather condition and entered into an instrument meteorological condition. This resulted in the crew experiencing spatial disorientation, ultimately leading to the pilot losing control of the aircraft. This scenario underscores the critical importance of pilots maintaining situational awareness and adhering to proper procedures, especially when confronted with adverse weather conditions. Navigating through clouds and weather build-up carries inherent risks, often resulting in tragic and fatal accidents. Therefore, it is imperative for all pilots to always adhere to VFR weather minimums. A prudent approach to avoiding such situations, such as weather build-up or thunderstorms, is to maintain a safe distance, adjust your flight path accordingly, or even cancel the flight if necessary.

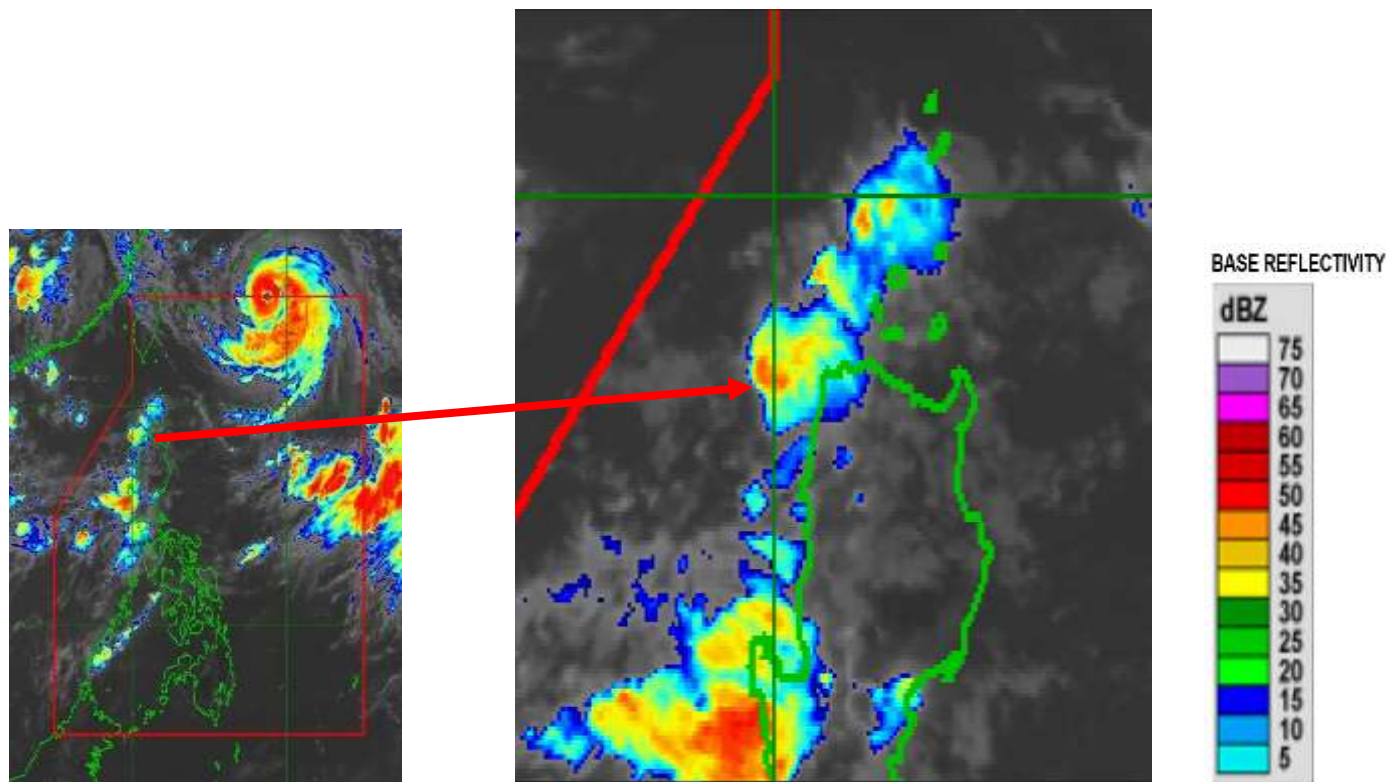
In addition to the above, the weather conditions on the area where the aircraft disappeared from the radar were corroborated by the crew of RP-C9062 who initiated the initial search for the missing company aircraft. Their search was hindered by the deteriorating weather conditions in the area, which complicated the search operation.

Figure 20 - The Laoag weather radar image.
