# AIRCRAFT ACCIDENT INVESTIGATION AND INQUIRY BOARD

## FINAL REPORT

RP-C8840

Cessna152

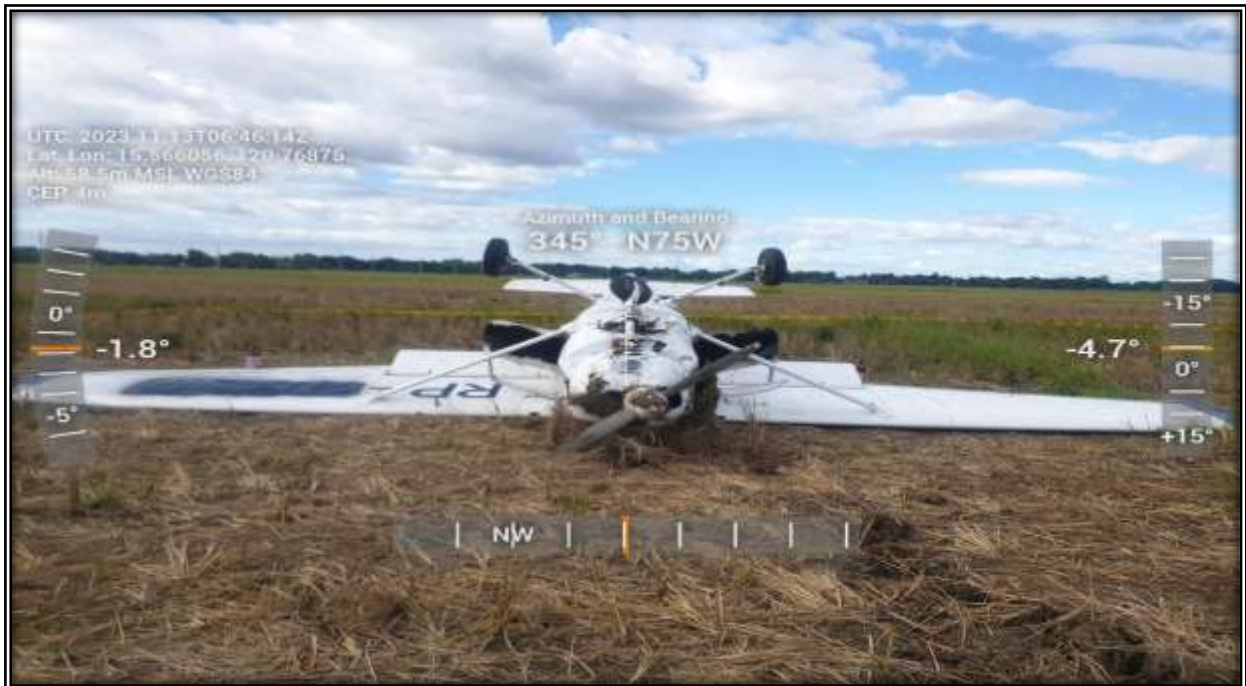
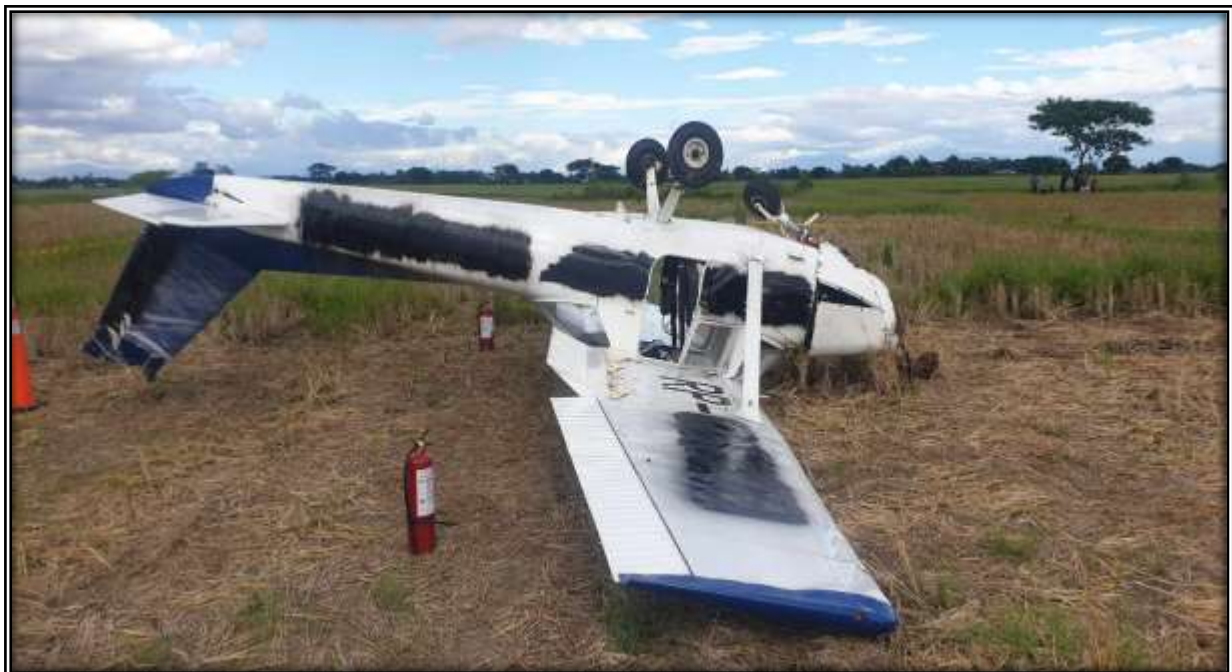
embankment. The aircraft again landed on its nose wheel, 75 feet away from its initial touchdown. It continued to move forward for another 75 feet before the nose wheel collapsed and had a prop strike with the ground. The aircraft came to a complete stop in an inverted position with the last heading of 75 degrees and grid coordinates of 15°.566056 N; 120°.76875 E.

Figures 1 and 2. RP-C8840 on its final resting position.

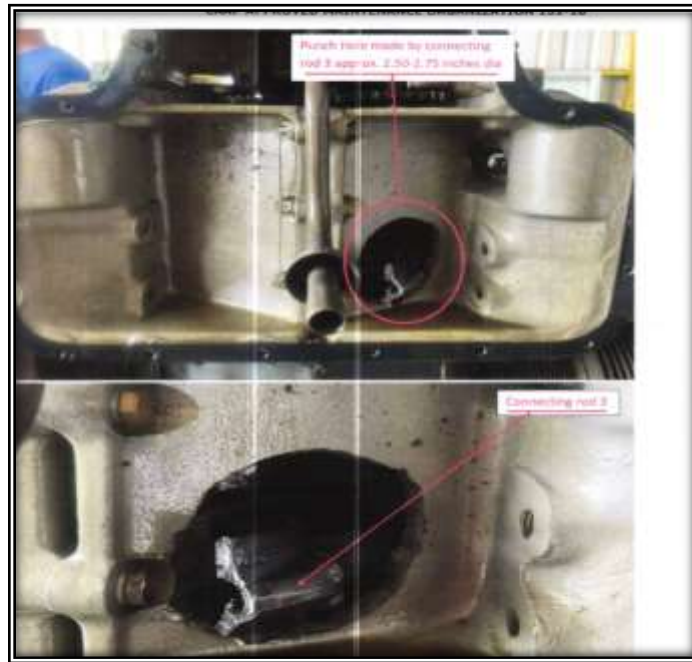
The engine was removed from the aircraft and was brought to the operator's hangar last November 13, 2023. The engine teardown report dated November 14, 2023, indicates that after the oil sump was removed, a punch hole approximately 2.50-2.75 inches in diameter at the bottom of the right crankcase half was seen (figures 3 and 4). It was caused by the nos. 3 connecting rod. The oil pump was also found stuck due to the misalignment pressure applied by the broken crankshaft end to the oil pump drive.

Figure 3 and 4 - Punch hole made by the connecting rod number 3

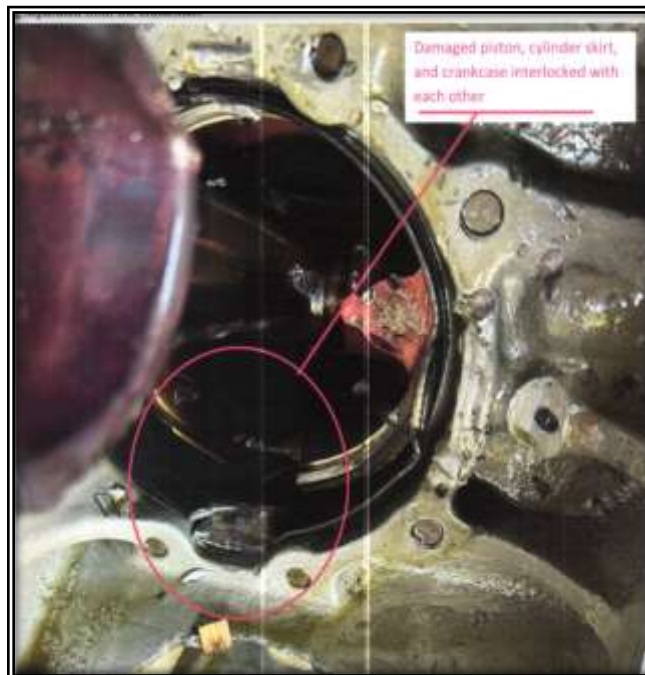
The cylinders number 1, 2, and 4 were removed from the crankcase, however cylinder number 4 was removed with force due to the damage at the bottom part of the piston and cylinder respectively. The damage was caused by the connecting rod being separated from the crankshaft that resulted to the interlocking with another piston, and cylinder. (figure 5). Moreover, after the crankcase was separated, the crankshaft assembly was found fractured at the crank pin journal number 3 (figure 6).

Figure 5 - Damaged piston, cylinder skirt and crankcase interlocked with each other.

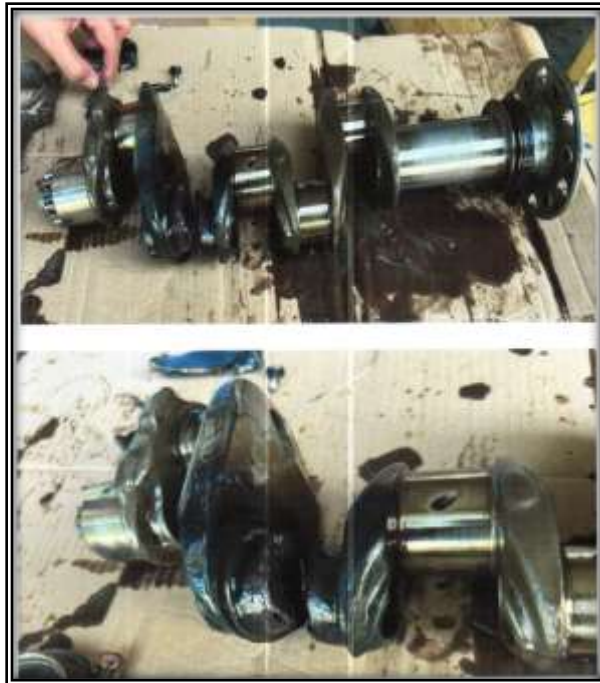
Figure 6 - Crankshaft assembly fractured at crank pin journal number 3.

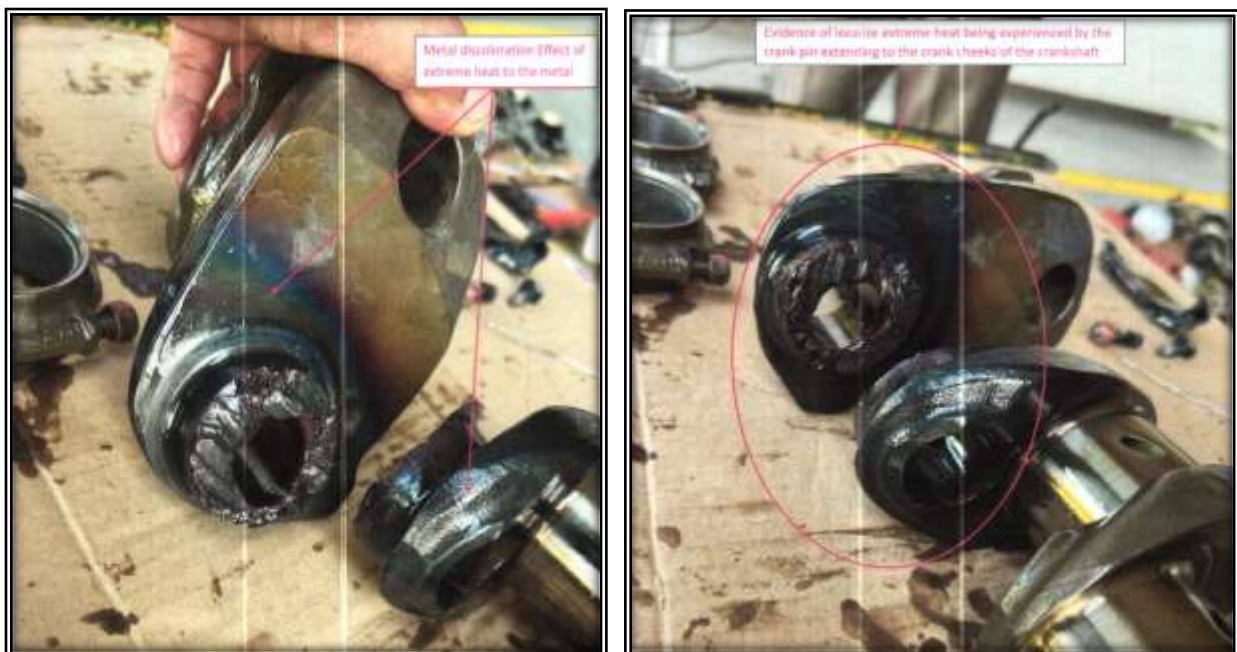
During the teardown inspection, the number 3 crank pin journal fractured area had an indication of extreme heat damage to the metal. This was indicated by the black and bluing discoloration of the metal extending to the crank cheeks area of the crank pin (figures 7 and 8).

Figures 7 and 8 - The metal discoloration due to extreme heat.

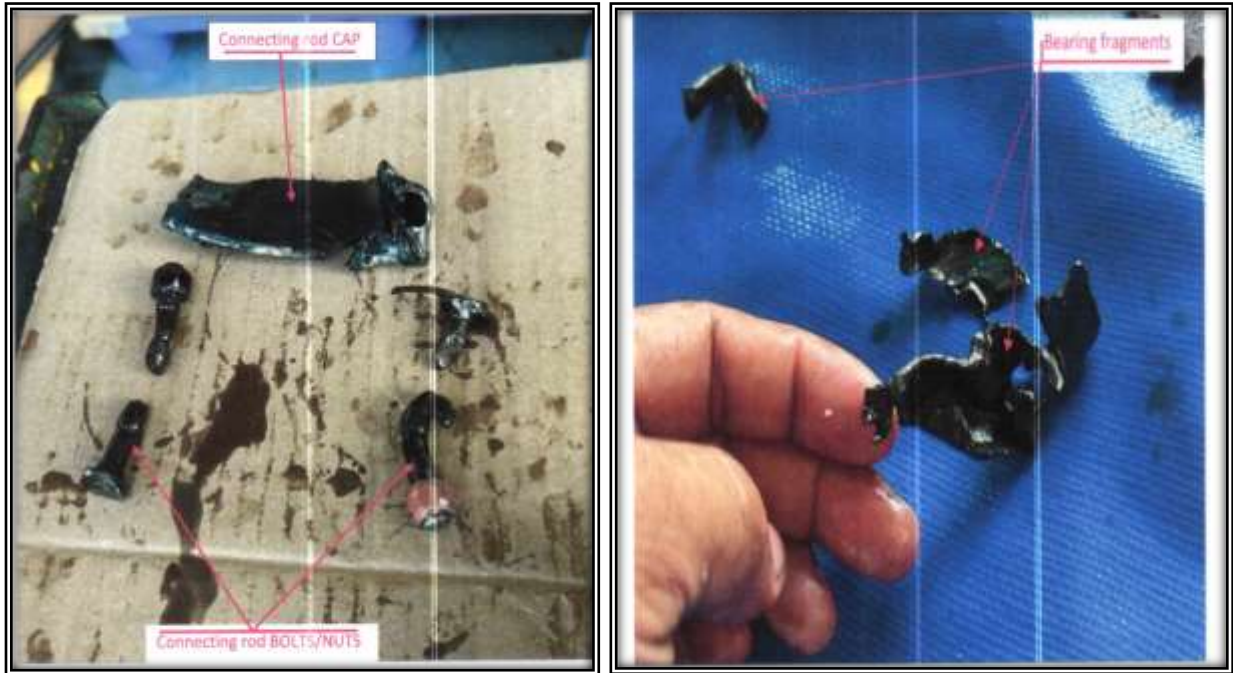
There was also evidence that the number 3 connecting rod bolts and bearing was subjected to an extreme heat resulting for them to be stretched and fractured (figure 9 and 10).

Figures 9 and 10 - Fractured connecting rod bolts and bearing fragments.

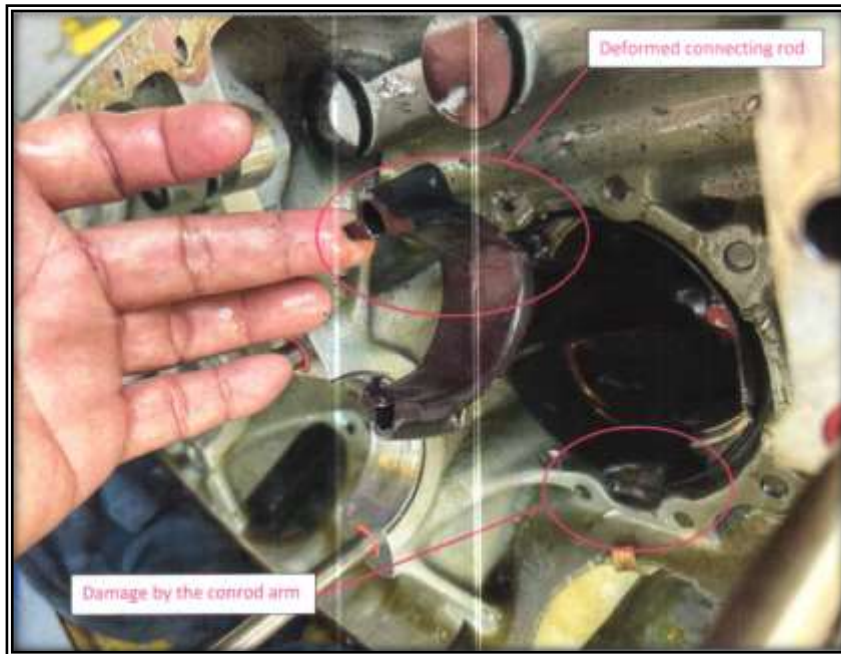
Further observations revealed that the separated connecting rod number 3 had evidence of being hit by the crankshaft pin journal number 3. This caused for the connecting rod to be deformed and damaged the bottom side of the piston and cylinder skirt respectively. There was also the punched hole seen at the bottom area of the right crank case half (figure 12).

Figure 12 - Deformed connecting rod and punched hole in right crankcase half.

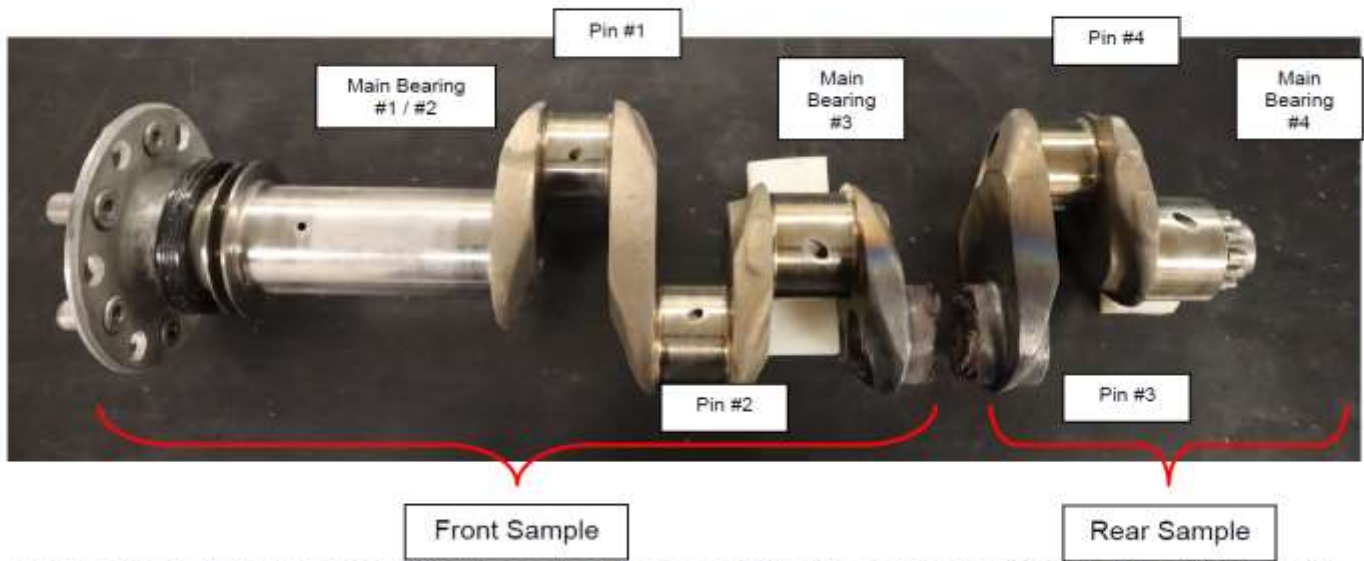
The crankshaft as was in received condition is shown in figure 13. The two halves of the crankshaft were identified as the front sample and rear sample. The crankshaft was fractured completely at the number 3 crankpin near the center of the crankpin, not through either of the journal fillet radii. Significant heat discoloration was observed that spread from the fracture location onto the nearby cheek number 4 and cheek number 5 surfaces, indicating a significantly high temperature was experienced in this localized area.

Figure 13 - Fractured crankshaft in the as-received condition.

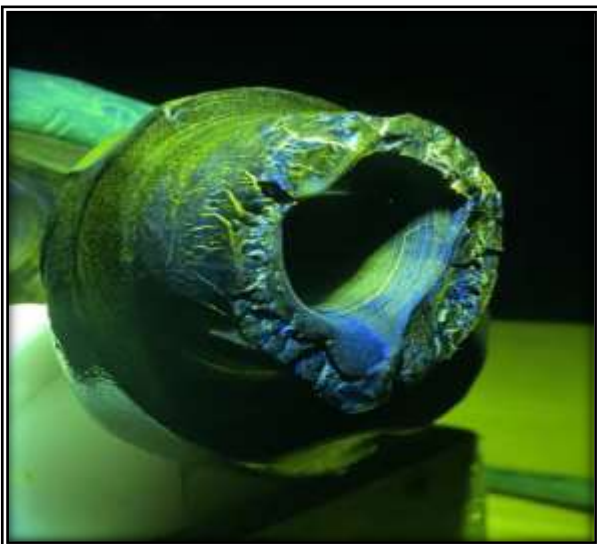
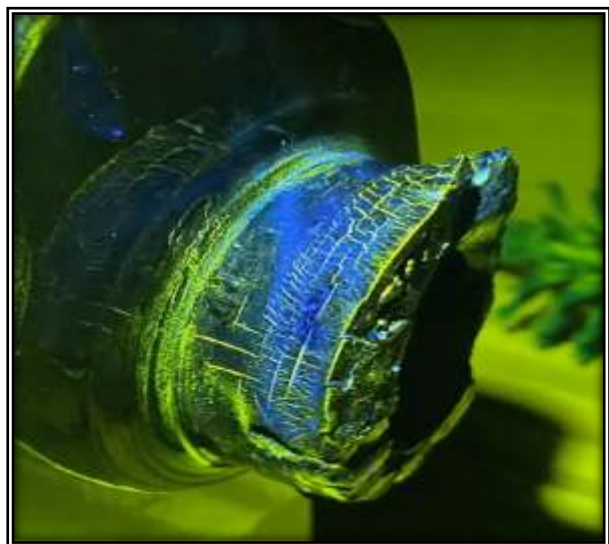
The two halves of the crankshaft were evaluated via magnetic particle inspection to determine if any additional indications were present on the crankshaft. In figures 14 and 15, the front sample fracture surface was shown with multitude of additional cracks visible adjacent to the main fracture. An additional larger crack was visible on the ID of the front sample. The cracking likely corresponds to heat checks.

Figures 14 and 15 - Front sample surface during fluorescent dye mag particle inspection

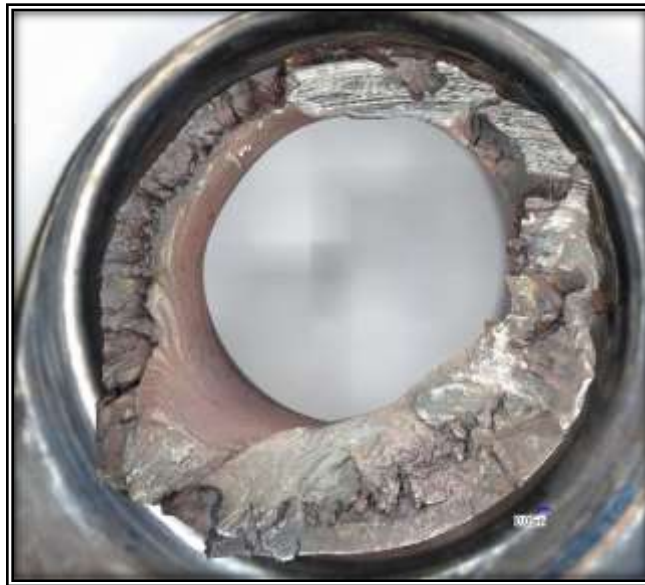
The fracture surface from the front sample is shown in figure 16. The fracture surface has signs of contact damage, likely from contacting the rear sample while the engine was still operating. In figure 17, subsurface cracking was present in a region of overload failure. Metal smearing observed is shown in figure 18.

Figure 16 - Fracture surface from the front sample.

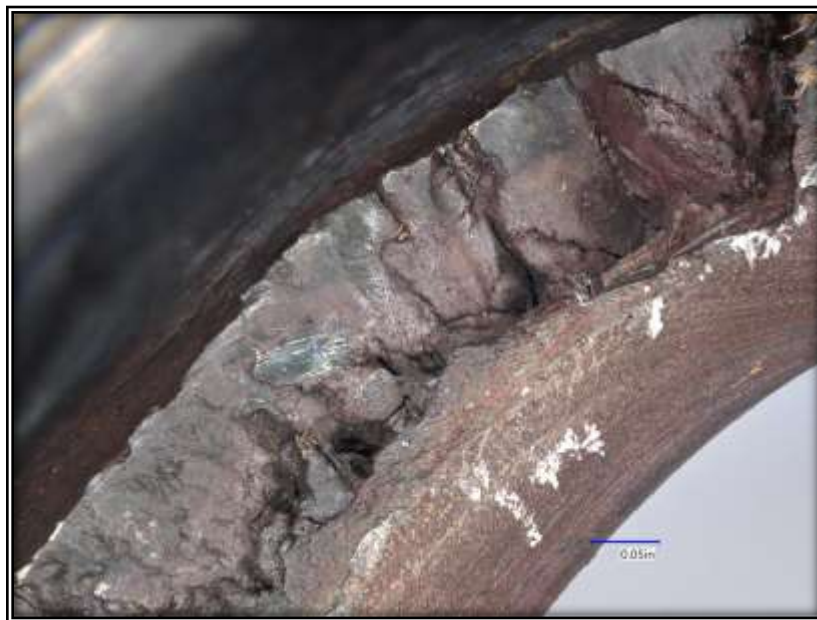
Figure 17- Subsurface cracking is present in a region of overload failure.

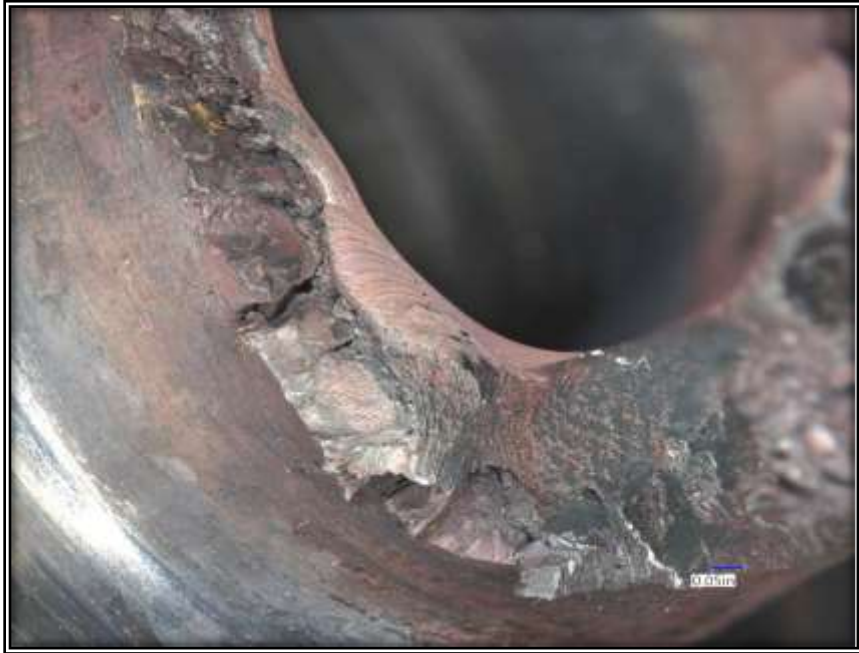
Figure 18 - 20x original magnification of the smeared metal on the fractured surface.

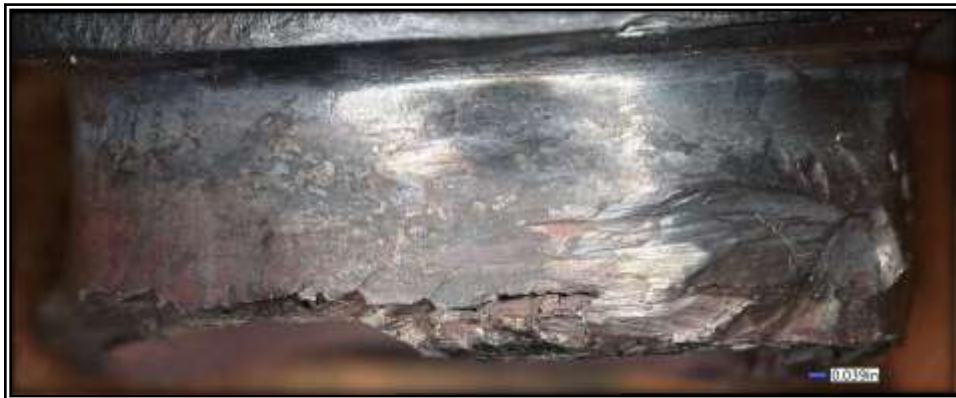
A side view of the front sample fracture surface is shown in figure 19 and figure 20. In both figures, secondary cracking was observed to extend from the fracture surface and into the material. The cracks are also observed at a 45-degree angle, which may be indicative of torsional stresses. Figure 21, outlines cracking manifested by the oil

Figure 19 - 30x original magnification of the side view of the top fracture surface.

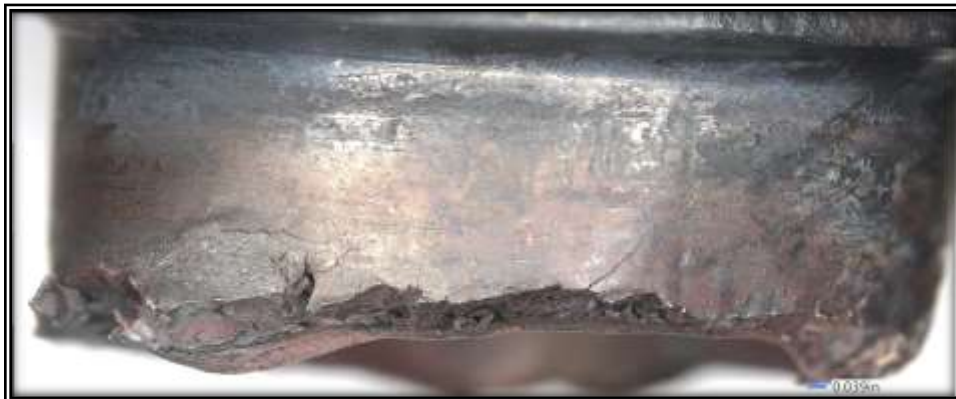
Figure 20 - 30x original magnification of the side view of the fracture surface from the front sample.

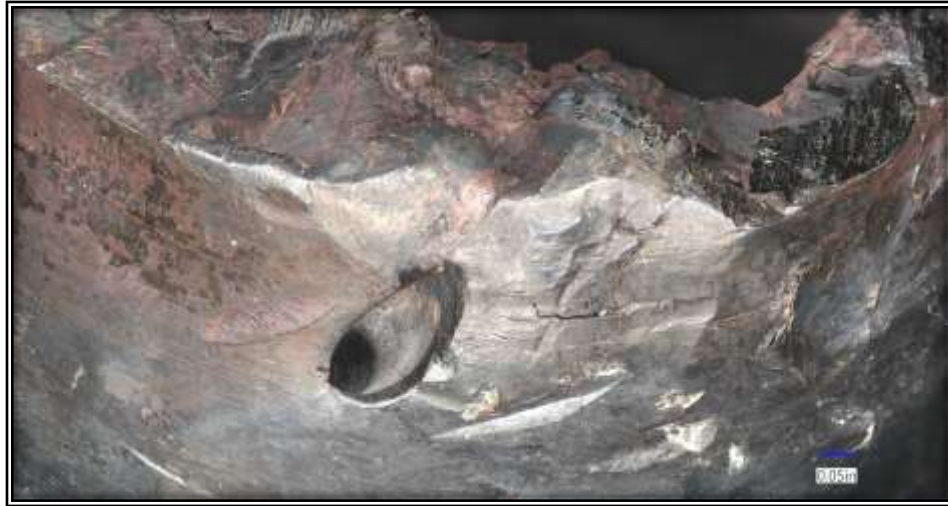
hole region on the pin that was also surrounded by significant flattening of the fracture surface from contact damage.

Figure 21 - 20x magnification of the damage on the outer diameter of the number 3 Pin on the front sample.

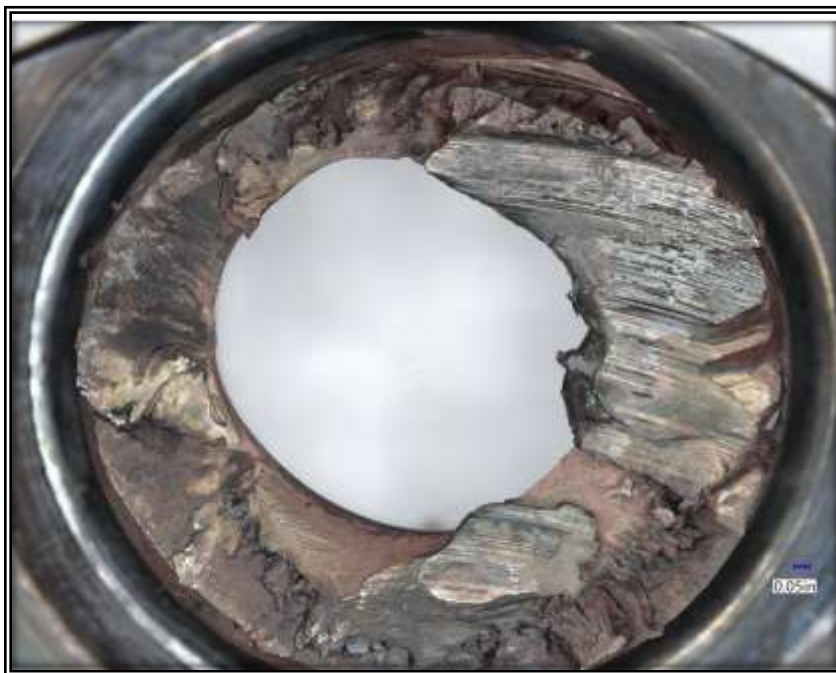
The fracture surface from the rear sample was shown in figure 22. Similar to the front sample, the fracture surface has many signs of contact damage and material smearing, which occurred after fracture. Figure 23 is an example of contact damage, along with additional material cracking present. A side view of the rear sample fracture surface is shown in figure 24 and figure 25. The jagged, alternating 45-degree crack parallel to the fracture surface is evidence of torsional fatigue.

Figure 22 - 20x original magnification stitched image of the fracture surface from the rear sample.

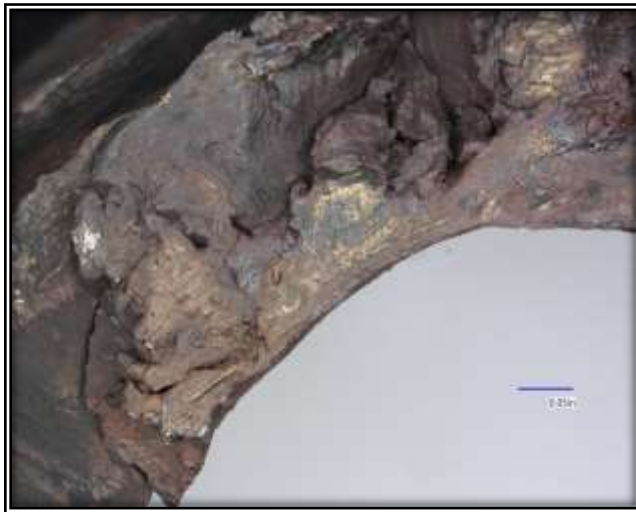
Figure 23 - 20x original magnification of a region of chipped and damaged material on the fracture surface of the rear sample.

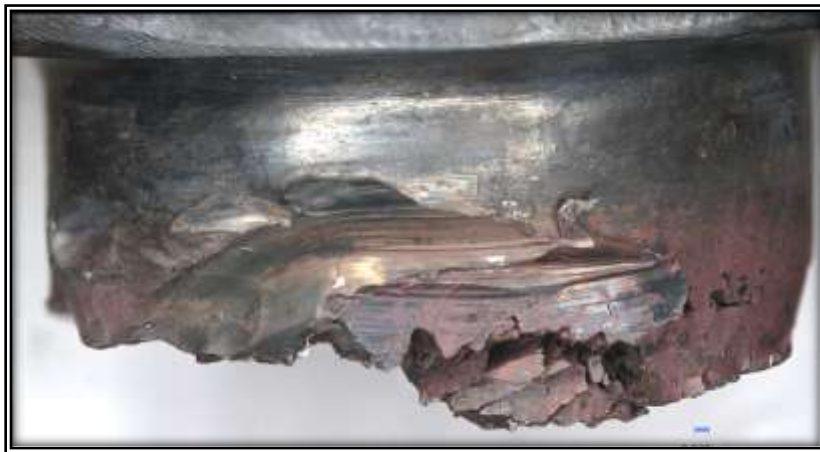
Figure 24 - 30x original magnification of the side view of the top fracture surface from the rear sample.

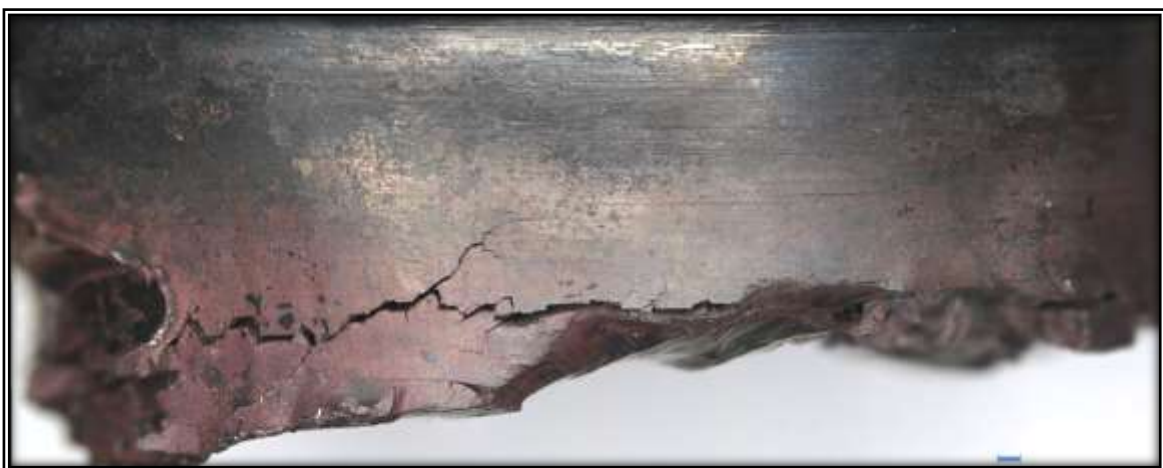
Figure 25. Original magnification of the side view of the top fracture surface from the rear sample, rotated 90 degrees clockwise.

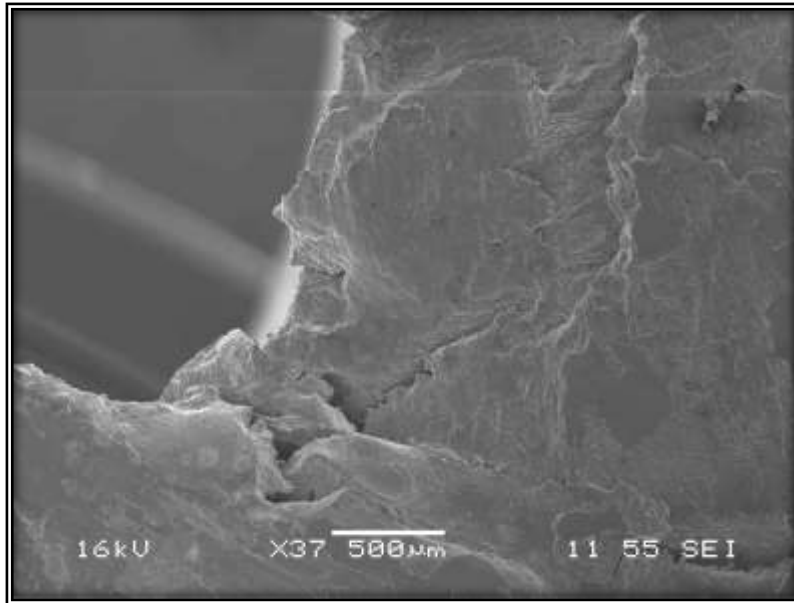
The rear sample fracture surface was evaluated via Scanning Electron Microscope (SEM), are shown in figures 26 to 28. In most locations, the fracture surface was either flattened or smeared, thereby removing any additional evidences of the failure mode of the fracture. Energy Dispersive X-ray Spectroscopy (EDS) was performed on the fracture surface with indications of iron and oxygen, indicative of iron oxide, along with carbon and lead from the combustion environment of the engine. EDS results are also outlined in figure 28.

Figure 26 - 37x original magnification SEM image of the fracture surface of the rear sample.

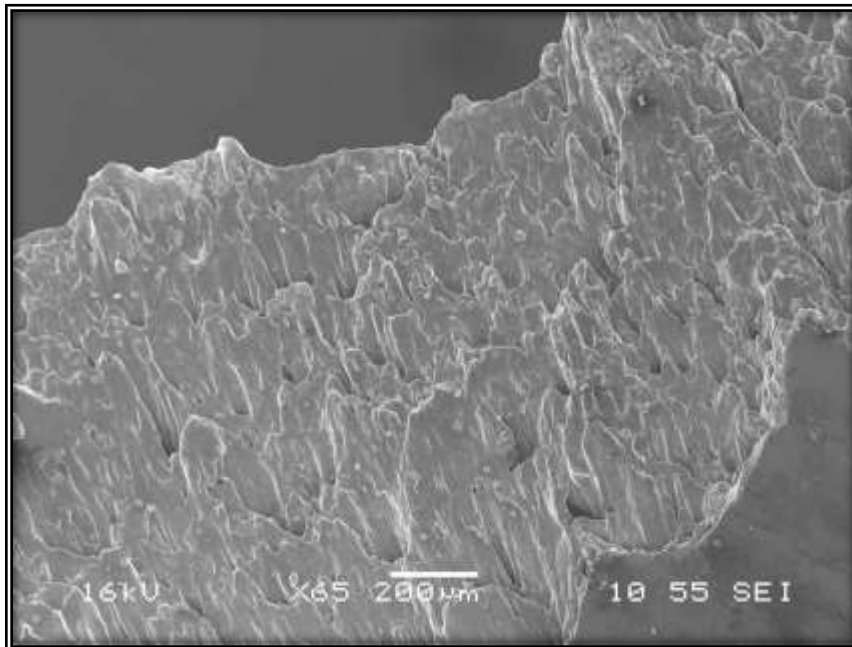
Figure 27 - 65x original magnification SEM image of the fracture surface of the rear sample.

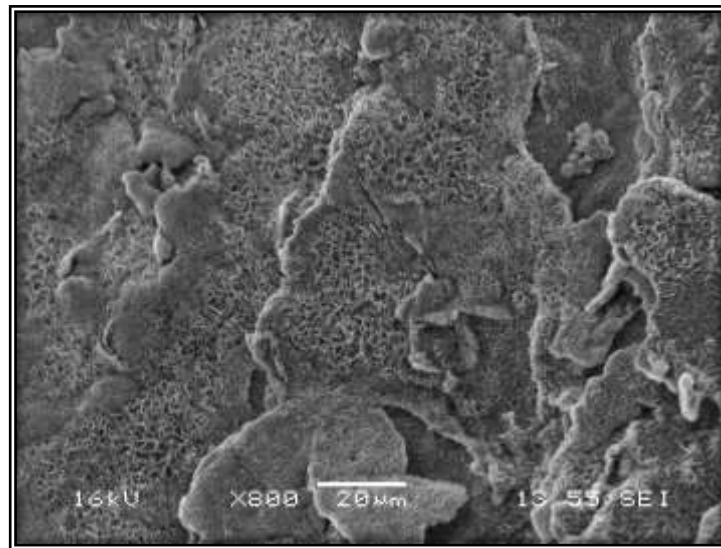
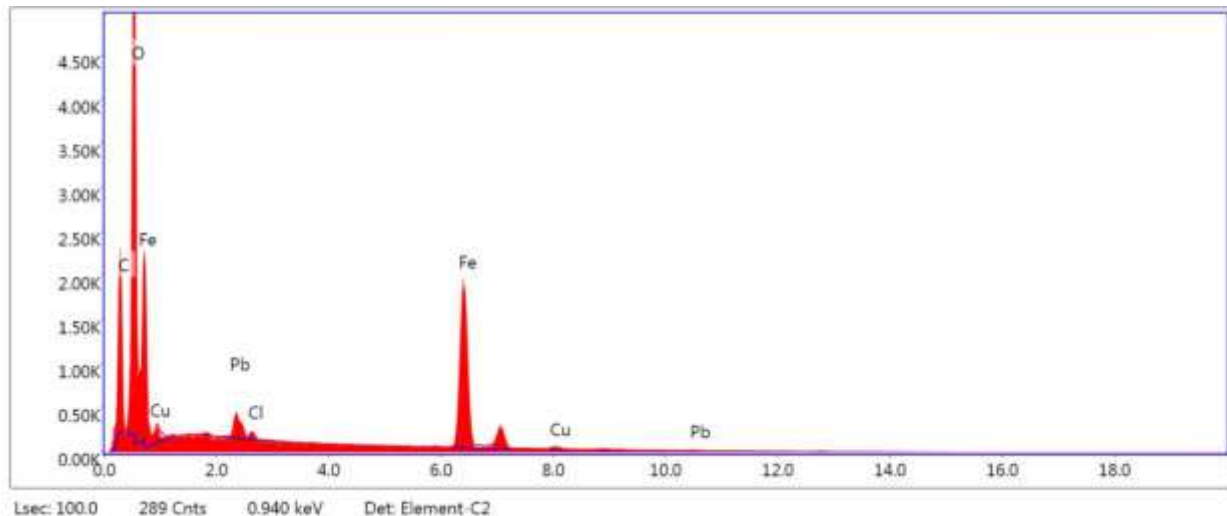
Figure 28 - 800x original magnification SEM image of the fracture surface of the rear sample with EDS results

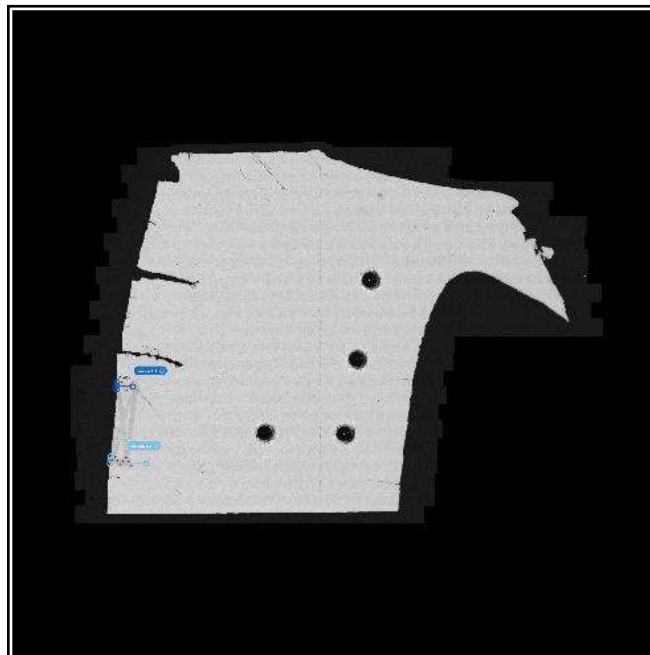
The fracture surface of the rear sample was sectioned in order to obtain a sample for hardness and microstructural analysis. The location of the sample section is shown in Figure 29, with the sectioned surface mounted face-down. Due to the damage that was sustained to the number 3 pin and its fracture surfaces, the values reported are for information only and should not be utilized as a judge of material conformance. Core hardness was measured at  $55.5 \pm 1.0$  HRC, which is significantly higher than the requirement of 32 - 39 HRC. Two microhardness traverses were placed, one on the ID and one of the OD of the sectioned sample. The microhardness profile is shown in figure 30, with the results recorded in HV then converted to HRC. The average hardness was 56 HRC, and no case depth was observed. For reference, the hardness value recorded is significantly higher than the 64 HR30N minimum requirement for the case hardness.

Figure 30 - Microhardness traverses that were placed on the ID and OD surfaces of the sectioned rear sample.

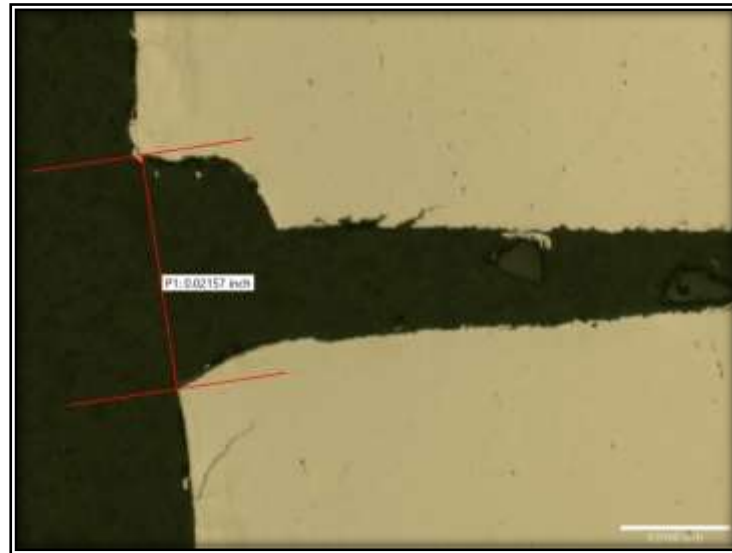
Multiple cracks are visible along both the ID and OD of the sample cross-section, with the largest crack visible in figure 31, with the maximum separation of 0.02157 inches. Additional cracking was observed likely resultant of heat checks stemming from rapid temperature changes during the failure is shown in figure 32. The sample was etched with nital to view the microstructure, which consist of tempered martensite in the core, is shown in figure 33. The case microstructure consists of fine grains with small

Figure 31. 50x original magnification of the largest crack separation on the sectioned rear sample.

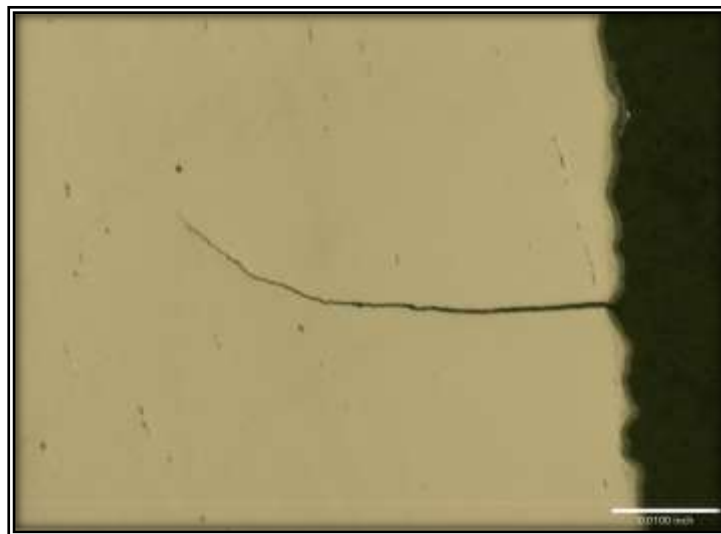
Figure 32 - 50x original magnification of a heat check crack visible on the ID of the sectioned rear sample.

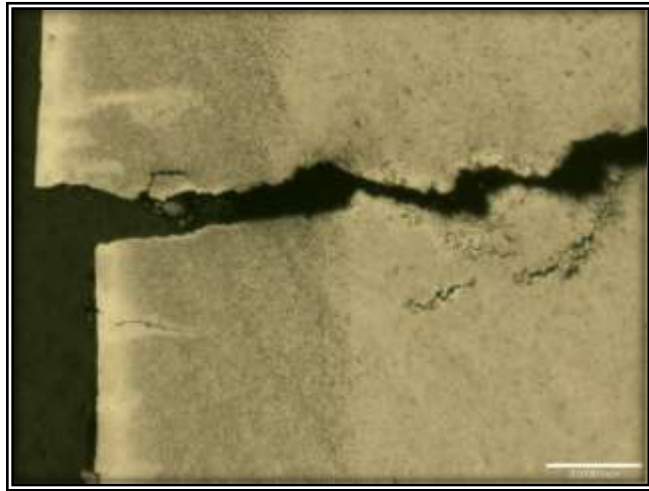
Along the OD of the sample, additional cracking was present is shown in figure 36. Adjacent to the main crack, subsurface cracking was also observed is shown in figure 37. The path for both the main crack and adjacent crack followed an alternating 45-degree path, which was evidence of torsional loading. The cracking also appeared to propagate along grain boundaries. Along the fracture surface, as seen in figure 38 and figure 39, oxide scale was observed along with the fine grain structure with precipitated particles along the grain boundaries. The oxide scale was likely due to excessive heat exposure after the fracture occurred. Rehardening along the fracture surface and evidence of contact damage via grain flow deformation are also observed.

Figure 36 - 50X original magnification of an additional crack observed on the OD of the pin surface of the sectioned Rear Sample after being etched with nital. The upper portion of the crack is displaced with respect to the lower section, which is a sign of unusual loading in the region.

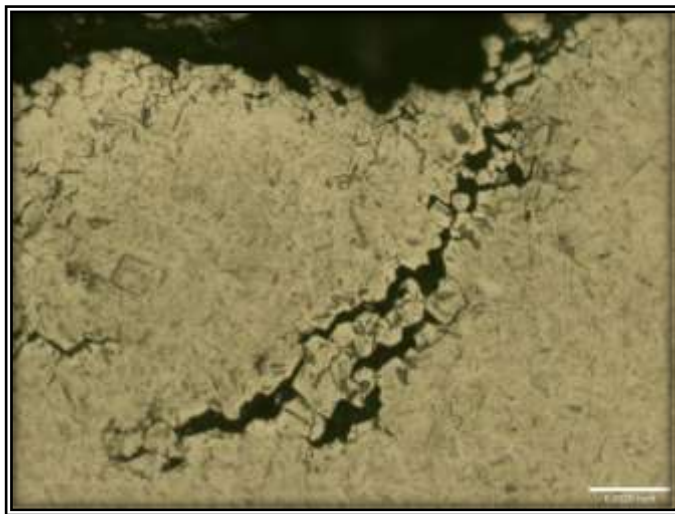
Figure 37 - 200X original magnification of the sub-surface cracking adjacent to the OD crack of the number 3 Pin after being etched with nital. The crack appears to follow a branching, intergranular path.

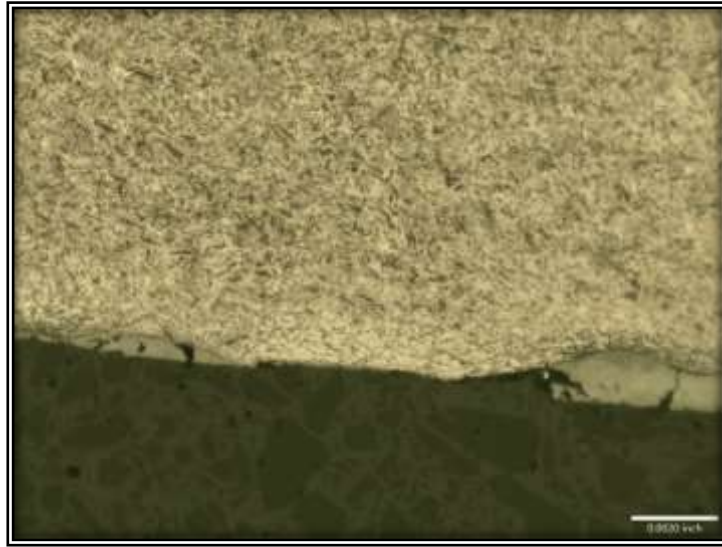
Figure 38 - 100X original magnification of the fracture surface of the sectioned rear sample after being etched with nital.

The fractured surface contain signs of an oxide scale layer, indicating that it was exposed to significant temperatures after fracture. The fine grain microstructure was visible at the fracture surface, while it transitions to tempered martensite away from the surface.

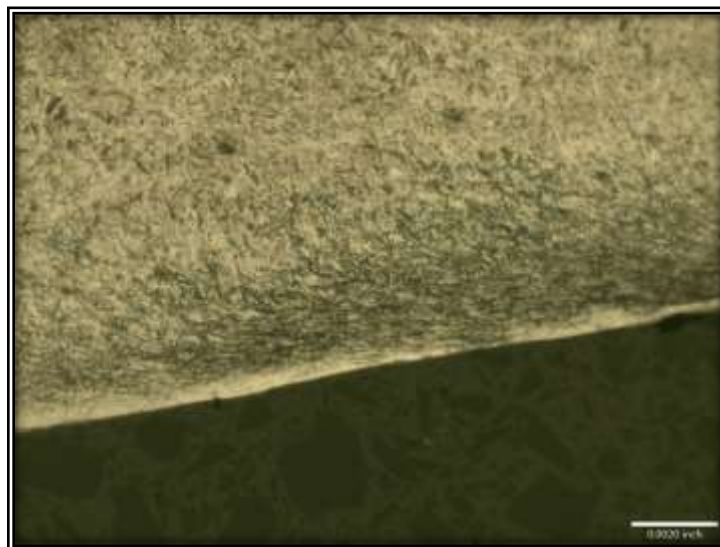
Figure 39 - 200X original magnification of the fracture surface of the sectioned rear sample after being etched with nital.

The fractured surface shows signs of rehardening due to high temperatures. The microstructure near the surface indicates material deformation due to the change observed in the grain flow.

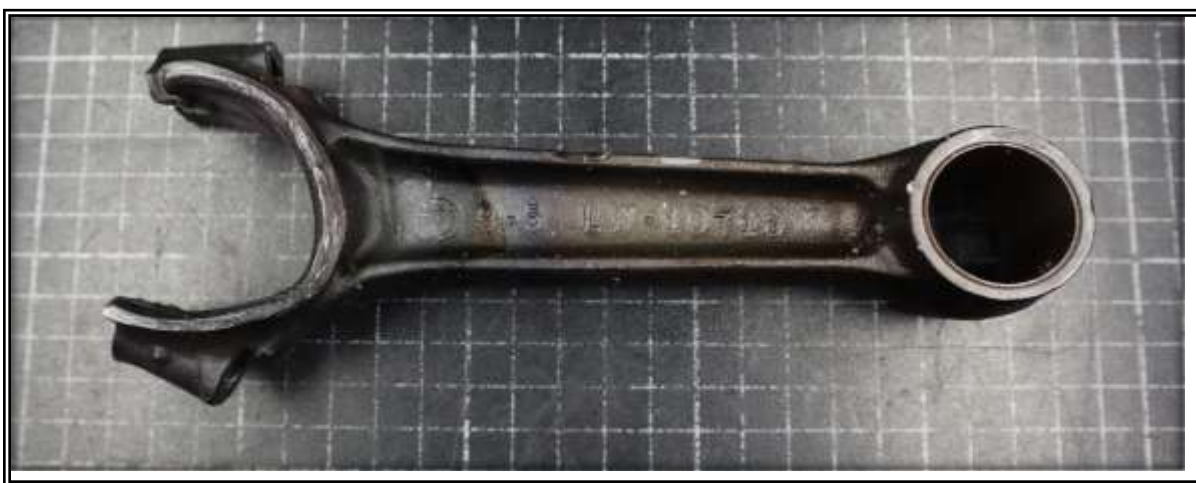
The damaged number 3 connecting rod is shown in figure 44 in the as received condition. The connecting rod experienced significant heat damage, was noted by the darkened color stemming from the cap location and down the handle. The connecting rod cap, bolts, nuts, and bearings were all separated from the assembly upon receipt. Additional contact damage on the connecting rod is shown in figure 45 and figure 46. In figure 47, shows the bent out of round shape of the material deformation that was experienced.

Figure 44 - The number 3 connecting rod in the as-received condition. The connecting rod experienced significant contact and heat damage. The connecting rod cap, bolts, nuts, and bearings were all separated from the assembly.

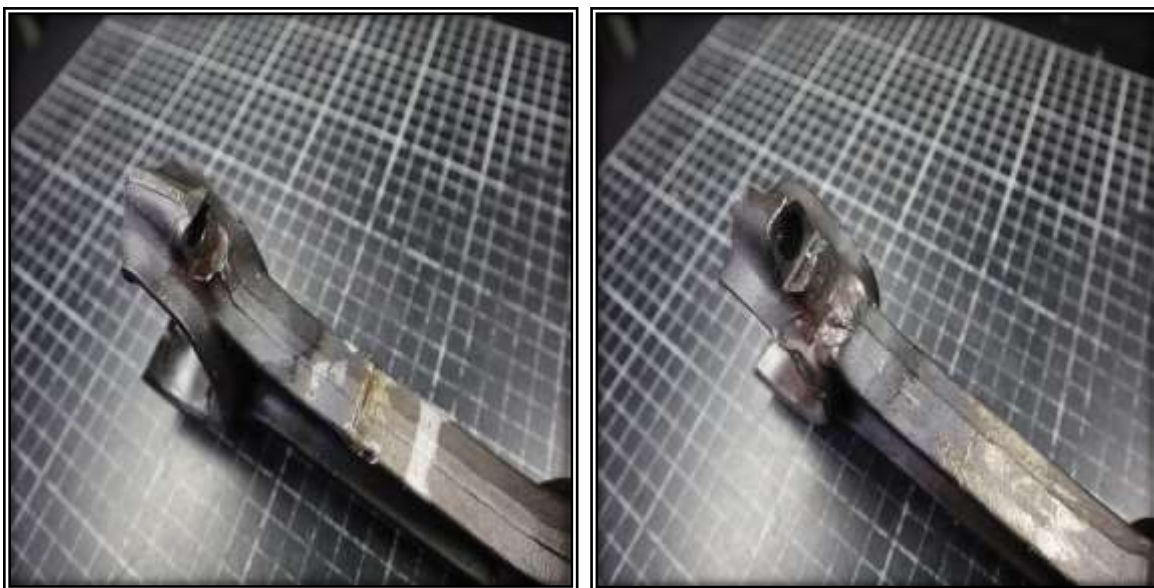
Figure 45 - Additional damage sustained to the number 3 connecting rod.

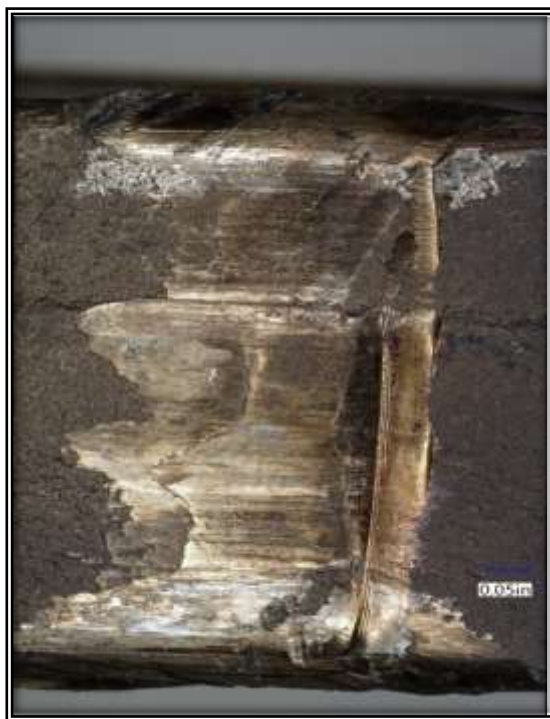
Figure 46 - Additional damage sustained to the number 3 connecting rod, noted by the deep gouge and material smearing.

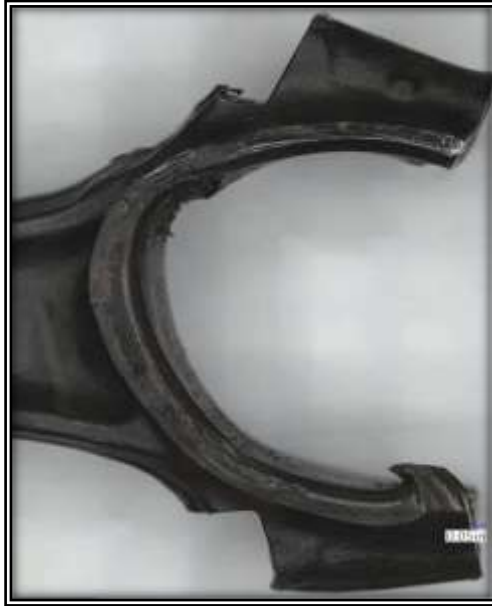
Figure 47 - Additional damage sustained to the number 3 connecting rod. The connecting rod is bent out of round with material cracking along the contact surfaces.

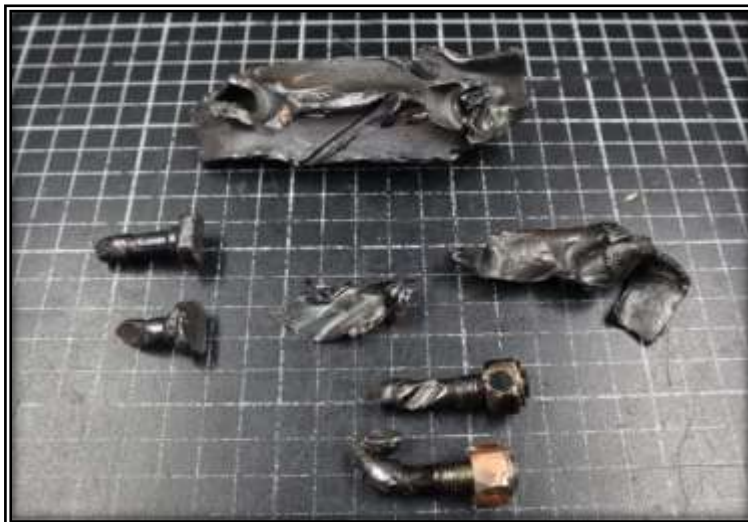
Additional components from the number 3 connecting rod assembly are shown in figure 48, consist of additional 7 pieces that correspond to the bearings and connecting rod bolts. The connecting rod cap shown in figure 49, has an evidence of heat damage, deep material gouging, and a flattened shape. The bearing pieces shown in figure 50, are severely heat damaged with discoloration and cracking. The bearings also sustained significant material loss. The two connecting rod bolts both fractured in the middle of the bolt, resulting in two halves of each bolt, is shown in figure 51 and figure 52. The fracture surfaces of both bolts were damaged, that the mode of failure could not be determined.

Figure 48 - Additional pieces of the number 3 connecting rod in the as-received condition.

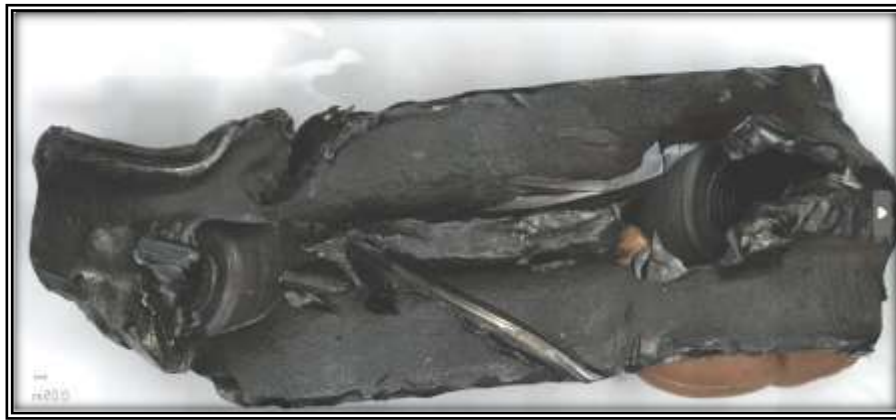
Figure 49 - The number 3 connecting rod cap piece. Significant deformation occurred to the shape of the cap, along with deep gouging on the part surface.

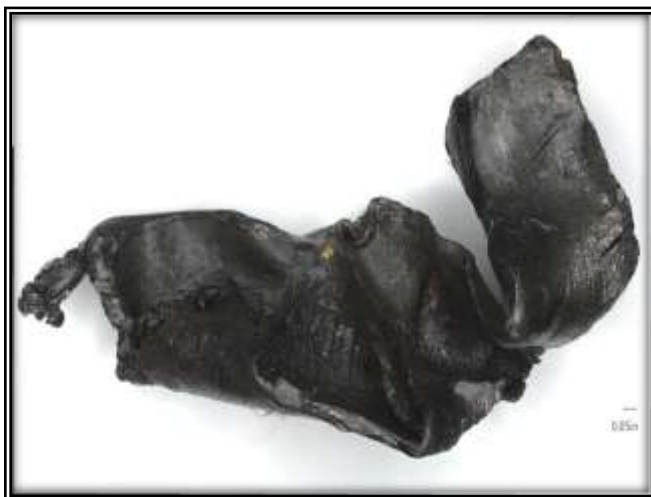
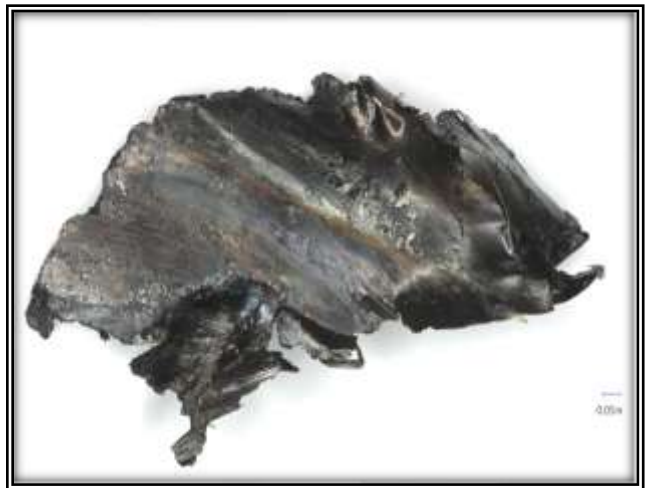
Figure 50 - Additional damaged pieces returned along with the number 3 connecting rod. The two pieces appears to be the damaged bearings associated with this connecting rod assembly. Both bearings have sustained significant material loss, deformation, and heat discoloration.
