# AIRCRAFT ACCIDENT INVESTIGATION AND INQUIRY BOARD

## FINAL REPORT

RP-C8840

Cessna152

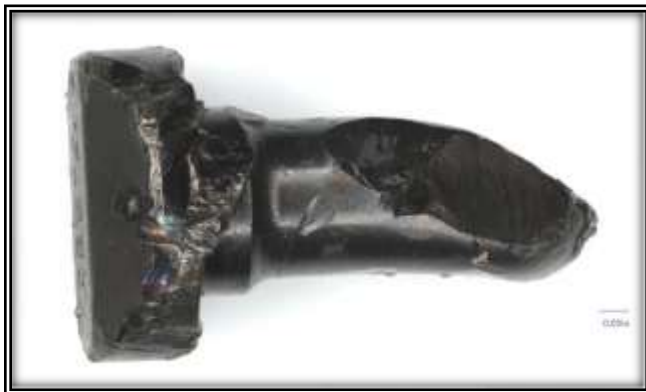
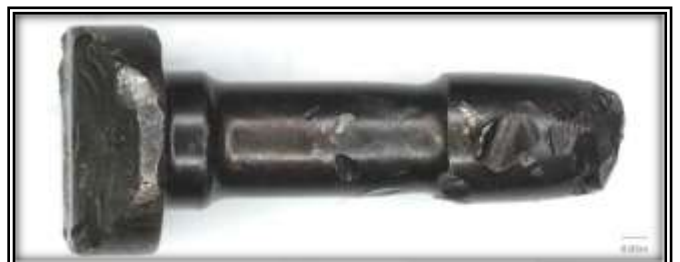
Figure 51 - Two fractured connecting rod bolt pieces associated with the number 3 connecting rod. Both bolts fractured in the stem, and sustained damage to both the stem and head.

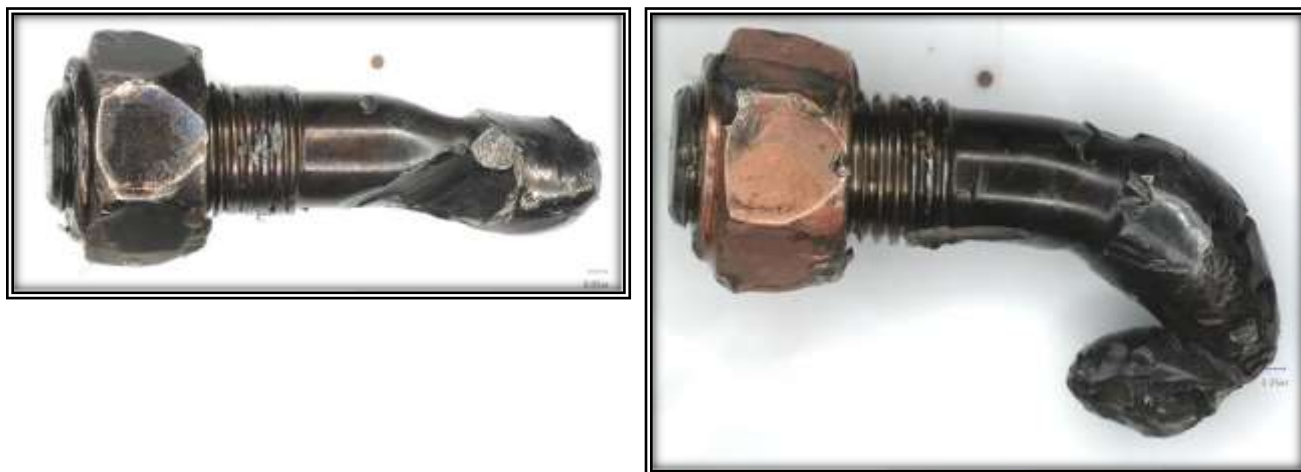
Figure 52 - Two remaining halves of the fractured connecting rod bolts along with their associated nut. Both bolts are fractured in the stem and contain significant deformation and gouging.

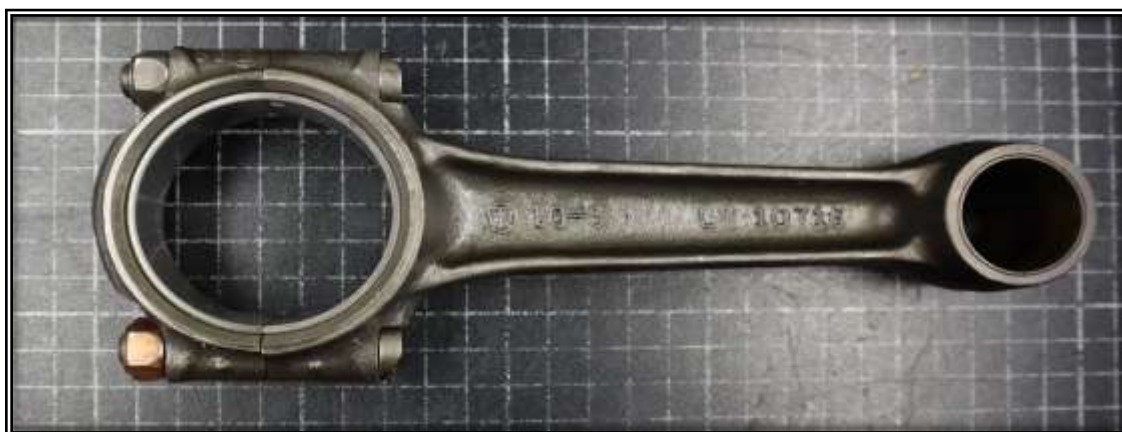
The remaining connecting rod for cylinders 1, 2, and 4 were also evaluated. The number 1 connecting rod assembly is shown in figure 53. It was noted that the number 1 connecting rod has different forging number than the other rods, indicating that it was likely replaced in the field. The number 1 connecting rod was noted to have a conical wear mark on the ID of the bearings is shown in figure 54. Minor signs of damage were observed on the outer circumference of the connecting rod is shown in figure 55. The bearings were removed from the assembly with more severe scratching on the ID is shown in figure 56.

Figure 53 - The number 1 connecting rod in the as-received condition. Minor signs of wear and damage were observed.

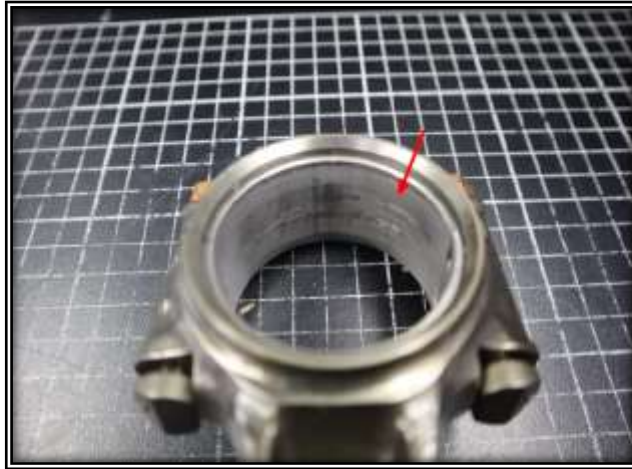
Figure 54 - On the number 1 connecting rod, deep wear grooves were observed on the interior of the connecting rod bearing, as indicated by the arrow.

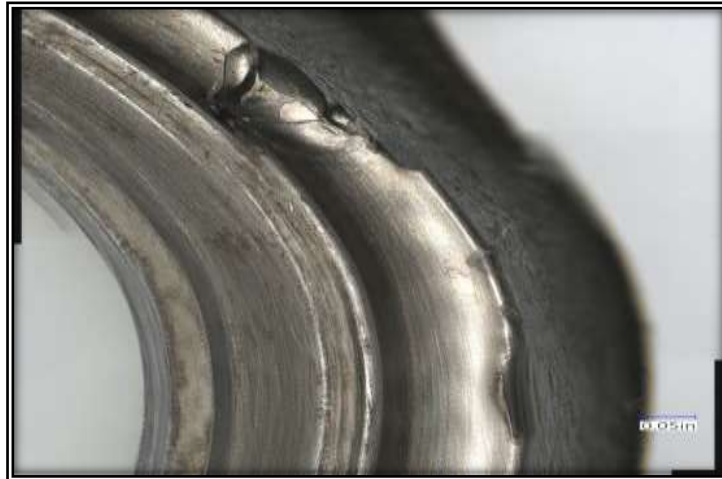
Figure 55 - The contact damage sustained to the outer circumference of the number 1 connecting rod.

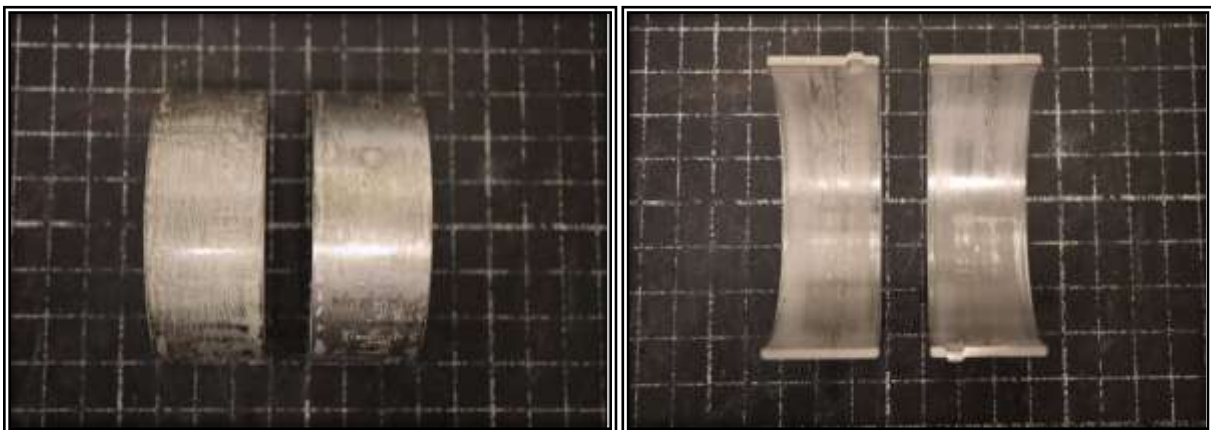
Figure 56 - The connecting rod bearings after being removed from the number 1 connecting rod assembly. Two deep wear marks are present on one of the bearings.

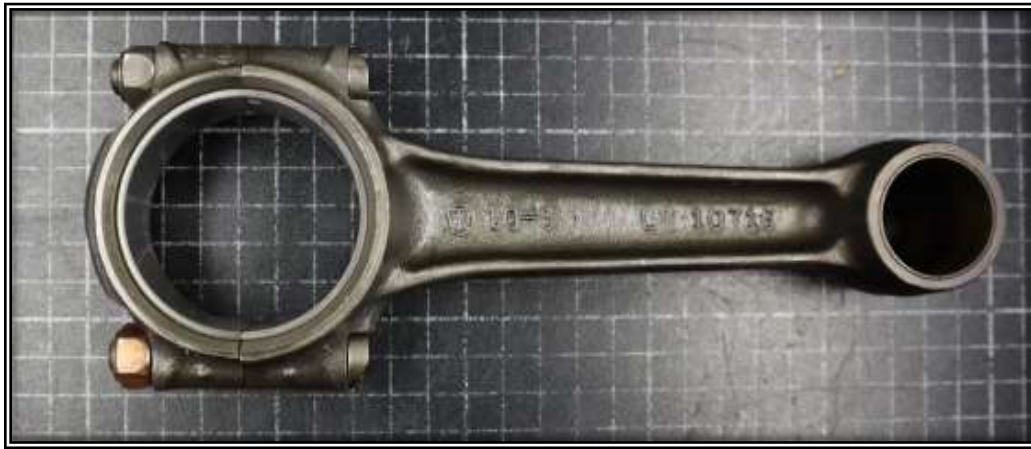
The number 2 connecting rod assembly is shown in figure 57, with no noteworthy signs of damage sustained to the rod itself. The bearings were removed from the connecting rod assembly, and a small scratch was noted on the ID contact surface of one of the bearings is shown in figure 47. Otherwise, the bearings had standard wear.

Figure 57 - The number 2 connecting rod in the as-received condition. Minor signs of wear and damage were observed.

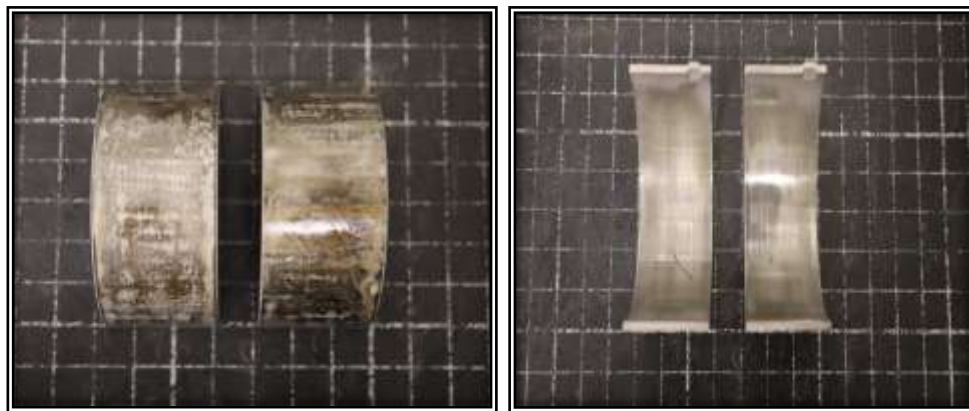
Figure 58 - The connecting rod bearings after being removed from the number 2 connecting rod assembly. A jagged scratch was observed on one of the bearings, with standard wear otherwise.

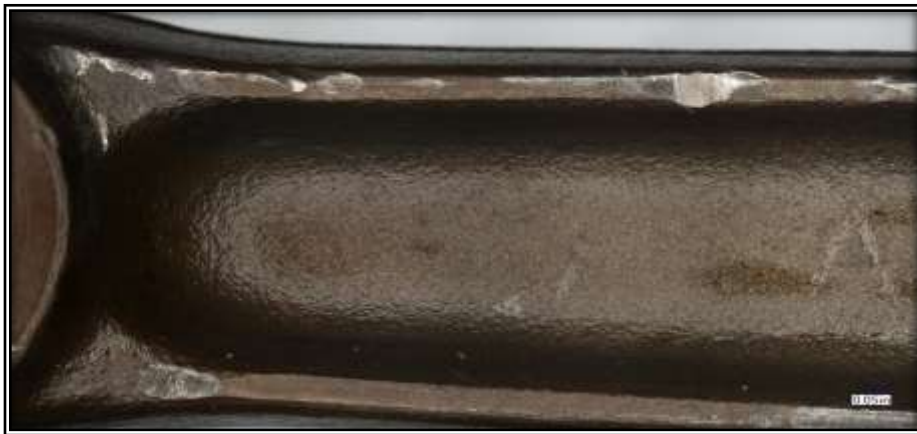
The number 4 connecting rod assembly is shown in figure 59 in the as-received condition. Some damage likely from debris from the fracture was sustained by the I-beam section of the connecting rod, is shown in figure 60. Signs of material smearing and heat tinting are present near the connecting rod bolts is shown in figure 61.

Figure 60 - Damage sustained to the I-beam section of the number 4 connecting rod

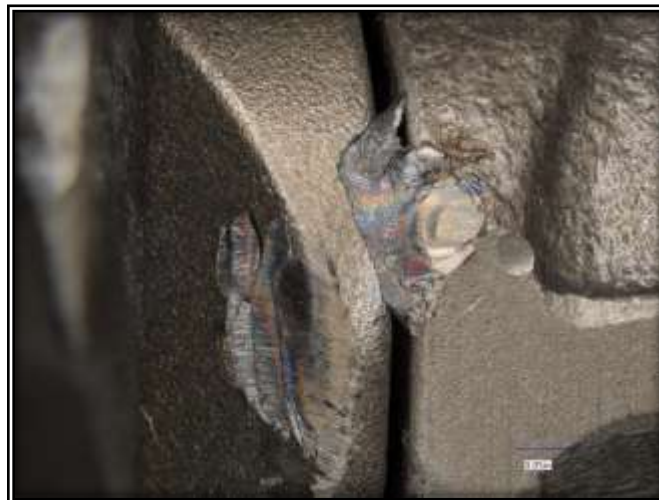
Figure 61 - Damage sustained to the number 4 connecting rod in the region of the connecting rod bolt. Material is smeared from contact damage and displays signs of heat tinting.

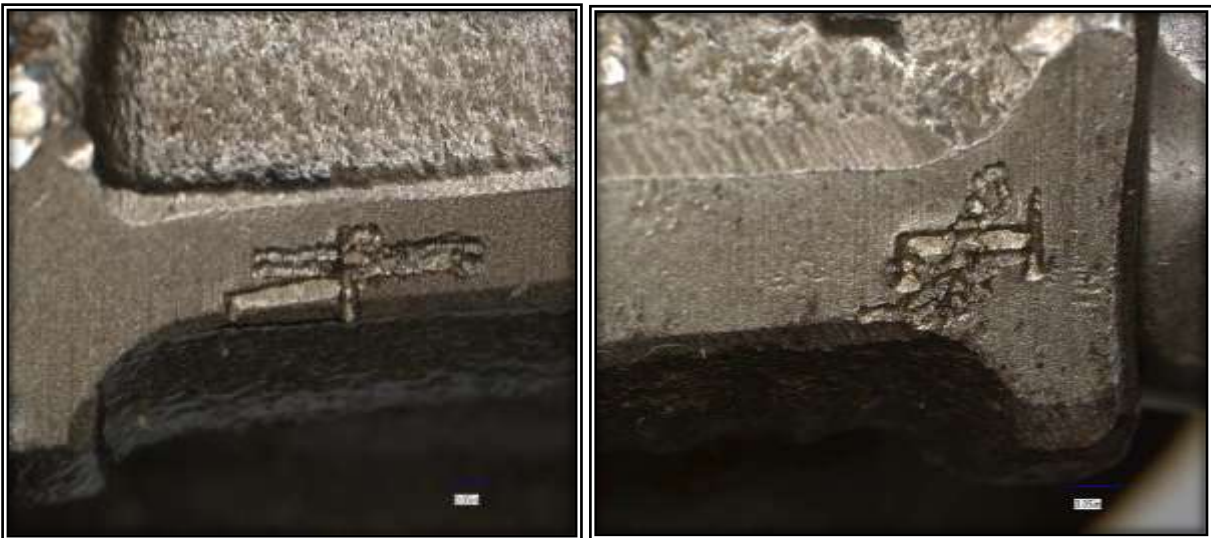
Figure 62 - Both halves of the connecting rod assembly appear to have had their initial cylinder number (1) marking vibro opened over to resemble a 4. This indicates that this connecting rod is not the initial part.

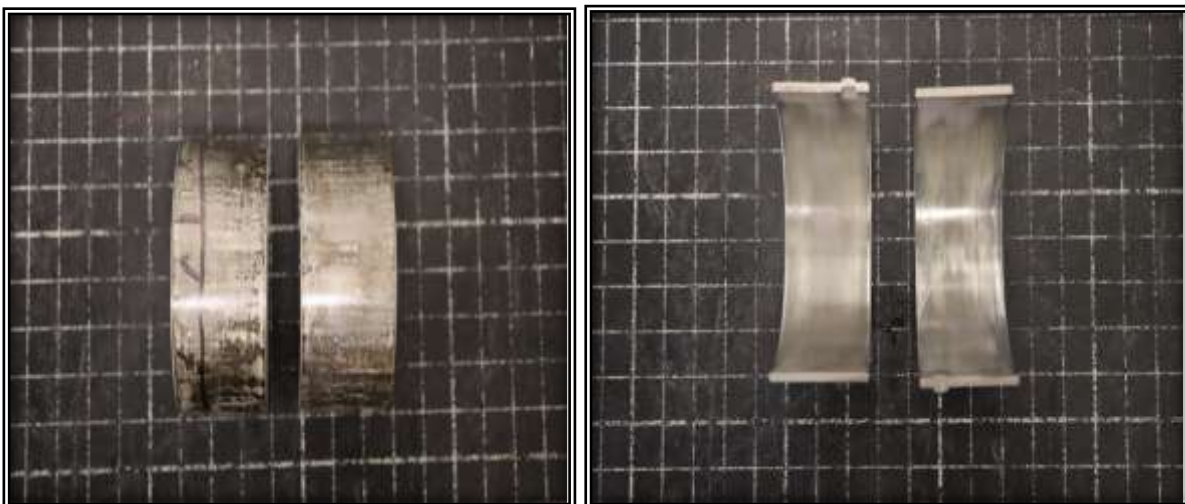
Figure 63 - The connecting rod bearings after being removed from the number 4 connecting rod assembly. A jagged scratch was observed on one of the bearings, with standard wear.
