## AIRCRAFT ACCIDENT INVESTIGATION AND INQUIRY BOARD

### **FINAL REPORT**

**RP-C8846**  
**CESSNA 152**

**TITLE:** An accident involving a Cessna 152 type of aircraft with Registry Number RP-C8846 owned and operated by OMNI Aviation Corporation that sustained damage following a bounced landing at OMNI Aerodrome, OMNI Aviation Corporation, Manuel A. Roxas Highway, Clark Freeport, Mabalacat, Pampanga, Philippines on February 16, 2023/1530H.

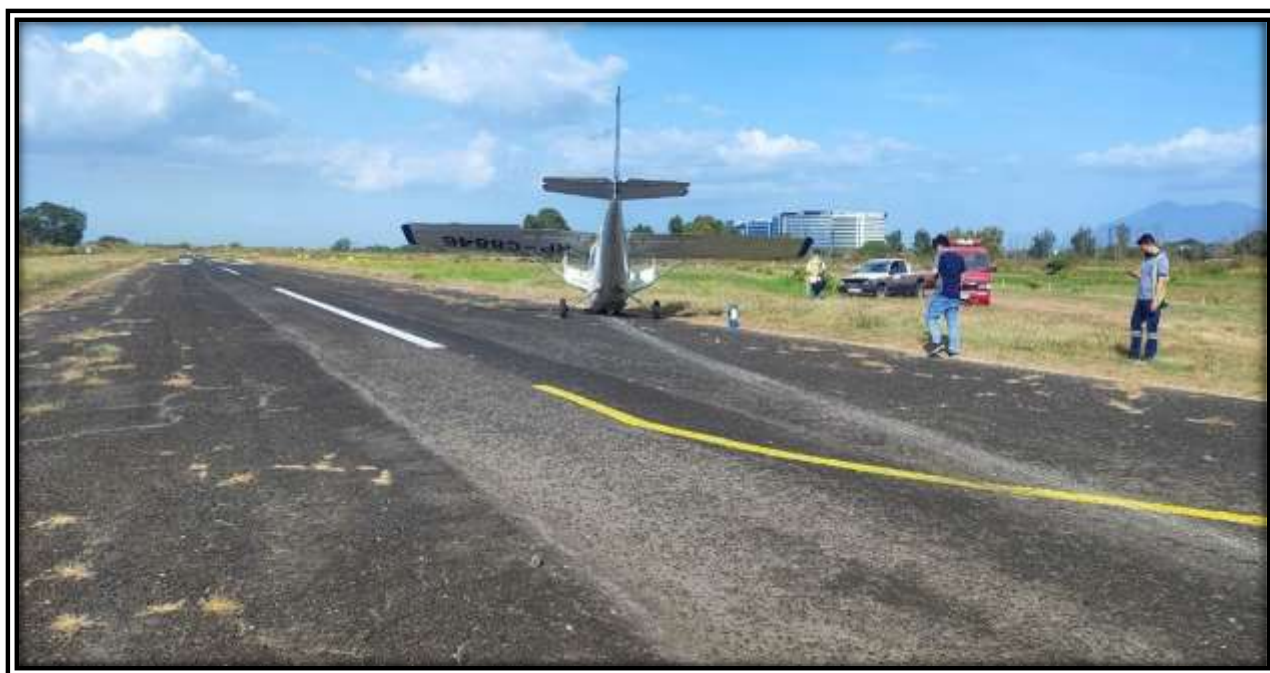
The aircraft took off at Omni Aerodrome with the SP on board for a series of solo accuracy landings within the traffic pattern. During touch-down of his eighth (8th) landing, the aircraft bounced three (3) times, and the nose landing gear collapsed. Seven (7) propeller strikes were also seen on the runway. The aircraft continued to move towards the right side of the runway for another sixty (60) feet before it came to a full stop with a heading of 62 degrees and grid coordinates of 15° 10' 23" N; 120° 33' 52" E.

Figure 1: RP-C8846 on its final resting position.

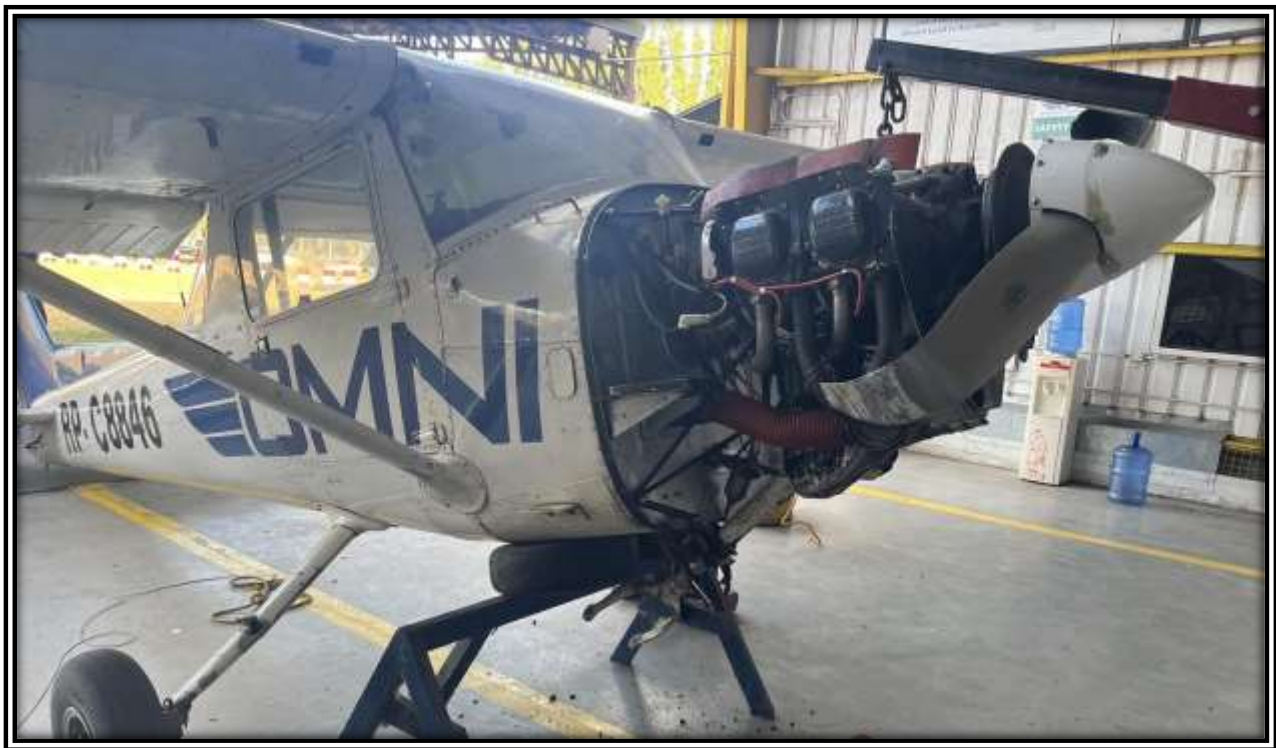
During landing, the aircraft bounced three (3) times before the nose landing gear collapsed. The runway has seven (7) visible propeller strikes as the aircraft continue to move towards the right side of the runway for another sixty (60) feet. It came to a full stop with a heading of 62 degrees and grid coordinates of 15° 10' 23" N; 120° 33' 52" E.

Figure 2. The aircraft damage nose landing gear and bent propeller blades

The SP was on his eighth (8th) solo accuracy landing within the traffic pattern when the event happened. The SP was fast on his approach for landing, and the aircraft was still high as it approached the intended landing point on the runway. The SP reduced the power to idle, causing the aircraft to land hard on its main landing gear. As the aircraft contacts the ground, it bounces back into the air. With the aircraft bouncing back into the air, the SP pushed the elevator control forward, resulting in a nose-low contact with the runway and a porpoise. It was after the third bounce that the nose landing gear collapsed, causing the propeller to strike the ground. A total of seven (7) propeller strikes were noted from the runway.

- a.** The SP has valid license and medical certificate issued by the CAAP.
- b.** The SP was on his eight (8th) solo accuracy landing within the traffic pattern when the bounced landing happened.
- c.** The SP was fast on his approach for landing.
- d.** The SP egress safely from the aircraft.
- e.** The current School Training and Procedure Manual does not include the bounce recovery and rejected landing procedures.
- f.** Visual meteorological condition prevailed at the time of the accident.
- g.** The aircraft was properly released for flight without any discrepancies noted on its logbook.
- h.** The aircraft has current Certificates of Airworthiness and Registration.
- i.** The aircraft sustained damage as a result of propeller strike and collapsed nose landing gear assembly.

1. A safety meeting was conducted to all FI and SP to mitigate the probability of the same incident from happening again. The meeting covered the following subject matter/topic:
  - a. Bounced and Balloon Landing recovery procedures
  - b. Rejected Landing.
2. Reinforced and included as part of the Training and Procedure Manual the following:
  - a. Recovery procedures on bounced and balloon landing.
  - b. Factors that contribute to landing conditions requiring a go-around.
