FINAL REPORT

RP-C9005
CESSNA 150L

OPERATOR: MACTAN AVIATION TECHNOLOGY CENTER INC.

DATE OF OCCURRENCE MARCH 7, 2022

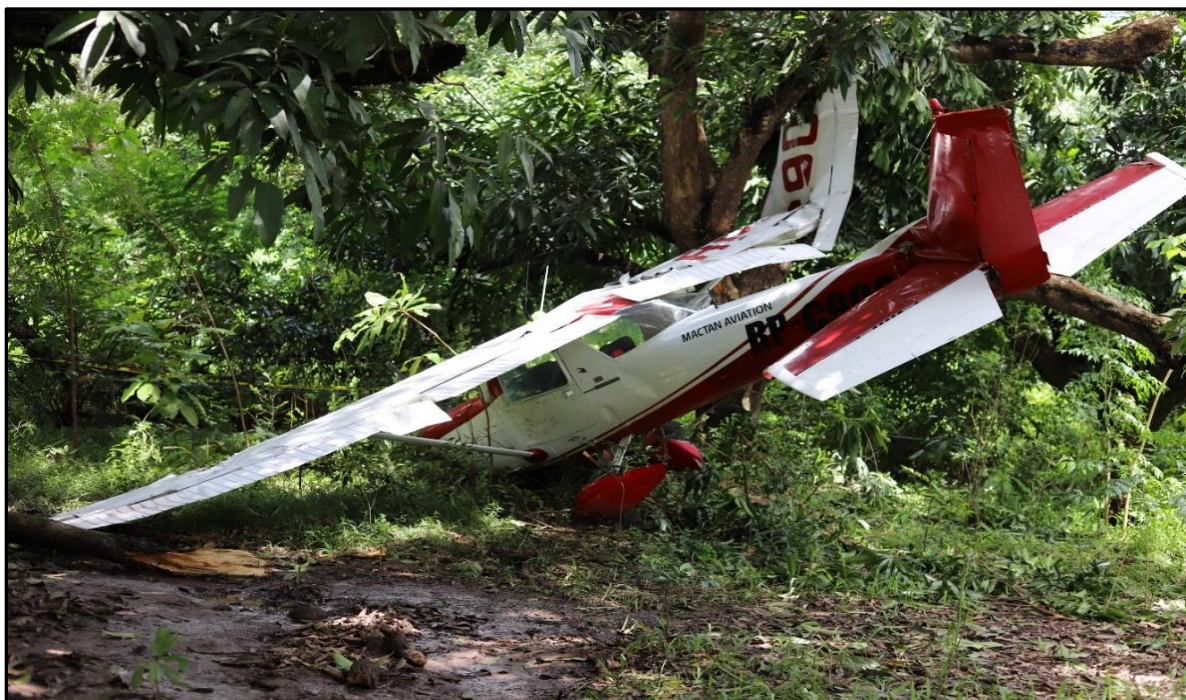
Figure 1: RP-C 9005 final position

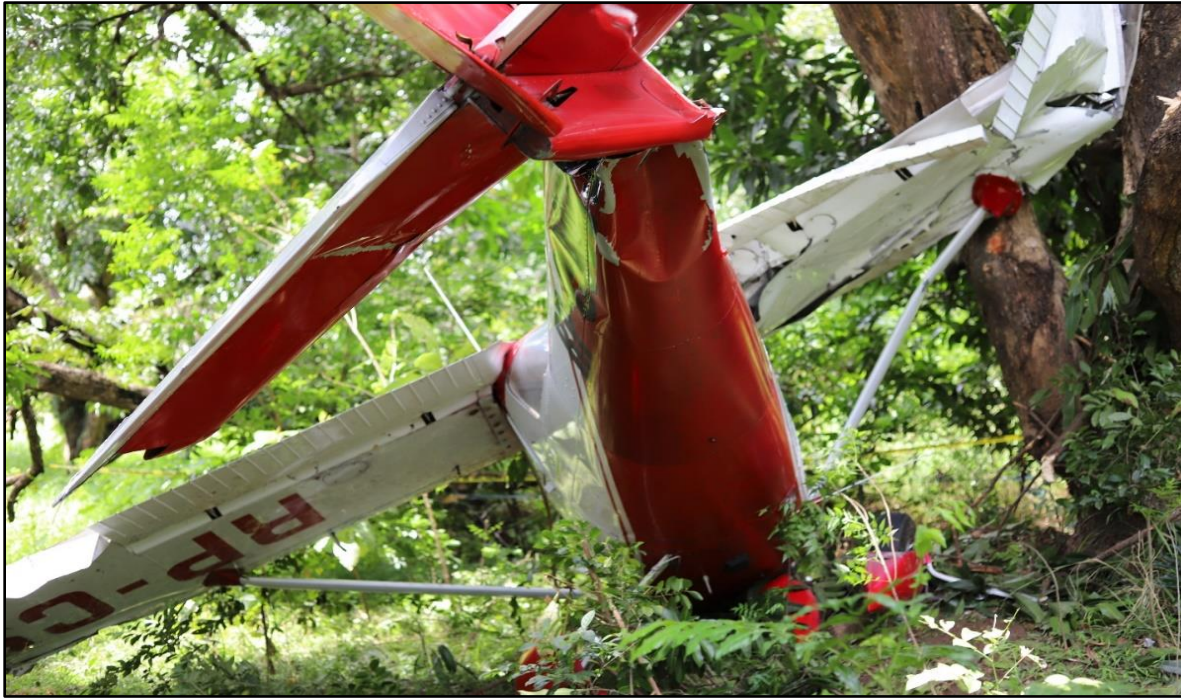
The aircraft settled on an open area in an inverted position near Lambayong Airstrip, Sultan, Kudarat with last heading of 60 degrees and with coordinates of 6° 51.847 N, 124° 38.521 E. The aircraft sustained damage on the propeller, engine, portion of both wings, horizontal stabilizer, vertical fin, and elevator.

Figure 2: Rear View of RP-C 9005 final position

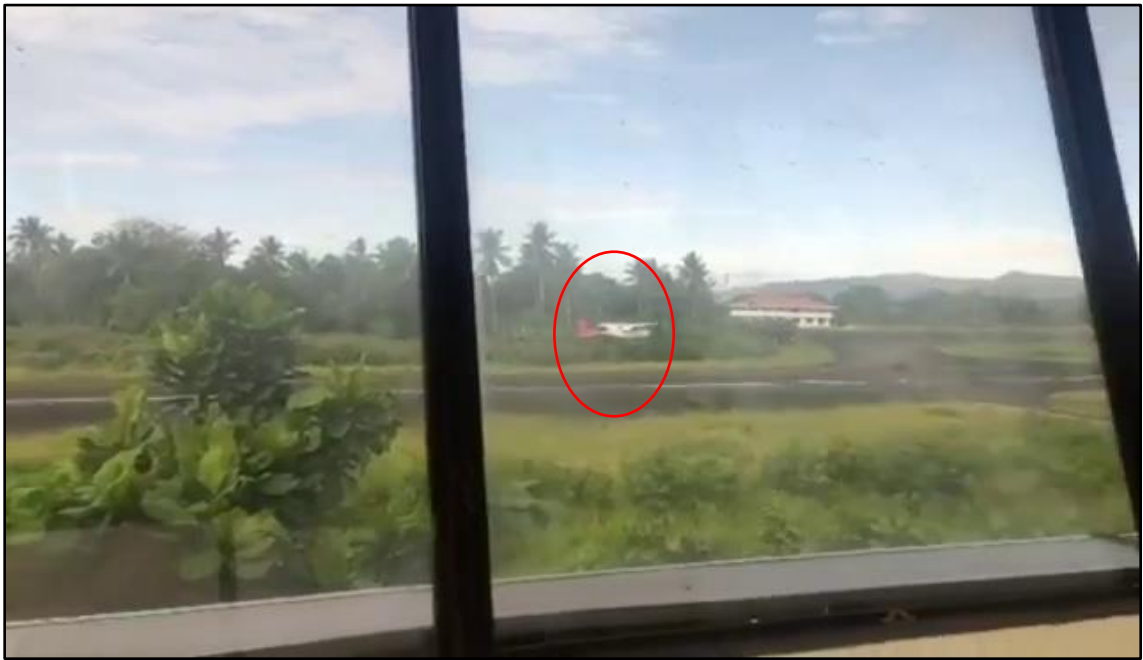
In the course of investigation, the Student Pilot (SP) revealed that it was her second (2nd) lesson of touch and go at Mati Airport prior for first solo flight. Before the accident happened, she was observing the Flight Instructor (FI), throughout the traffic pattern and during the second approach for landing. Upon landing while transitioning for another takeoff, she informed the FI that the flaps were not retracting. The FI aborted the takeoff and taxi the aircraft back to the ramp. The FI checked the flaps by retracting them but the SP could not recall if the flaps did retract. The FI then told the SP that such flaps setting is for short field takeoff and proceeded to the active runway for takeoff. While lining up, the FI, said to her that the full length of the runway will be used. During takeoff roll, she was monitoring the airspeed however, upon lift off she noticed that the airspeed started to decrease. A video acquired by AAIB investigators from one of the witnesses suggest that the aircraft was in full flaps configuration and in nose level attitude when it passed the tower (Figure 3). Inspection of the RH flaps by AAIB

Figure 3: RP-C9005 in nose level attitude and full flaps configuration

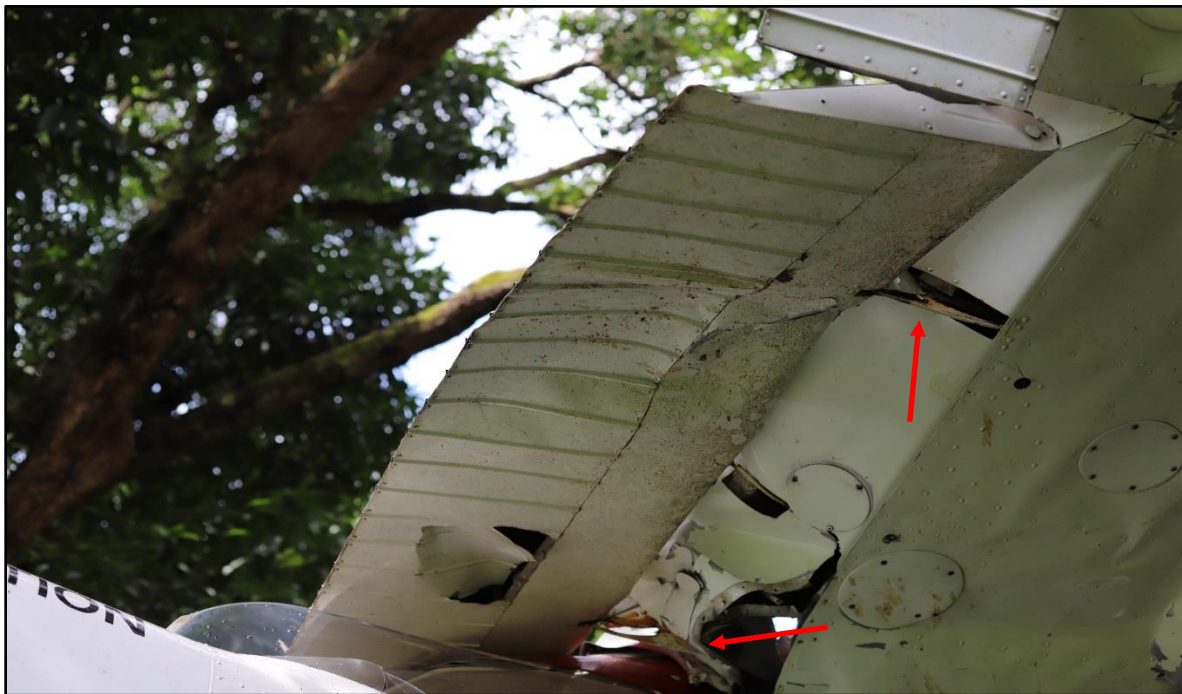
investigators in the crash site appeared to be in full flaps configuration before the impact (Figure 4).

Figure 4: RH flaps in full flaps configuration after impact to a tree

According to the Cessna 150 Pilot Operating handbook (POH), flaps setting for normal and short field takeoffs are performed with flaps up. The use of flaps will shorten the ground run and in case with obstacles ahead. Flap deflections greater than 10° are not approved for takeoff. It is also stipulated in the POH for short field takeoff that if an obstruction dictates the use of a steep climb angle, accelerate to and climb out at an obstacle clearance with flaps retracted.

- a. The decision of the Flight Instructor to fly the aircraft with known discrepancy (flaps retraction fault) resulting to aerodynamic stall.

- a. Establish company procedure in reporting aircraft discrepancy happened in the outlying station.
- b. Include in their regular safety meeting the importance of adhering to the Operating Limitations and Performance of all aircraft being operated by the company.
