## **AIRCRAFT ACCIDENT INVESTIGATION AND INQUIRY BOARD**

### **FINAL REPORT**

**RP-R1423**  
**ALLIED AG CAT PRODUCTIONS, INC. G-164**

**TITLE:** Accident involving an Allied Ag Cat Productions, Inc. G-164 type of aircraft with Registry Number RP-R1423, operated by South Pacific Aerial Spraying Services (SPASS) had a forced landing at Purok 5, Barangay Concepcion, Maco, Davao de Oro, Philippines, on December 20, 2023, at around 0645H.

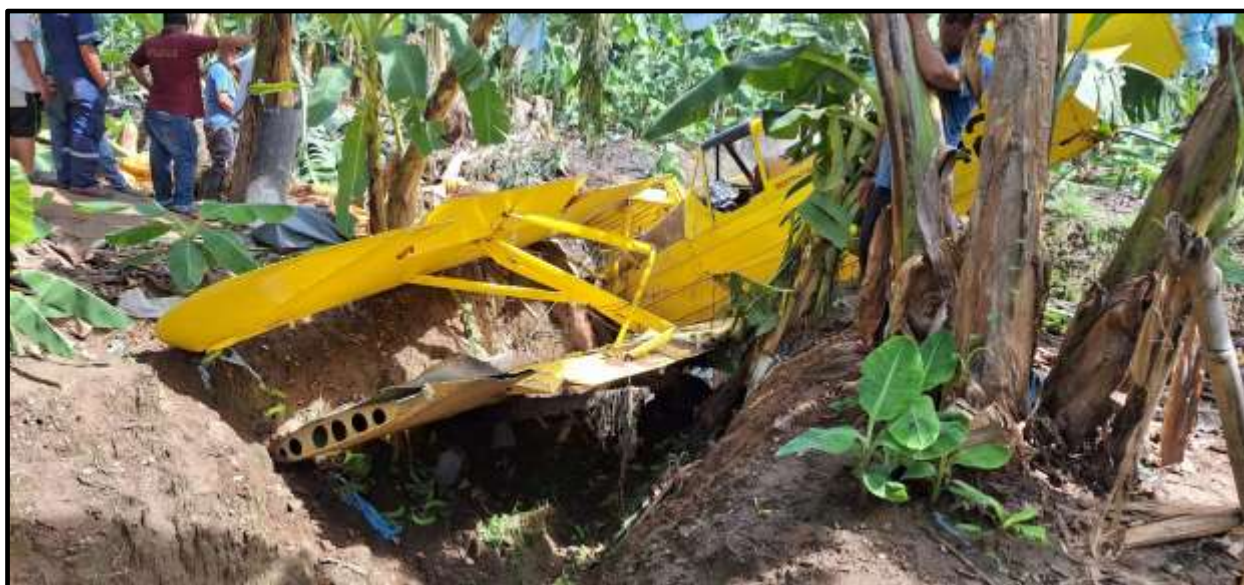
Figure 1 – Aircraft wings were damaged after making contact with the ground.

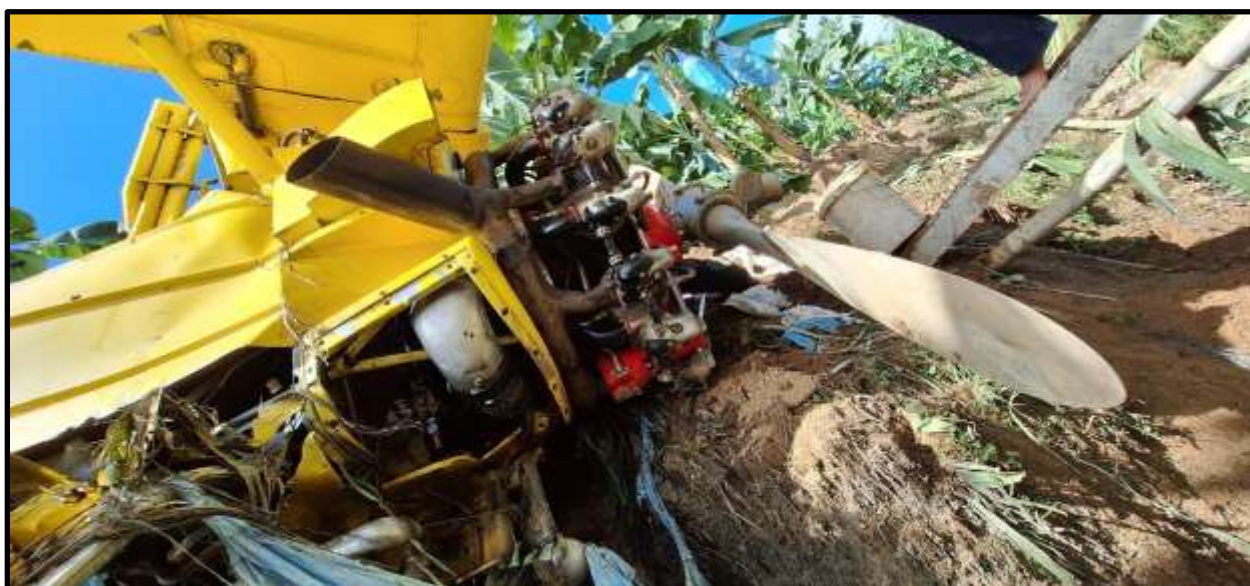
Figure 2 – Damage on the aircraft's lower fuselage and engine.

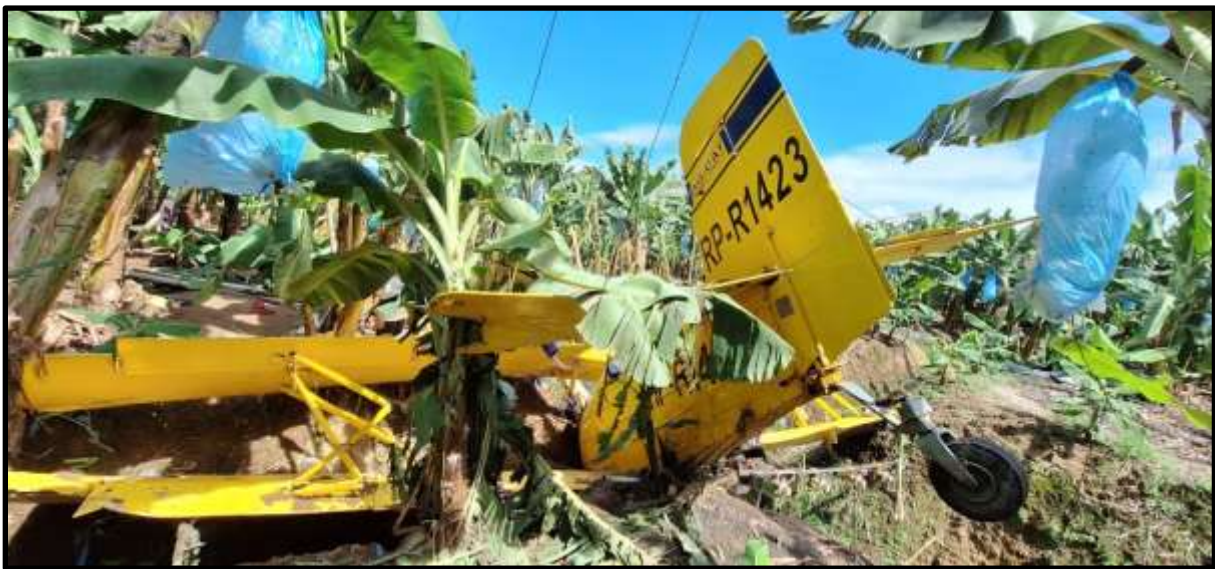
During the landing, the aircraft wings collided with steel wires used within the plantation, causing the aircraft to sway around and eventually settle in a water ditch approximately 4-5 meters in depth. Approximately twenty (20) or more banana crops were uprooted or damaged due to a collision with the aircraft.

Figure 3 – The aircraft hitting some banana trees.

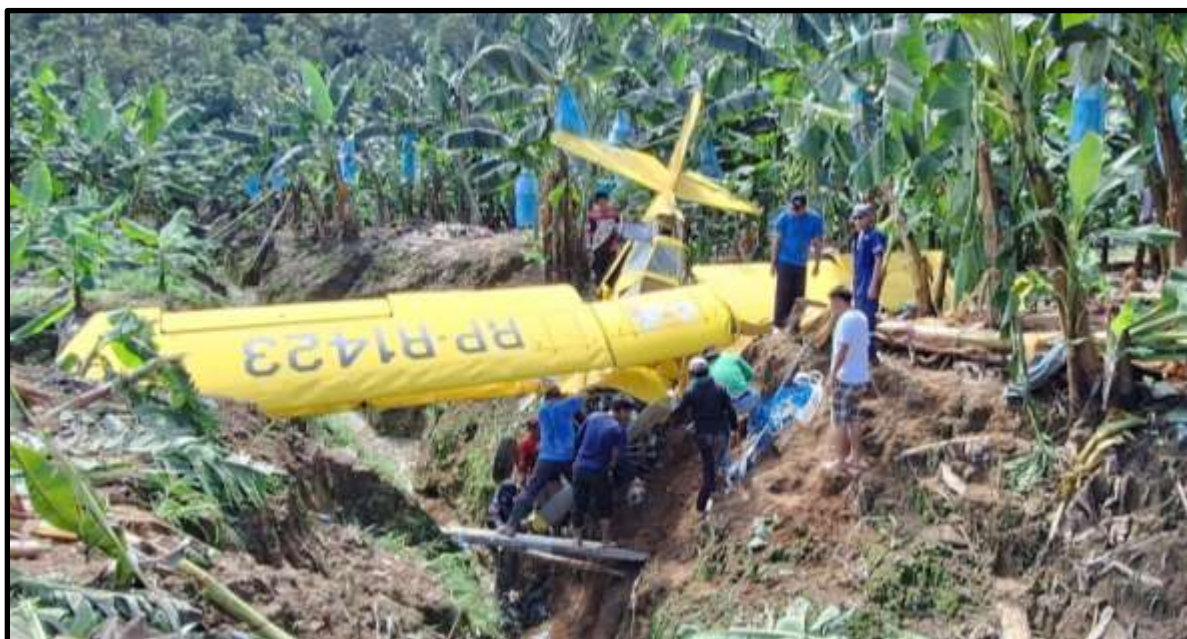
Figure 4 – The aircraft hanging in the ditch.

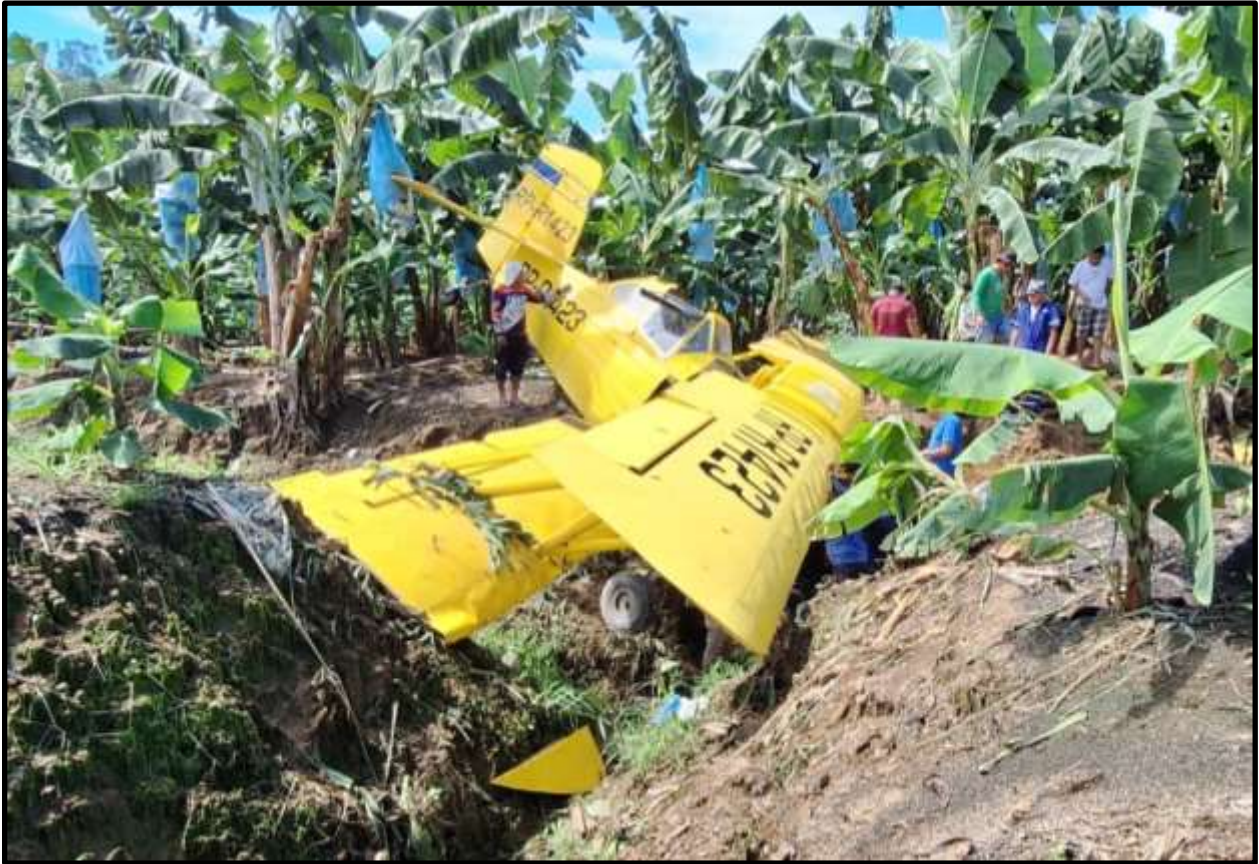
Figure 5 – The aircraft's right wing as seen from the other side of the ditch.

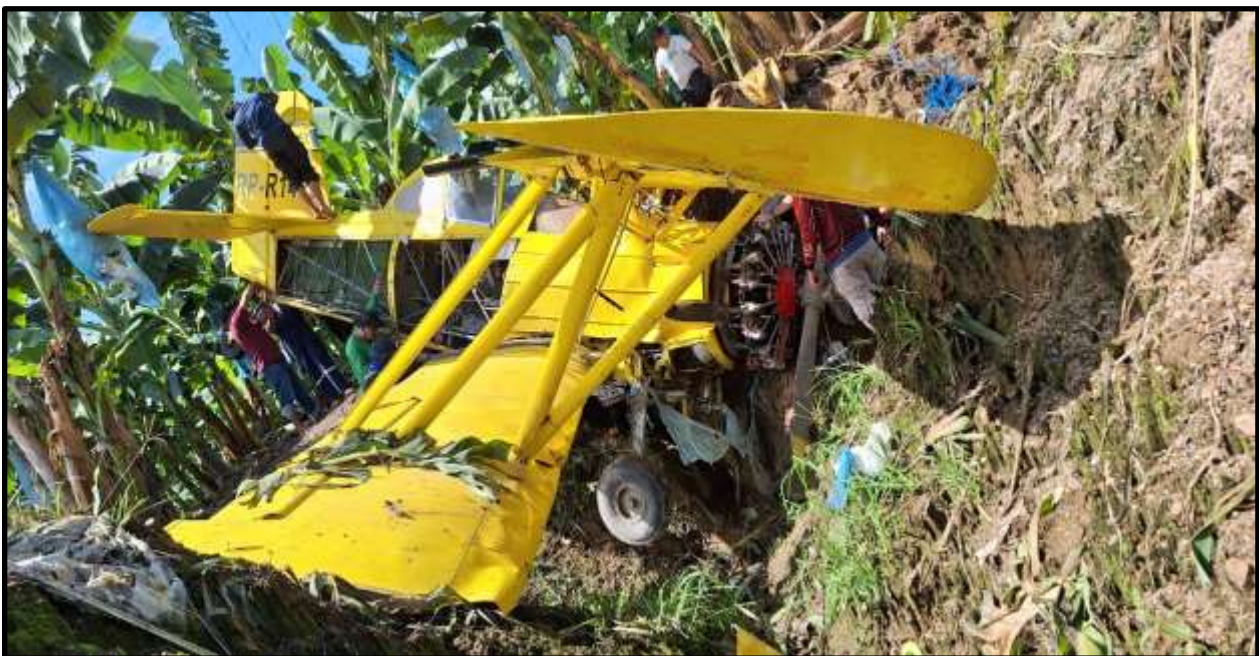
On ocular inspection of the site, it was observed that part of the engine was partly buried in the soft ground due to impact.

Figure 6 – A portion of the aircraft engine is embedded in soft ground.

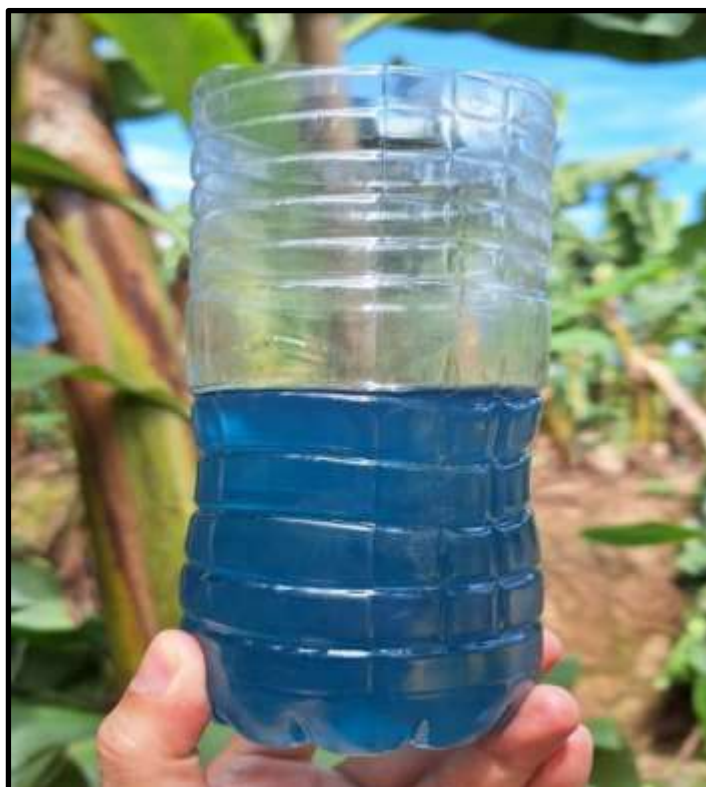
The first thing considered was to check the fuel for any contaminants that may have affected the engine's performance. A sample of fuel was taken from the aircraft and subjected to a thorough visual inspection to detect any residue that might have led to sputtering. Based on the inspection, it can be said that the fuel used on the aircraft during the accident was free from any impurities.

Figure 7 – Fuel sampling taken on the site.

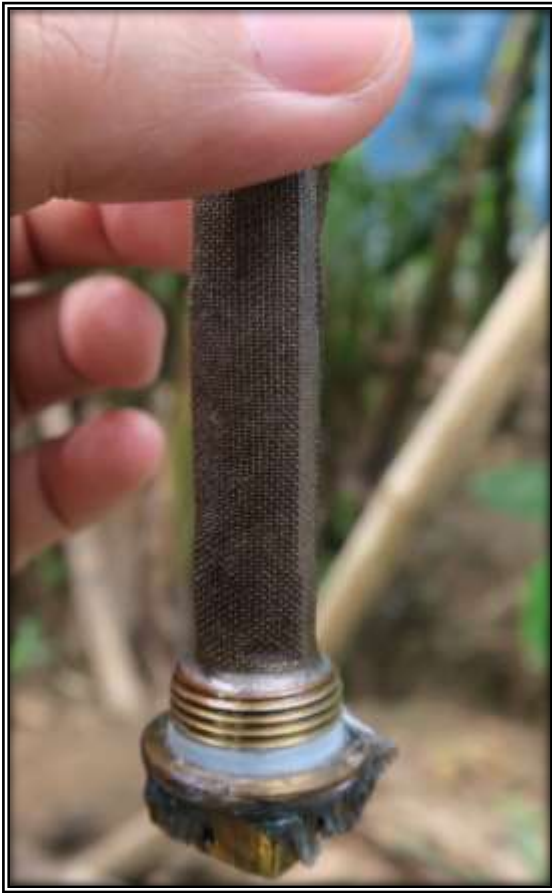
After the fuel sampling, the carburetor filter was removed for inspection. Upon examination, the filter appeared significantly darkened or blackened and almost opaque, suggesting a substantial buildup of contaminants. This discoloration indicated that the filter was likely obstructed, potentially affecting the flow of fuel and causing the engine's performance to degrade. To address this, the filter was shaken to remove the suspected clogs, and it was confirmed that a significant residue of fibrous material was blocking the filter. Additional material came off when the filter was further cleaned.

Figure 8 – Carburetor filter upon retrieval.

- a. Fuel starvation due to clogged fuel filter.

- a. The operator should review their current preventive maintenance schedule for inspecting the engine's carburetor filter to ensure that it is free and clear from foreign objects.
- b. The operator should define in their published Fuel Maintenance Policies and Procedures the criteria for determining the serviceability of filters, such as chamois, used during refueling.

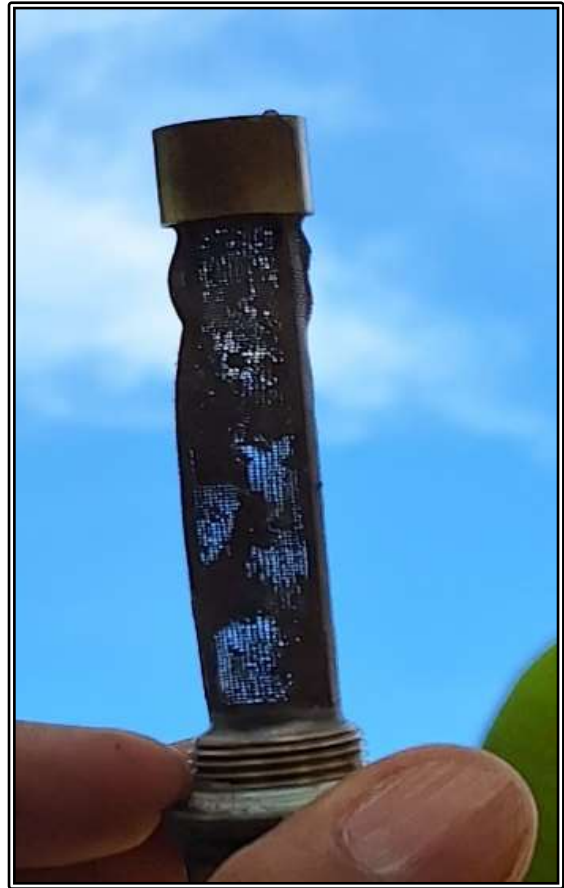
Figure 9 – Carburetor filter after being shaken off.

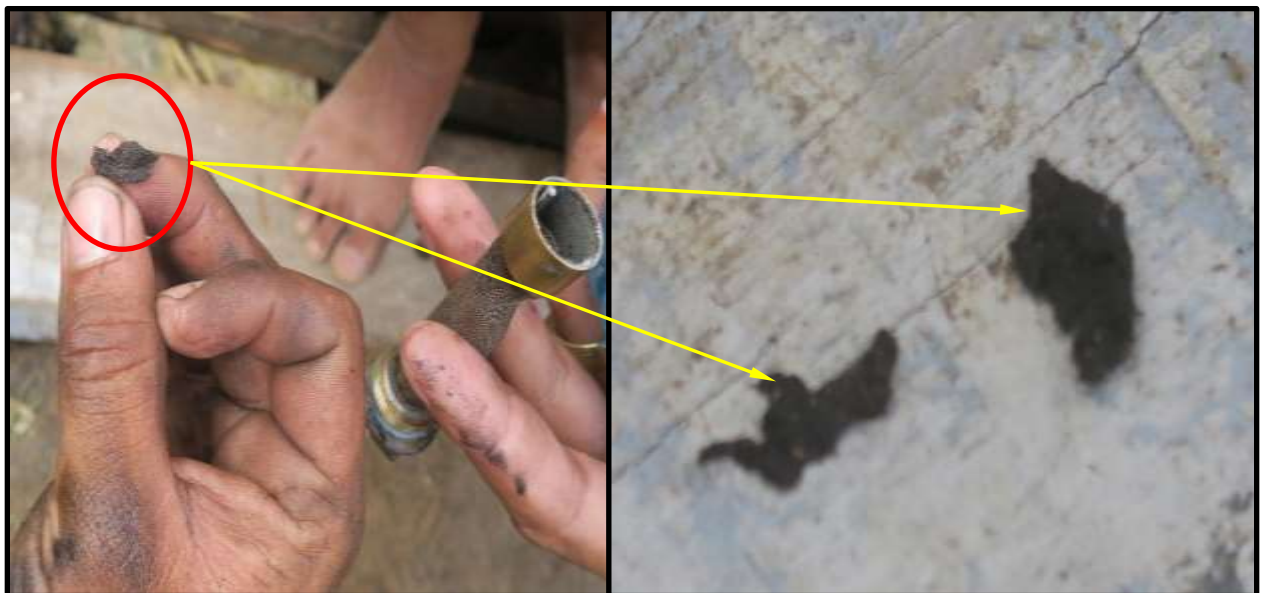
In the discussion with maintenance personnel, it was suggested that the material retrieved from the carburetor filter might have originated from the chamois used as a filter during refueling. It was further learned that the inspection and cleaning of the filter are part of the 50-hour scheduled inspection, which was recently completed on September 28, 2023. According to the maintenance personnel who conducted the inspection, the filter was checked and cleaned during the last 50-hour inspection. Based on experience, such residue can be observed on the filter during inspection. As for the chamois being used as a filter during refueling, this is noted to be part of the existing SPASS Fuel Maintenance Policies and Procedures. However, it can also be noted that currently, there is no specific written process outlining the condition under which a certain chamois can be used as a filter or the duration for which it can still be used.

Figure 10 – Fibrous material taken out from the carburetor filter.

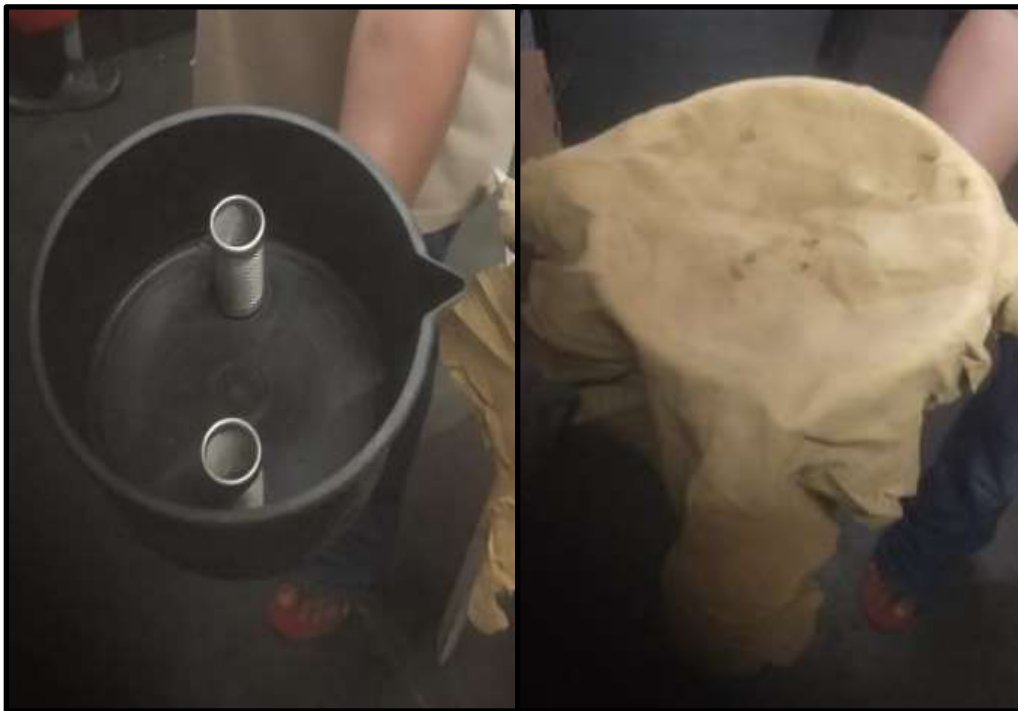
Figure 11 – Funnel and chamois used during refueling.

- a. The use of a chamois as a filter during refueling without any defined criteria or timeline for its serviceability.

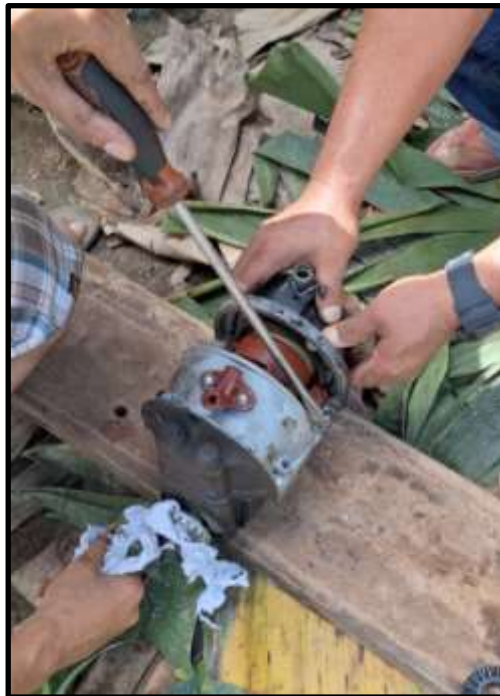
Furthermore, the engine's magnetos and spark plugs were also tested for operational functionality and found to be in working order. An engine compression check was also performed and yielded satisfactory results. Additionally, the airframe filter was removed and inspected, revealing that it was clear of any obstructions.

Figure 12 – SPASS personnel checking one of the engine's magnetos.

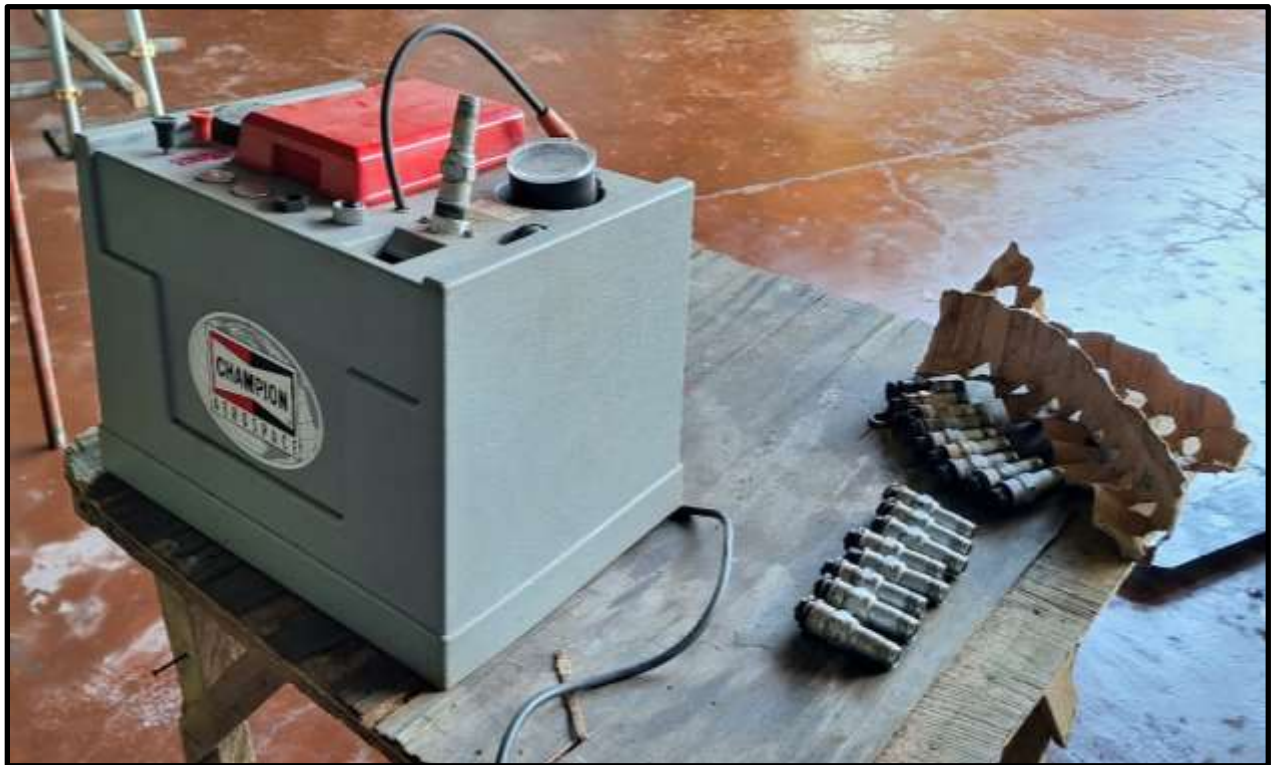
Figure 13 – The engine spark plugs with the tester.

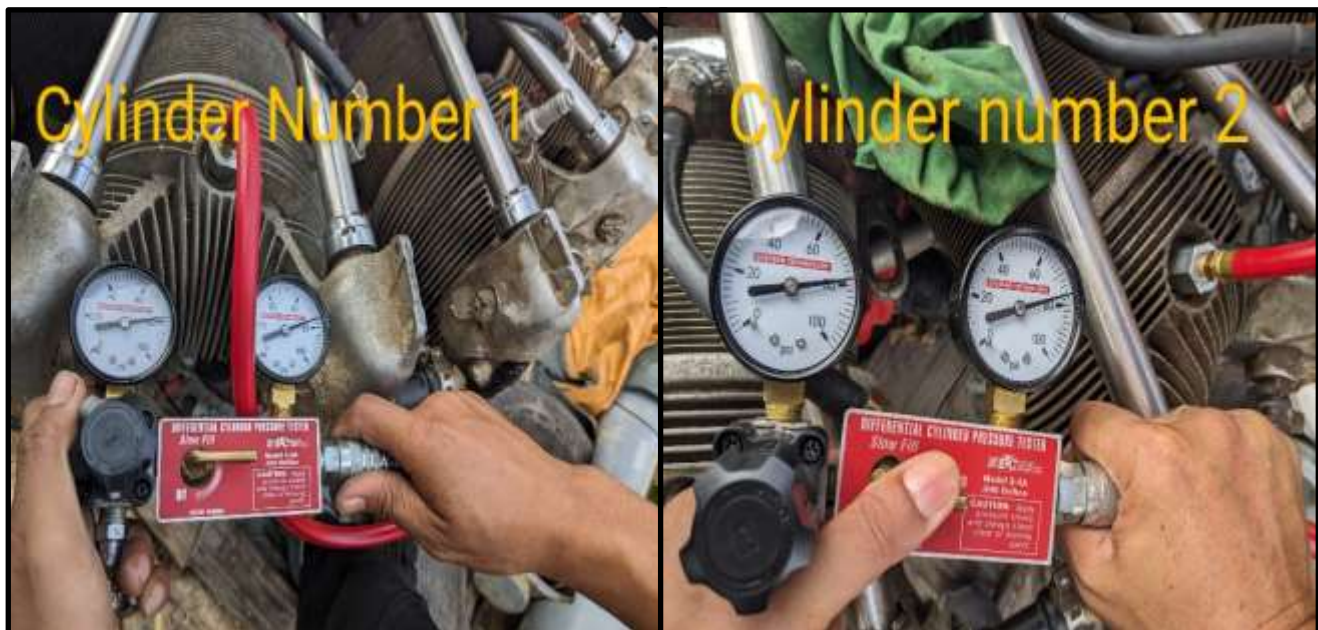
Figure 14 – Some compression checks performed on the engine's cylinders.

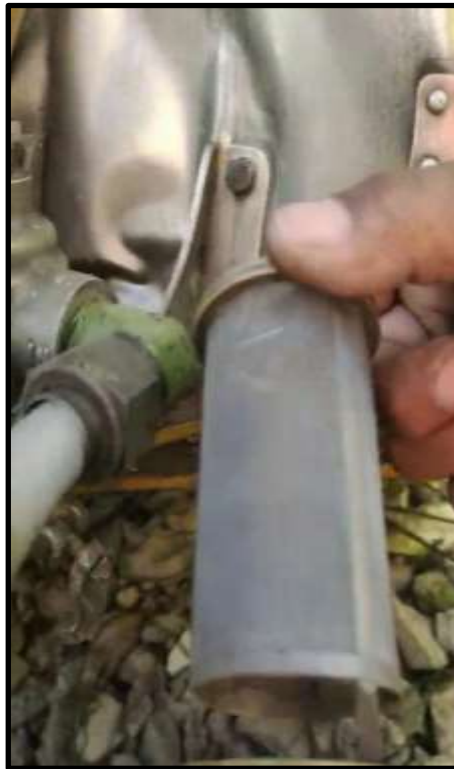
Figure 15 – The engine airframe filter.
