FINAL REPORT

RP-R4456
AG CAT G-164A

TITLE: Accident involving an Ag Cat G-164A aircraft with Registry Number RP-R4456 that experienced loss of engine power upon take-off at Lambayong Airstrip, Lambayong, Sultan Kudarat, Maguindanao, Philippines, on August 21, 2023/ 0730H.

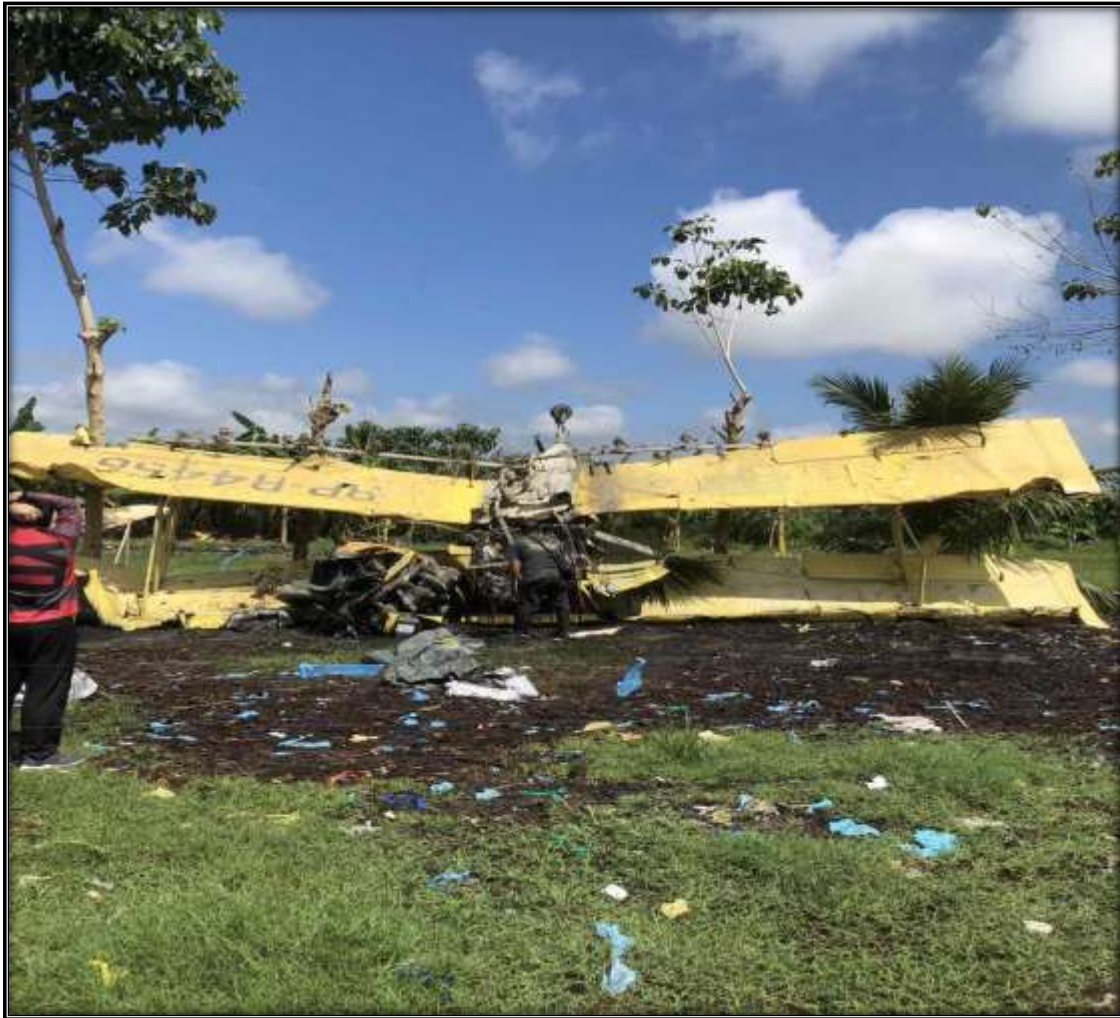
Figure 1 - RP-R4456 on its final resting point.

After initially landing on its main gears and swerving to the left, the aircraft sustained substantial damage. It came to a full stop in an inverted position after colliding with two gemilina trees with a final resting point of 291 degrees and grid coordinates of 6° 51'27" N; 124° 38'44" E.

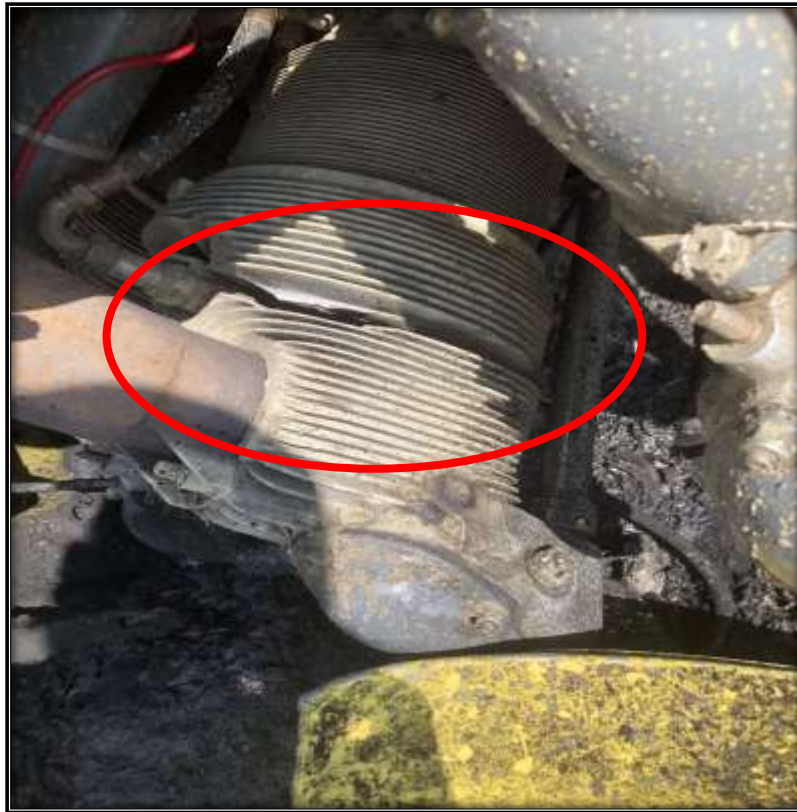
A post-accident site examination revealed that the aircraft cylinder head number three (3) had visible cracks near where the spark plug is located. On August 25, 2023, the engine was removed from the crash site and was brought to the SPASS hangar. A tear-down inspection by the Operator's AMO and witnessed by an AAIB investigator was conducted on RP-R4456 in determining the cause of the crack and failure.

The site investigation revealed a crack near the spark plug on engine cylinder number three (3) (Figure 2). The engine was removed from the crash site and was brought to the

Figure 2 - Crack seen at Cylinder Number 3.

- a. Include in the pre- and post-flight checklist the inspection of the cylinder head cooling fins for discoloration or casting marks, for exhaust emissions stains and exhaust carbon deposits as an indication that a crack was developing.
- b. Strictly complies with the CAAP-issued Memorandum Circular (MC) No. 28-18 dated October 1, 2018 addressed to all Agricultural Air Operators that operates with R-985 engines aircraft.
- c. Include in the refresher training and regular safety meetings of pilots and maintenance personnel the specific temperature limitations to be observed while operating aircraft with R-985 engines.
- d. Place a placard with the temperature limitation of the cylinder head in the cockpit of aircraft with R-985 engines.

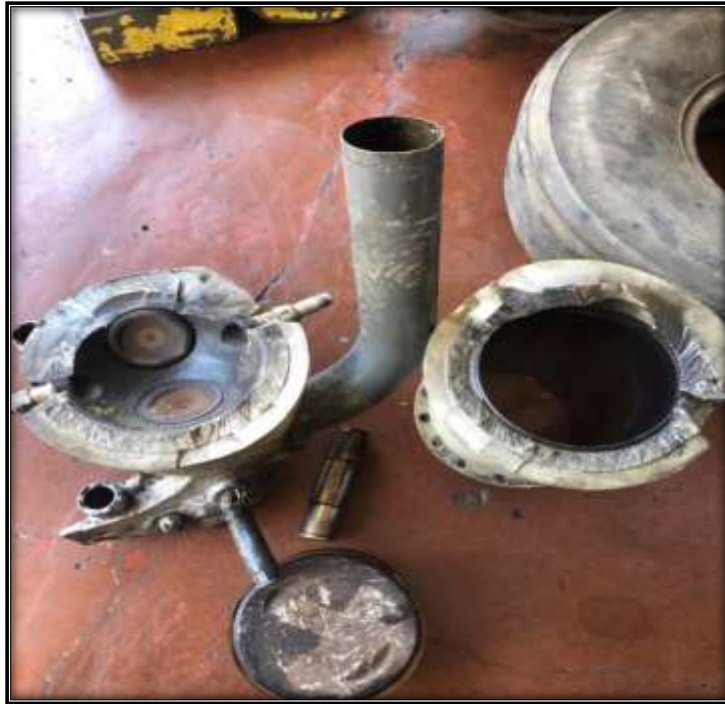
company's hangar for further examination. The tear-down inspection revealed that the cylinder head was completely separated from the barrel between the cooling fins. The separation was due to pre-ignition or detonation stresses, which no longer allowed the pushrods to operate the valves. This resulted in a loss of engine power during the initial climb after take-off (Figures 3, 4, and 5). Pre-ignition is the ignition of the air-fuel charge while the piston is still compressing the charge. A cracked spark plug tip, carbon or lead deposits in the combustion chamber, or a burned exhaust valve can act as a glow plug, causing the ignition source to ignite the charge prematurely. Detonation is an explosion of the fuel-air mixture inside the cylinder. It occurs after the compression stroke, either near or after the top dead center. During detonation, the fuel/air charge explodes rather than burning smoothly. Because of this explosion, the charge exerts a much higher force on the piston and cylinder, leading to increased noise, vibration, and cylinder head temperatures.

Figure 3 - Separation of the cylinder head from the barrel.

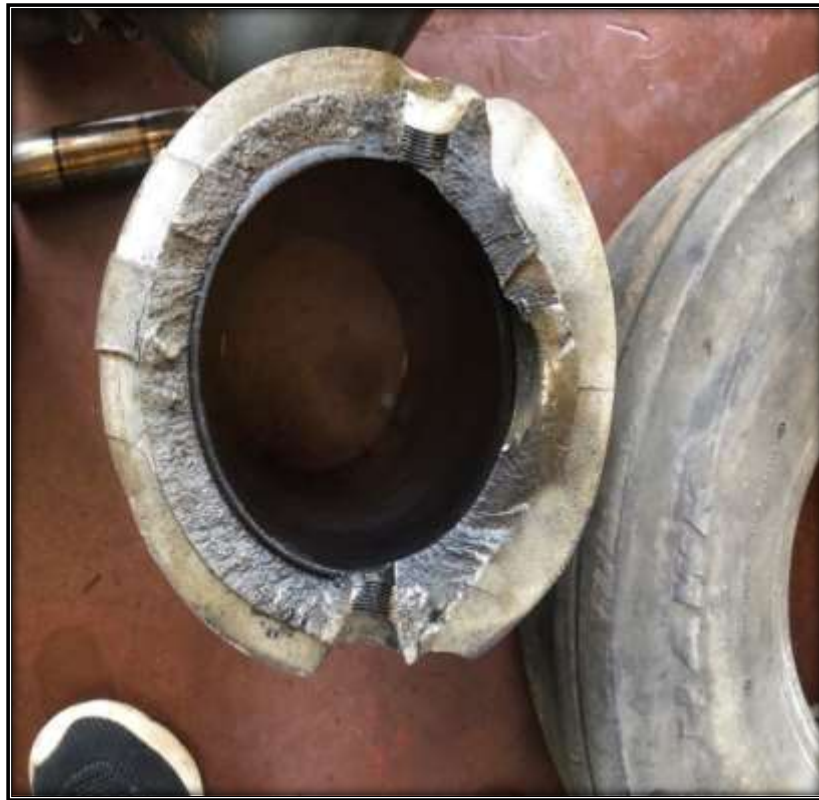
Figure 4- Close up view of Cylinder Nos. 3 barrel.

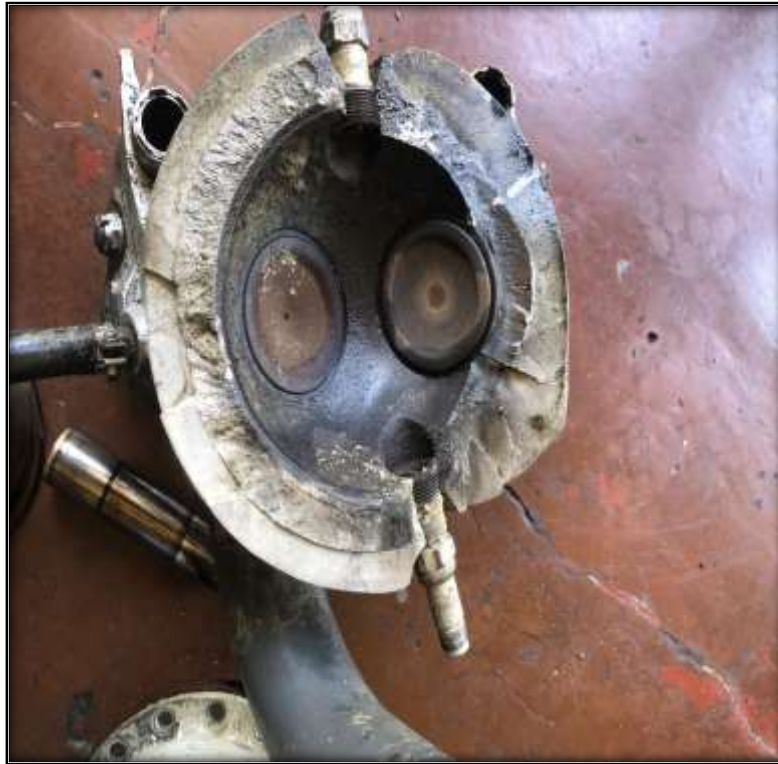
Figure 5- Close up view of cylinder head Nos. 3.

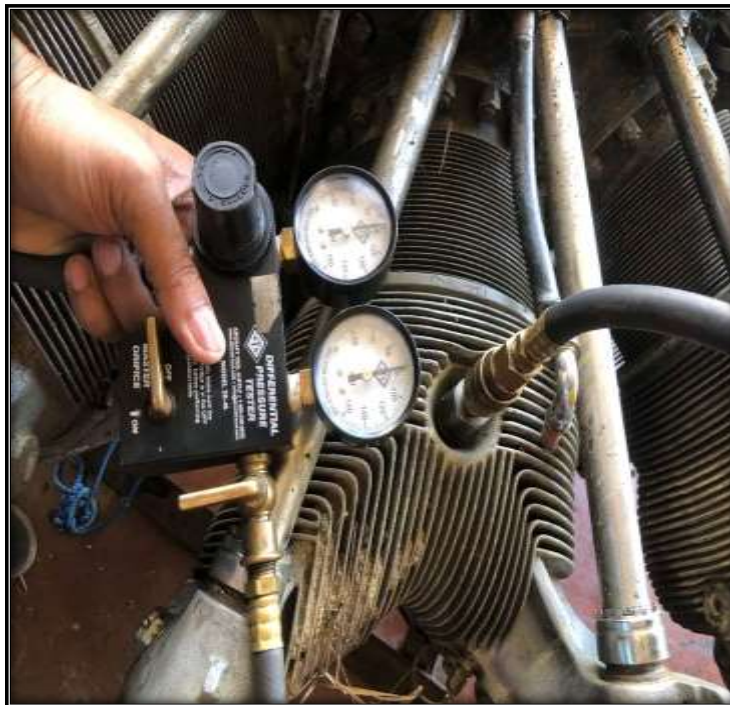
Aside from inspecting the remaining cylinders, a cylinder compression test was also conducted for any leaks or cracks, however it showed no relation that could contribute to the loss of engine power (Figure 6).

Figure 6 - Cylinder Compression Test

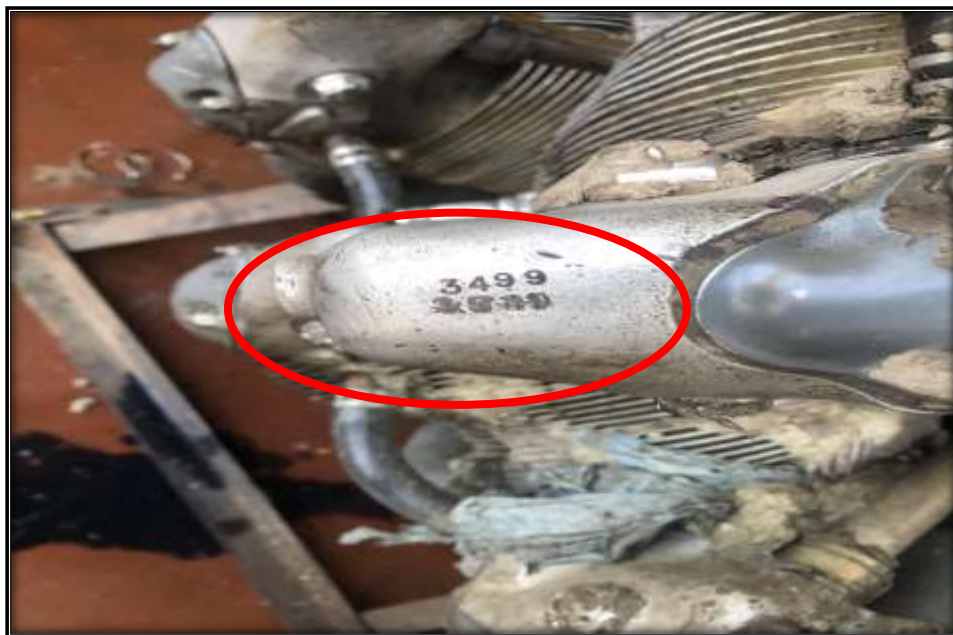
During the tear-down inspection, it also revealed that cylinder nos. three (3) was subjected to an ultrasonic test based on the markings of the 3499 stamp on the head near the intake port (Figure 7). The markings on the head were consistent with the markings required by FAA Airworthiness Directive 78-08-07 which denote that an ultrasonic inspection was conducted during the overhaul. Inspection of the cylinder assembly by visual and ultrasonic inspection were required to detect and replace cracked cylinders that exceed specified limits.

Figure 7 - Cylinder Nos. 5 with markings 3499 stamp.

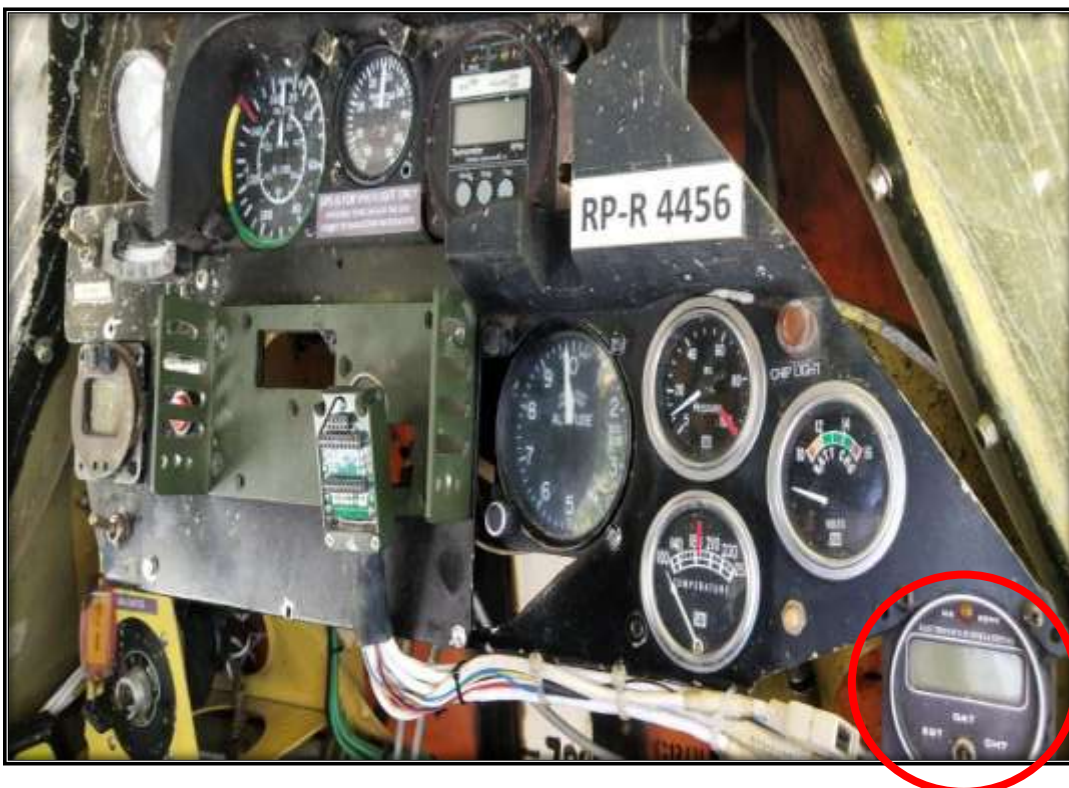
The RP-R4456 has a Cylinder Head Temperature (CHT) gauge installed inside the aircraft (Figure 8). Through the CHT gauge, the pilot and crew can monitor and take necessary preventive measures in case there is an increase in cylinder head temperature and excessive manifold pressure. However, during the interview, the pilot was not familiar with the operating limitations of R-985 engines. Hence, putting a placard with the temperature limitation of the cylinder head in the cockpit is the safest way to perform a task like aerial spray. Although there is no guarantee that it will prevent accidents, such operational limitations increase the possibility for pilots to be aware of risks and how to manage them.

Figure 8 - RP-R4456 Cylinder Head Temperature (CHT) gauge
