AIRCRAFT ACCIDENT INVESTIGATION AND INQUIRY BOARD

FINAL REPORT

RP-R5380
AGCAT G-164A

TITLE: An accident involving an AGCAT G-164A type of aircraft, with registry number RP-R5380 owned and operated by Aerowurkz Aerial Spraying Services that sustain substantial damage due to engine failure while on an aerial spraying operation at Sta Fe, Tagbina, Surigao del Sur, Philippines, on December 17, 2022/0900H.

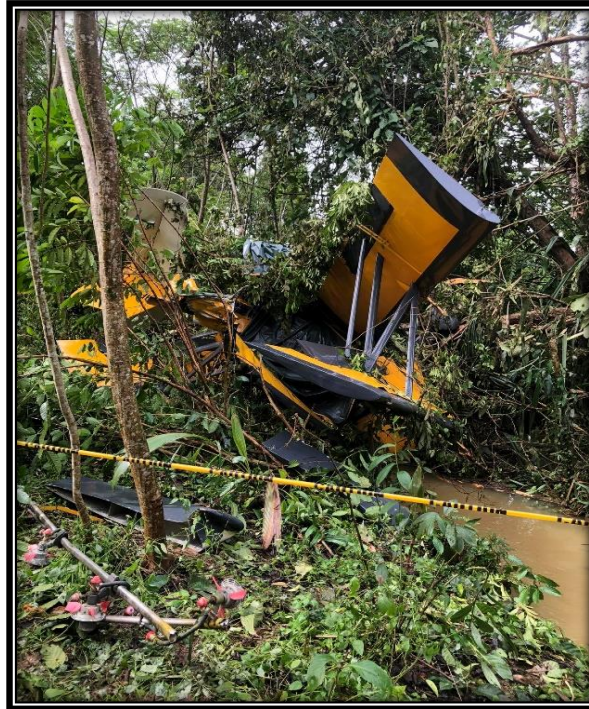
Figure 1: The aircraft came to complete stop in a nose-down position.

The engine failure resulted for the aircraft to forced land in wooded area. Before touchdown, it initially collided with two (2) falcata trees and came to a full stop in a nose down position after the right wing collided with another full-grown tree near a creek with final heading of 360 degrees and grid coordinates of 08° 48'78" N; 126° 13' 45" E.

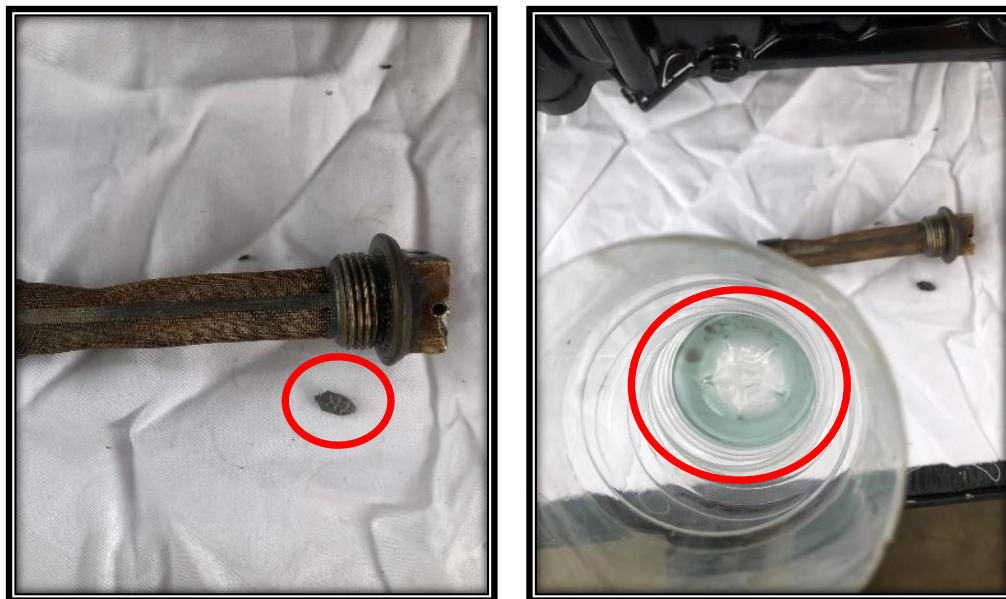
During the site investigation, the aircraft fuel strainer assembly located at the left side of the engine firewall was inspected and inside the assembly found to contain substantial amount of foreign particulates. The engine was removed from the crash site and brought to the Operator's hangar. A tear-down inspection was conducted on RP-R5380 to determine any engine malfunction or failure that might cause the accident. The inspection revealed that the cylinder heads, cylinder barrels, and cooling fins have no signs of crack that could contribute to the engine failure. Further, a cylinder compression test was also conducted for any leaks or cracks but shows negative findings. The inspection further revealed that both magnetos are emitting sparks during magneto check and of the retrieved spark plugs, eight (8) are emitting sparks except for one that was impact damaged. The fuel carburetor assembly was also inspected and the carburetor fuel filter screen inside was found to contain foreign particulates (Figure 2 and 3). The substantial amount of foreign particulates in the firewall fuel filter blocked the fuel supply to the engine. Once the fuel supply was cut-off, fuel starvation occurred and led to engine failure.

Figure 2 and 3: Foreign particulates found in the fuel carburetor filter screen

Fuel strainer assembly is contaminated with substantial quantity of foreign particulates blocking the fuel supply that leads to engine failure.

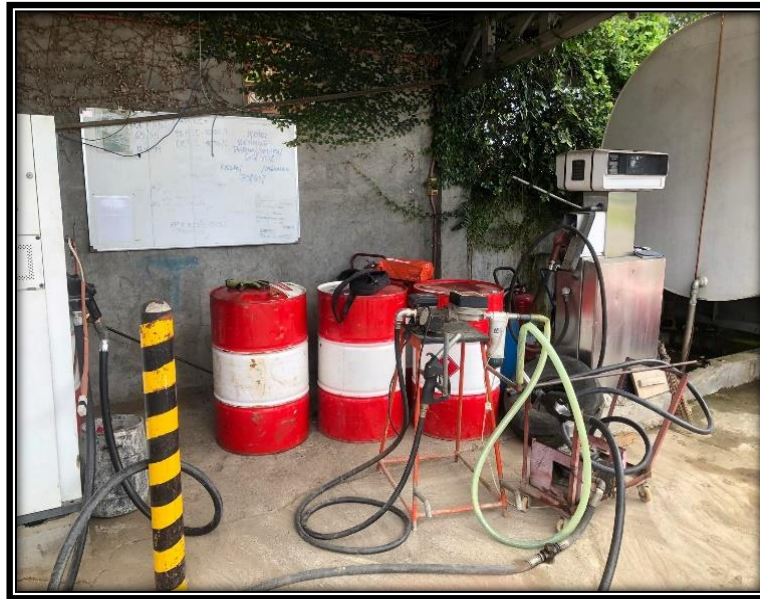
Figure 4 Recycled drums used for multi transfer fueling cycle

This multi transfer fueling cycle to service aircraft in remote locations exposes the fuel and equipment for contamination to occur. Likewise, the use of plastic containers not designed for fuel and recycled drums particularly the cap gasket may pose as a hazard. Apart from falling out of the cap and preventing proper sealing, the gasket will become brittle and degrade wherein the fragments can then be tipped into the aircraft fuel tank along with the fuel. This fragment over time can either clog fuel system filters.

Since fuel was stored in underground tank where full capacity is not maintained for extended periods of time, fuel being a gyrosopic fluid, absorbs moisture from the air around it. This develops into water and mixed with the fuel in suspension. Combined with water from condensation can result in contaminated fuel being introduced into the engine. Available records of the company do not show regular inspection of fuel contaminants in under-ground fuel tanks.

- a. Include in the Company Operations Manual Standard Operating Procedures (SOP), a comprehensive procedure on dispensing of Aviation Fuels.

- b.** Conduct training/seminar to Pilots and Maintenance personnel on standards, practices, and safety measures to be observed in refueling an aircraft including hazards associated with improper refueling procedures for them to be fully aware of the potential risks.
- c.** Conduct regular inspection of fuel contaminants in under-ground fuel tanks.
- d.** Fueling containers that are used to facilitate easy transfer of fuel must be of an appropriate standard, configuration and cleanliness.
- e.** Logged all aircraft discrepancy in the maintenance logbook (ie Cylinder Head Temperature Gauge, etc.).
- f.** Adhere to CAAP Memorandum Circular (MC) No. 28-18 dated October 1, 2018, compliance with the General Operating Instructions (GOI) for R985 engines on specific temperature.

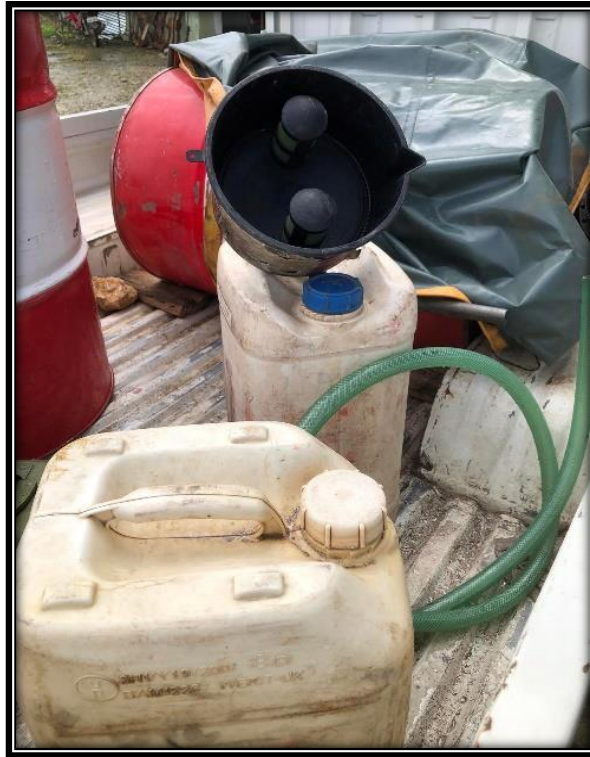
Figure 5 Plastic containers and plastic funnel used for refueling aircrafts

- i. Fueling containers that are used to facilitate easy transfer of fuel is not in appropriate standard, configuration, and cleanliness.
- j. Review of the aircraft maintenance logbook does not show any reported defective CHT by the pilot.
