AIRCRAFT ACCIDENT INVESTIGATION AND INQUIRY BOARD

FINAL REPORT

RP-C2673
Cessna 152

TITLE: A serious incident involving a Cessna 152 type of aircraft with Registry Number RP-C2673 owned and operated by Fliteline Aviation School, Inc that made a forced landing following a loss of power at Barangay Barihan, Malolos, Bulacan Philippines on February 10, 2024/1415H.

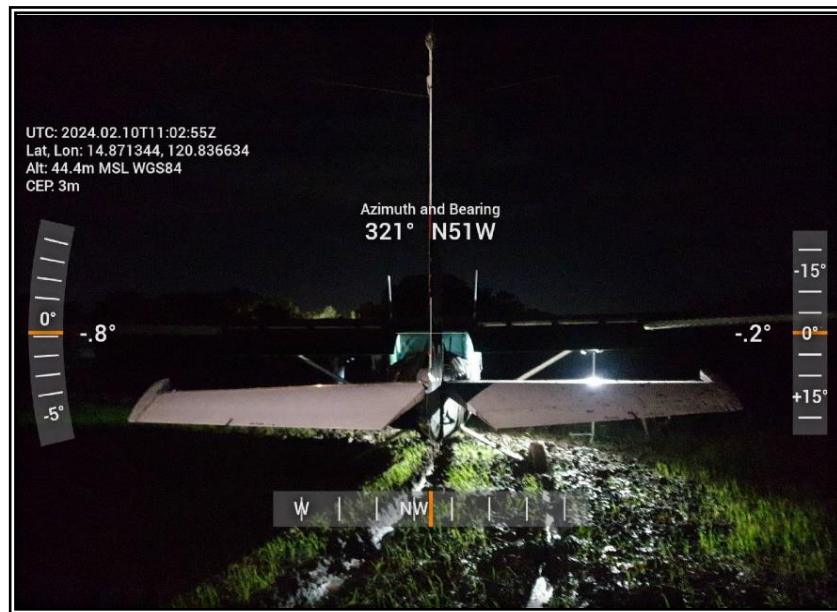
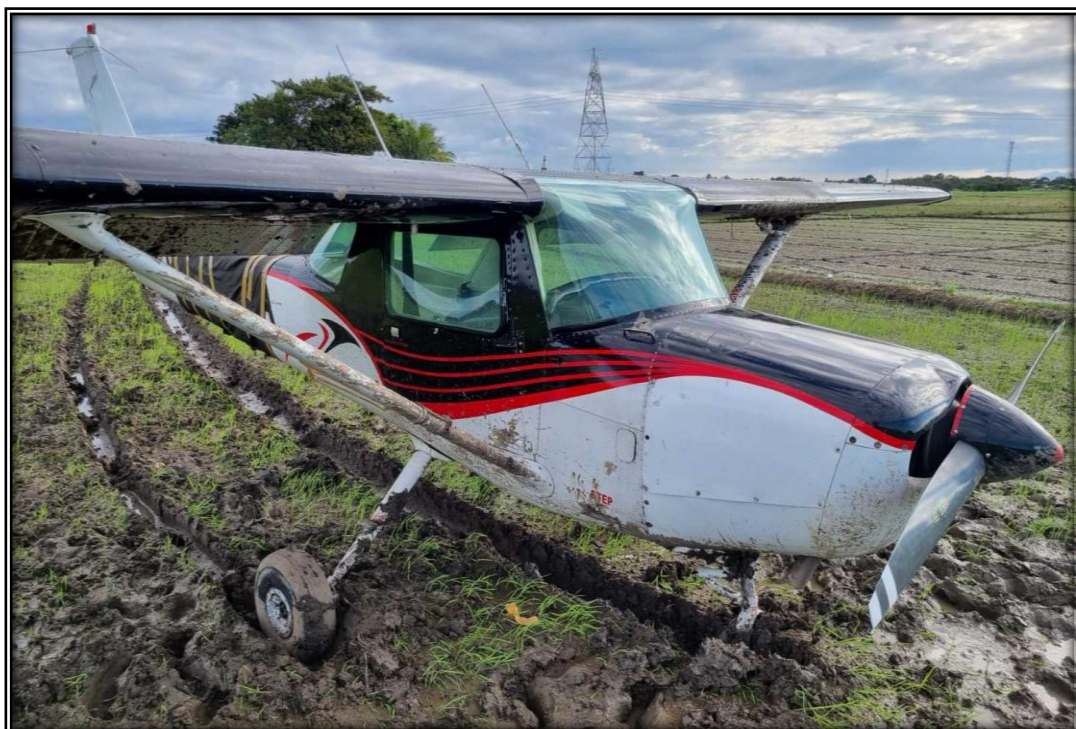
engine lost its power. The FI took over the controls from the SP and attempted to restart the engine several times but to no avail. The FI decided to make a forced landing on a rice field at Brgy. Barihan, Malolos, Bulacan. The aircraft initially touched down on its main gears and continued to move forward for another 310 feet. The aircraft came to a complete stop in an upright position, with the final resting point located at 321 degrees and grid coordinates of 14°.871344 N and 120°.836634 E (Figures 1 and 2).

Figures 1 and 2 - Aircraft's final resting position.

The aircraft initially touched down on its main gears and continued to move forward for another 310 feet. It came to a complete stop in an upright position, with the final resting point located at 321 degrees and grid coordinates of 14°. 871344 N; 120°. 836634 E.

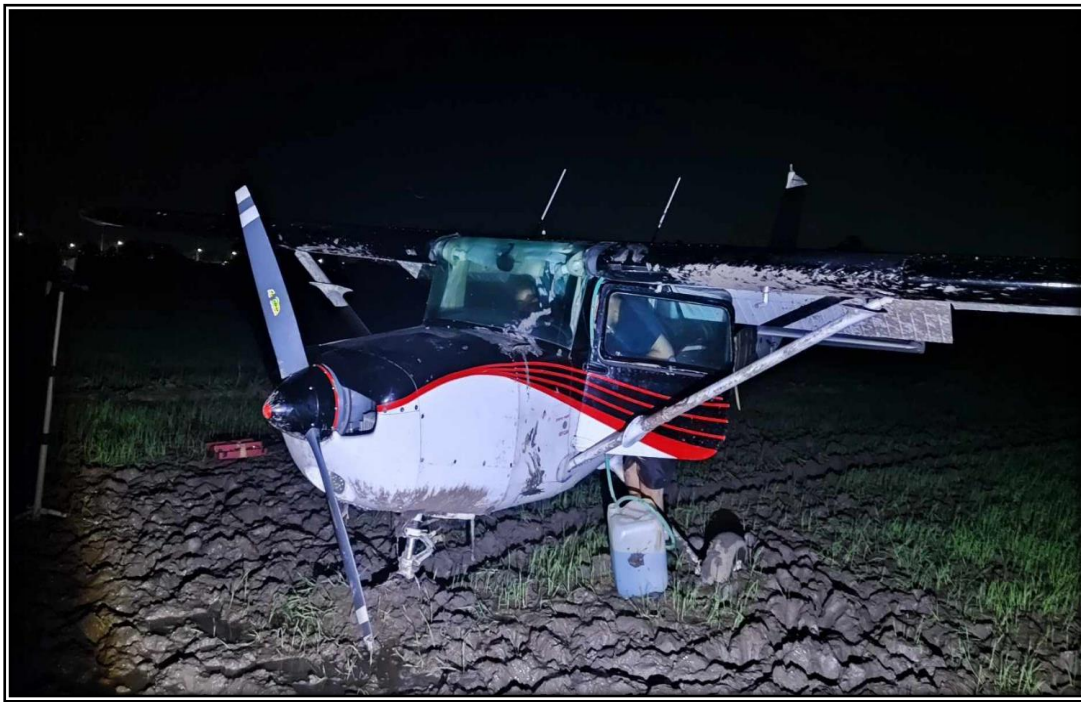
A post-accident site examination revealed that the aircraft landed safely and did not sustain any damage. Before the aircraft was removed from the site, both fuel tanks were defueled. However, no fuel was collected in the right tank, and a small amount of fuel, approximately two gallons, was recovered in the left tank (Figure 3). There was neither traces of fuel leakage under the wings nor smell of gasoline fumes (Figure 4).

Figure 3 - RP-C2673 while being defueled.

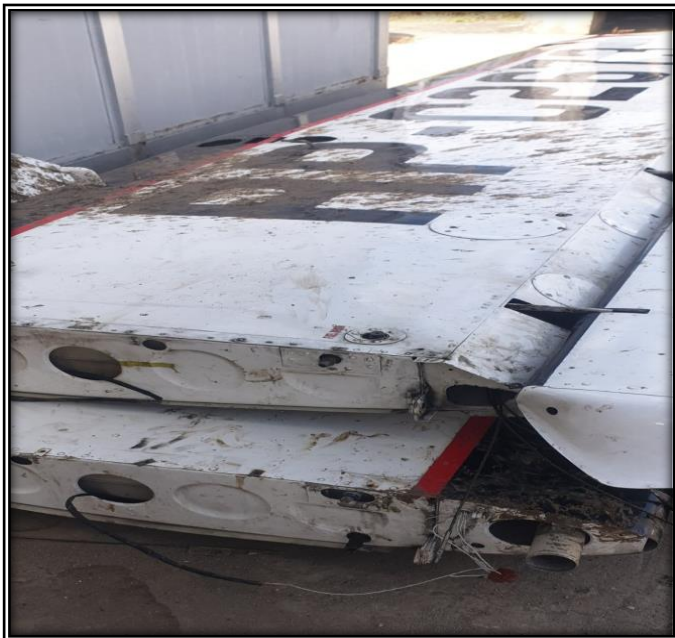
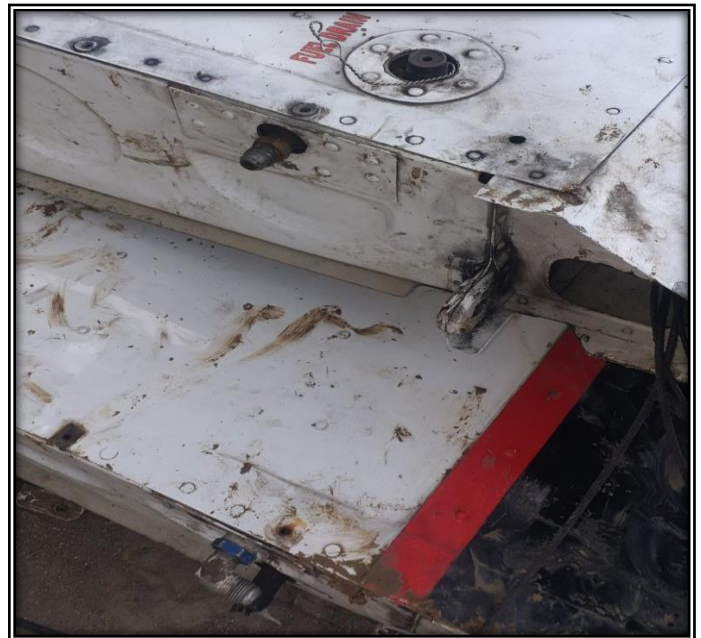
Figure 4 - Aircraft's left and right wing after being removed from the fuselage.

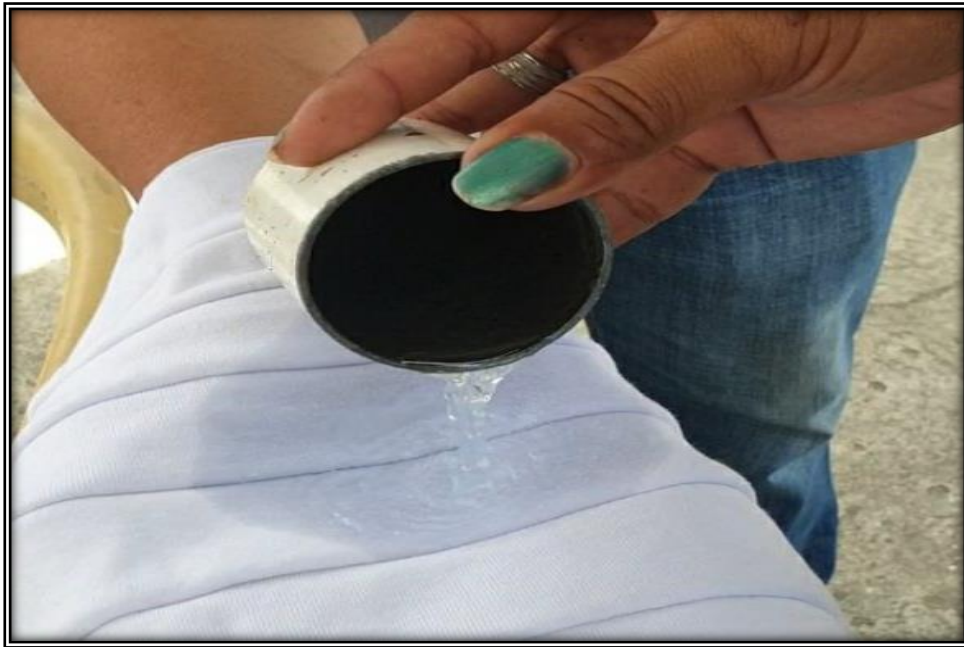
During component inspection, small amount of unusable fuel was found inside the fuel strainer. The fuel sample was subjected to a visual inspection to detect any residue that might have led to engine failure. Based on the inspection, it can be said that the fuel used on the aircraft during the accident was free from any impurities (Figure 5).

Figure 5 - Visual inspection of fuel strainer.

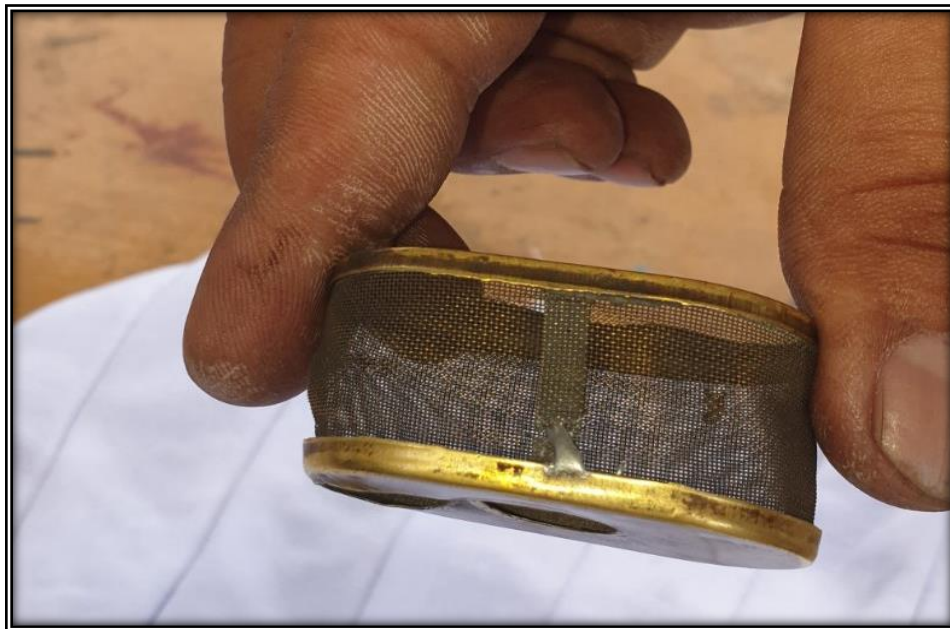
Engine fuel and carburetor filter inspections were also performed. The engine's fuel and carburetor filter inspection revealed negative findings that may contribute to engine power loss (Figures 6 and 7).

Figure 6 - RP-C 2673 fuel filter

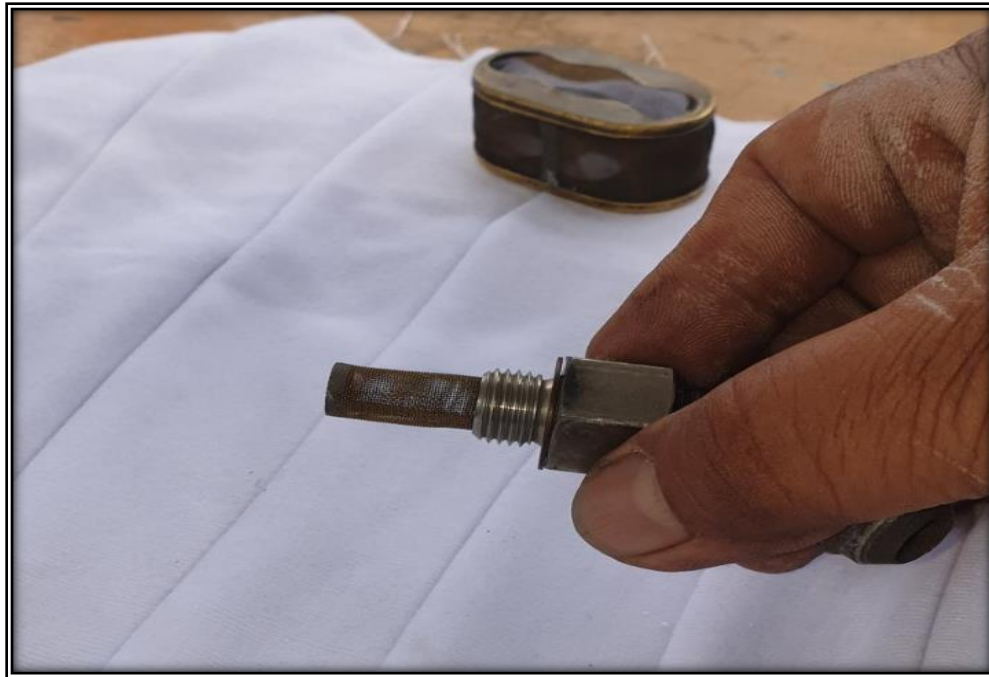
Figure 7. RP-C 2673 Carburetor filter
