Republic of the Philippines
CIVIL AVIATION AUTHORITY OF THE PHILIPPINES

AIRCRAFT ACCIDENT INVESTIGATION AND INQUIRY BOARD

FINAL REPORT

RP-R3298
S2R-T34

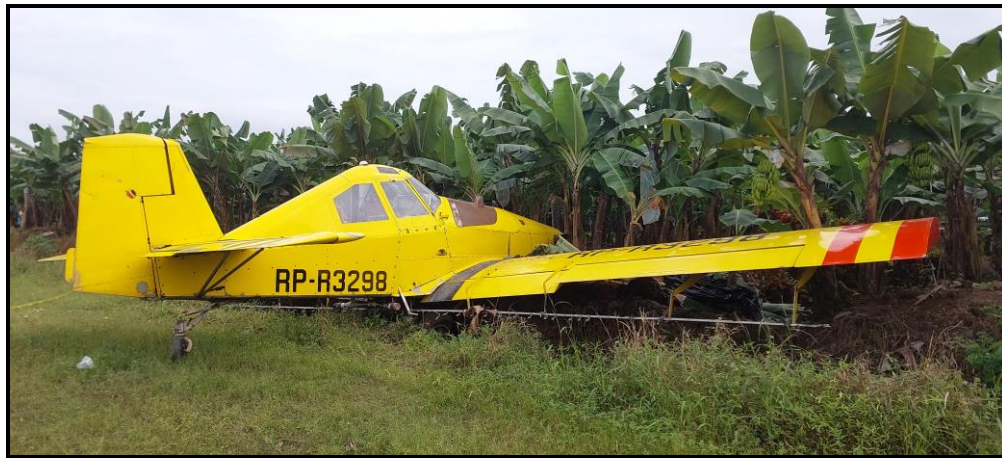
Subsequently, the aircraft made a sharp turn to the left, exited the runway, and rested on the canal between markers 6 and 7. The aircraft came to a halt with a last heading of 89 degrees and coordinates of 7 34.433N, 126 05.684E. All three propeller blades were

bent, while the main landing gears and portions of both wings incurred substantial damage due to ground impact.

Figure 1. RP-R3298 final resting place at Osmeña Aerodrome

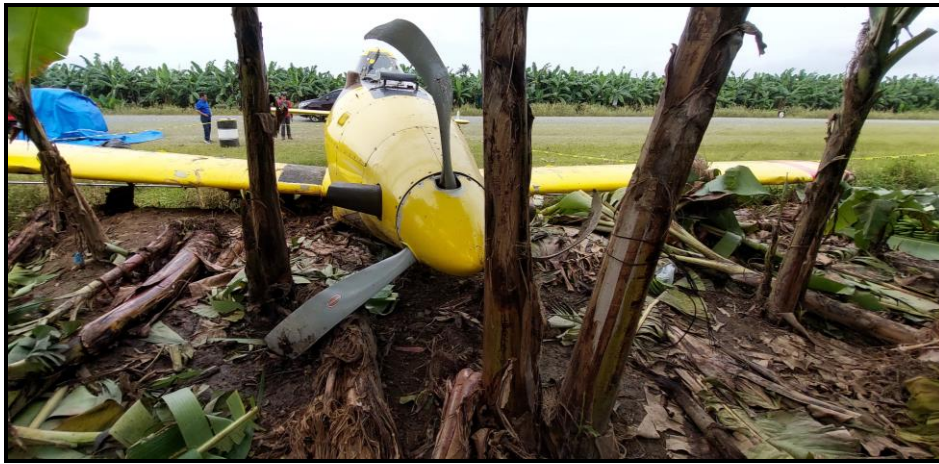
The aircraft is equipped with a three-bladed Hartzell propellers. These type of propellers are installed on Pratt & Whitney engines. During the damage assessment conducted by the Company, all three(3) propellers was bent due to the aircraft impact during landing.

Figure 2: All propeller blades were bent.

1. Propeller deformed beyond repair-Replaced
2. Engine internals suspected damaged due to engine shaft seized-overhaul
3. Right/Left landing gear deformed beyond repair-replaced

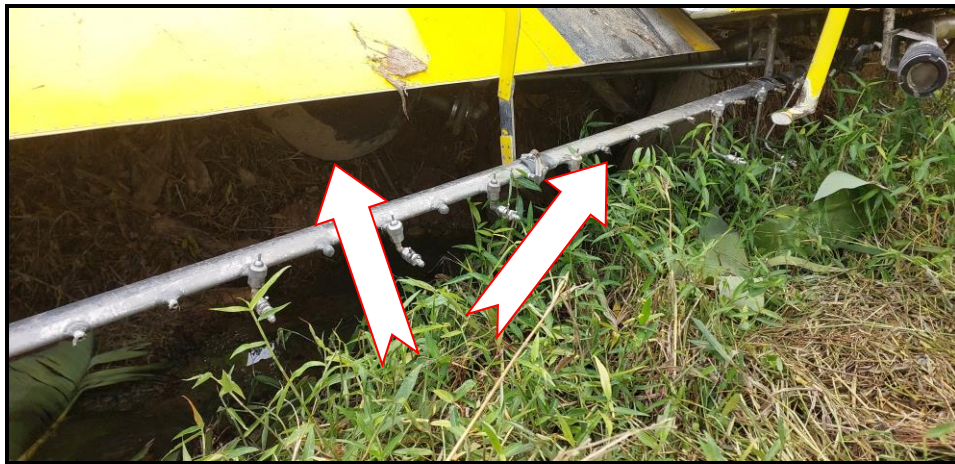
The aircraft came to a halt and rested on the canal between runway markers 6 & 7 with a last heading of 89 degrees and coordinates of 7 34.433N, 126 05.684E. All three propeller blades were bent, while the main landing gears and portions of both wings incurred damages due to ground impact.

Figure 3: Both main landing gears were damaged
