AIRCRAFT ACCIDENT INVESTIGATION AND INQUIRY BOARD

FINAL REPORT

RP-R5859
AGCAT G-164A

TITLE: Accident involving a G-164A agricultural type aircraft with Registry Number RP-R5859 that had a rejected take-off at Nova Vista Management and Development Aerodrome, Barangay Tagnanan, Mabini, Davao de Oro Philippines, on March 15, 2024/ 0700H local time

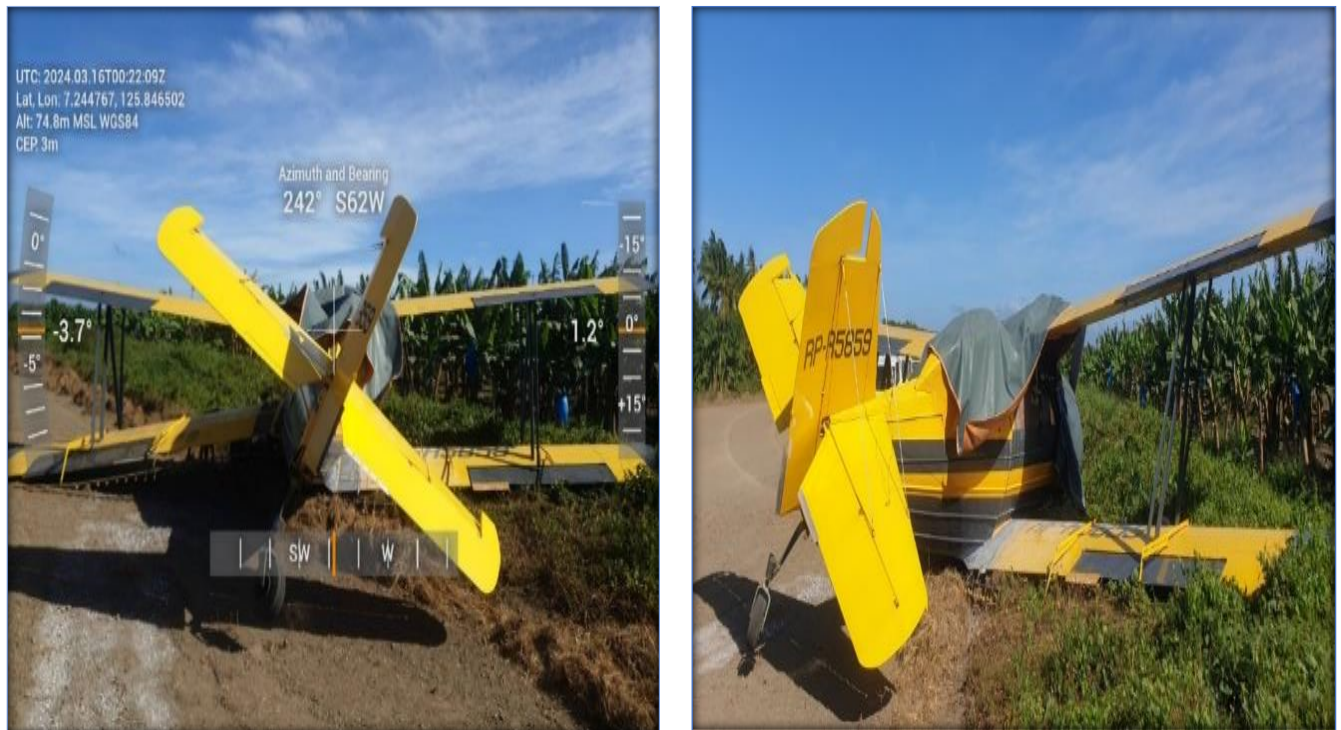
Figure 1 - RP-R5859 on its final resting point.

The aircraft made a ground loop and came to a full stop in an upright position after the right wing and right main landing gear hit an embankment. The aircraft's final resting point was located at 242 degrees with grid coordinates of 7.244767N, 125.846502E.

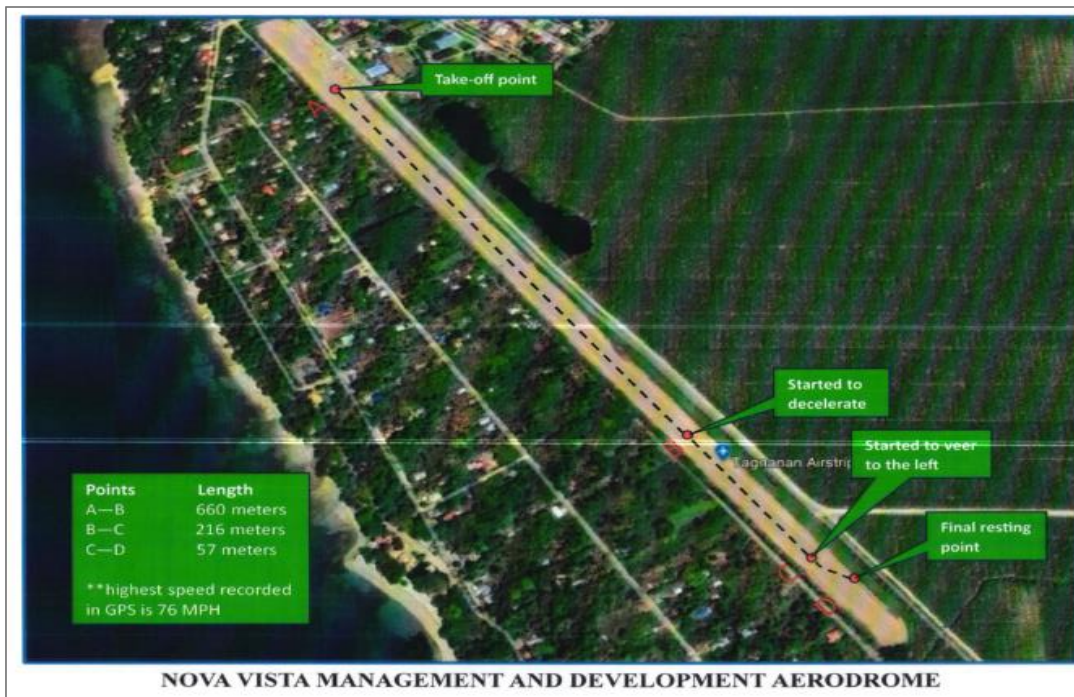
The installed GPS on the aircraft was removed and downloaded. The downloaded data shows the highest recorded speed during the take-off roll was 76 mph. The aircraft started to decelerate after being 600 meters away from the initial take-off point at RWY 14 of the airstrip. It continued to move forward for another 216 meters and decelerate while maintaining its runway heading. This deceleration was caused by the pilot's decision to initiate a rejected takeoff. The application of brakes after the rejected takeoff is only possible after the tail wheel is on the ground. Judicious use of the rudder for tailwheel steering and brakes may be required to keep the airplane on the runway after the rejected take-off. However, the primary goal is not necessarily to stop the airplane at the shortest distance, but rather to maintain control of the airplane as it decelerates. The GPS data also show that the aircraft moved for another 57 meters as it decelerated and started to veer to the left. The aircraft then made a ground loop and came to its final position after hitting an embankment (Figure 2). The veering to the left was the result of the pilot's application of full brakes to stop the aircraft as it was nearing the end of the runway. The maximum application of brakes and the right pedal to bring the aircraft back to the center imposes severe side loads on the landing gear and imparts ground looping tendencies. To avoid these side stresses or a ground loop, the pilot has to bring the aircraft smoothly to a halt using all of the remaining runway without severe use of the brakes while veering.

Figure 2: Aircraft's take-off path

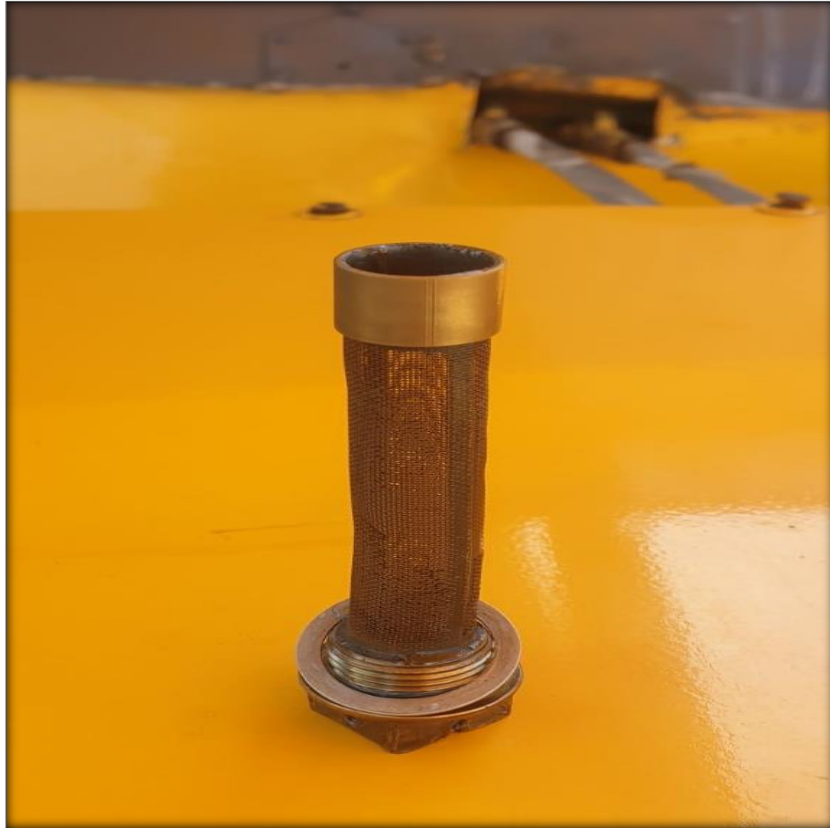
A post-accident site examination conducted by accident investigators of the aircraft carburetor fuel filter (Figure 3) and fuel bowl filter screen (Figure 4) revealed no foreign particulates.

Figure 3 - RP-R5859 carburetor fuel filter.

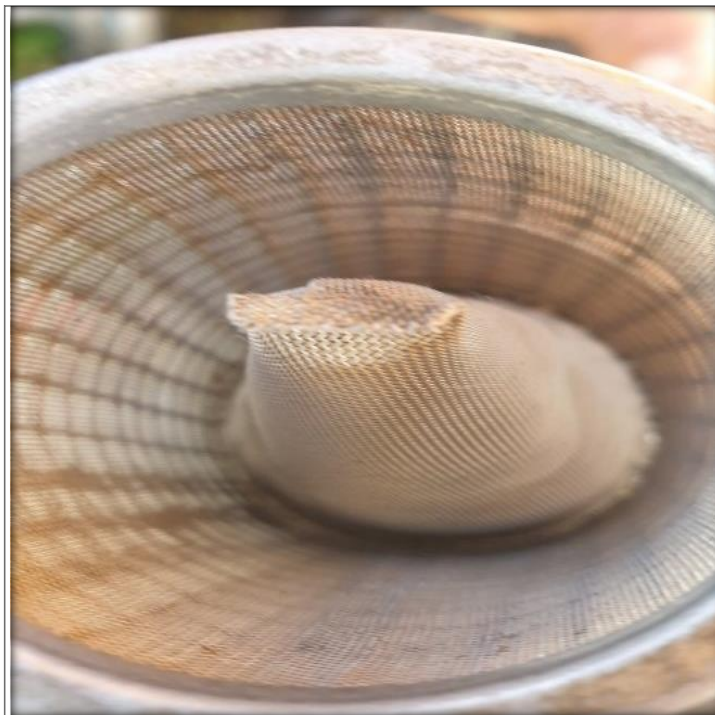
Figure 4 - RP-R5859 fuel bowl filter.

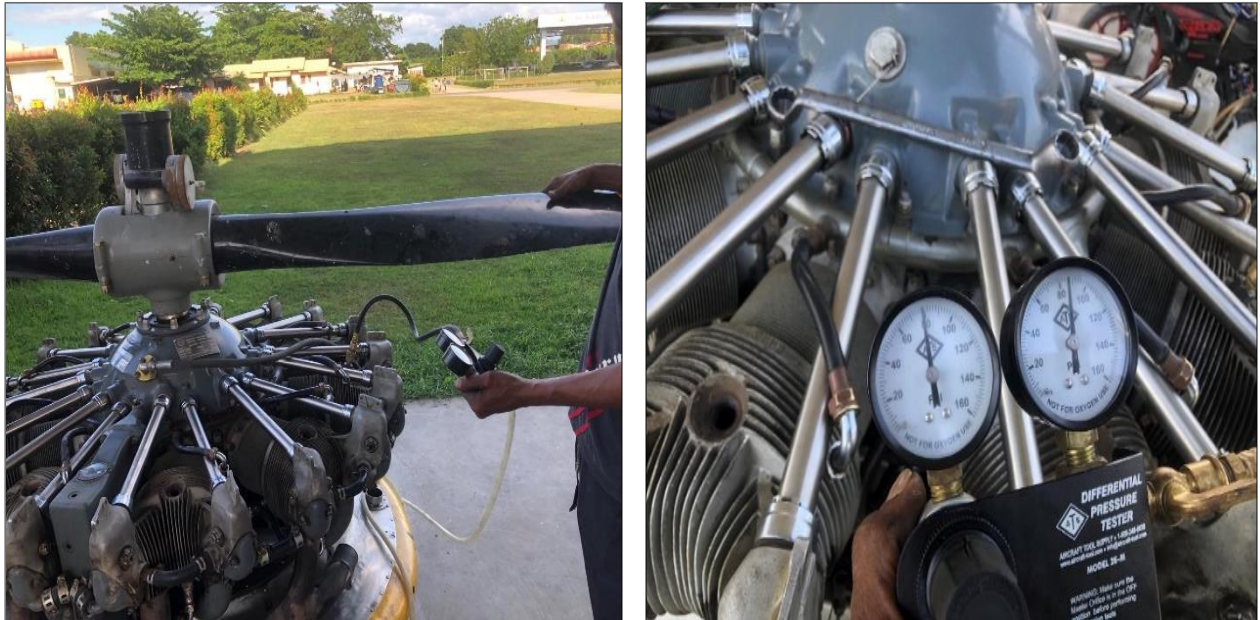
The engine of RP-R5859 was removed from the crash site on March 16, 2024, and brought to the operator's hangar for further inspection. During inspection, the cylinder heads, cylinder barrels, and cooling fins showed no signs of cracks. A cylinder compression test was also conducted for any leaks or cracks but showed negative findings (Figure 5). Inspection checks were further conducted on the spark plugs (Figure 6), including a spark check on both magnetos (Figure 7). The checks did not reveal mechanical malfunctions or anomalies that would have affected the aircraft's normal operation.

Figure 5 - Cylinder Compression Check

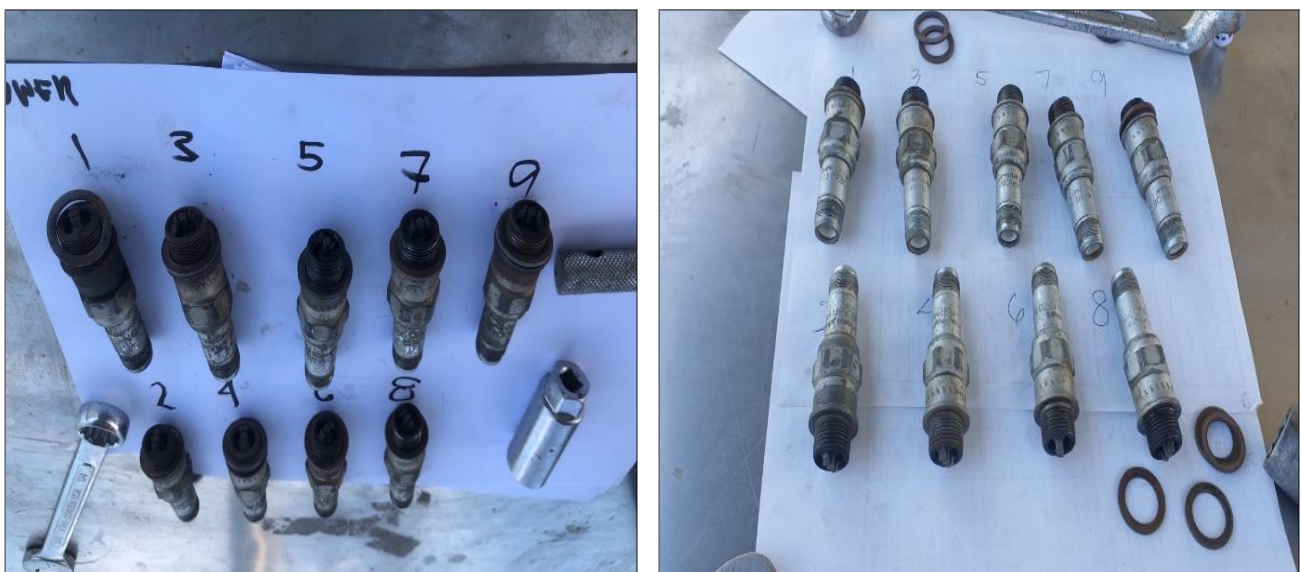
Figure 6 - Spark Plug Inspection.

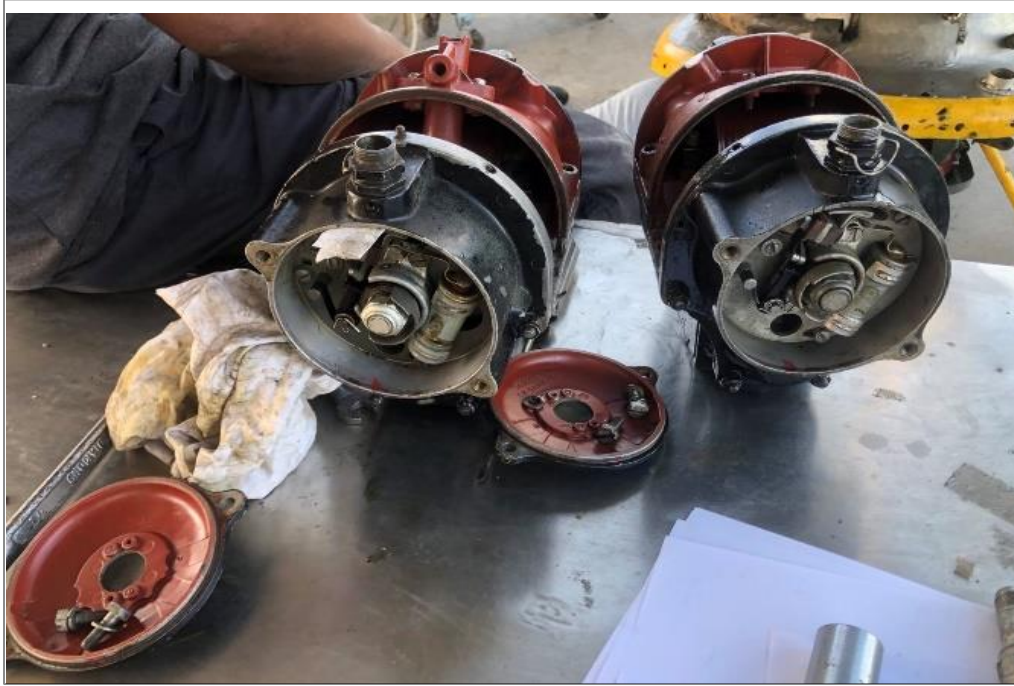
Figure 7 - Magneto Check.
