AIRCRAFT ACCIDENT INVESTIGATION AND INQUIRY BOARD

FINAL REPORT

RP-C2893
PA-23-250

TITLE: Incident involving a Piper Aztec PA-23-250 type of aircraft with Registry Number RP-C2893 owned and operated by Indiana Aerospace University that landed on its belly at RWY 18 of Ormoc Airport, Ormoc City, Southern Leyte, Philippines, on August 5, 2023/1028H.

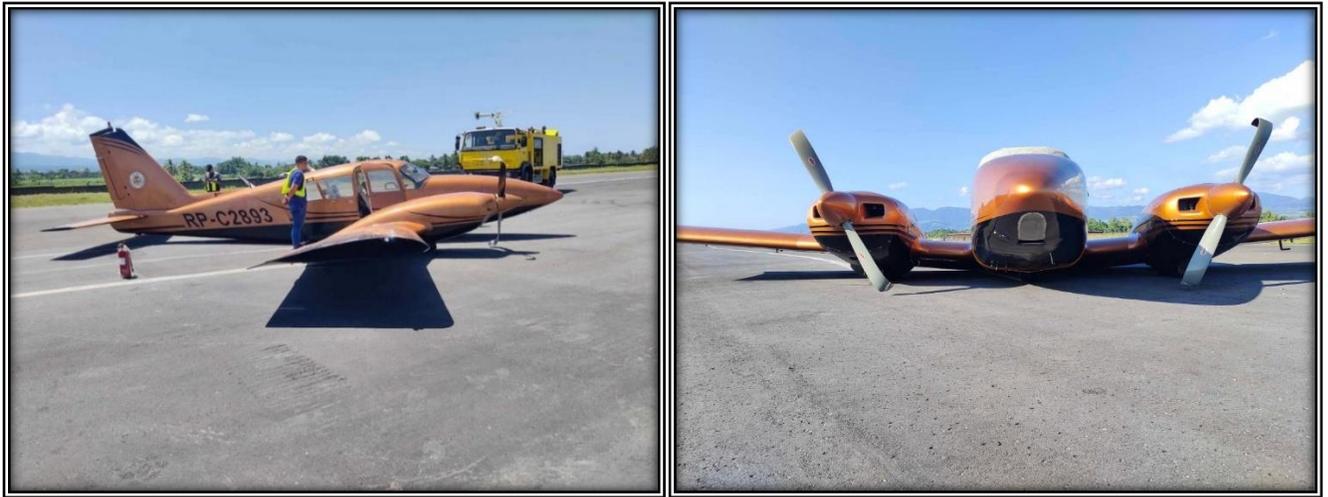
Figures 1: Aircraft's final resting point

The aircraft initially landed on its belly, 240 feet from the displaced marker on RWY 18. There were 200 and 89 propellers strike on both right and left propellers, respectively, as the aircraft continued to move forward on the runway. Both crews egressed safely after shutting down the engine.

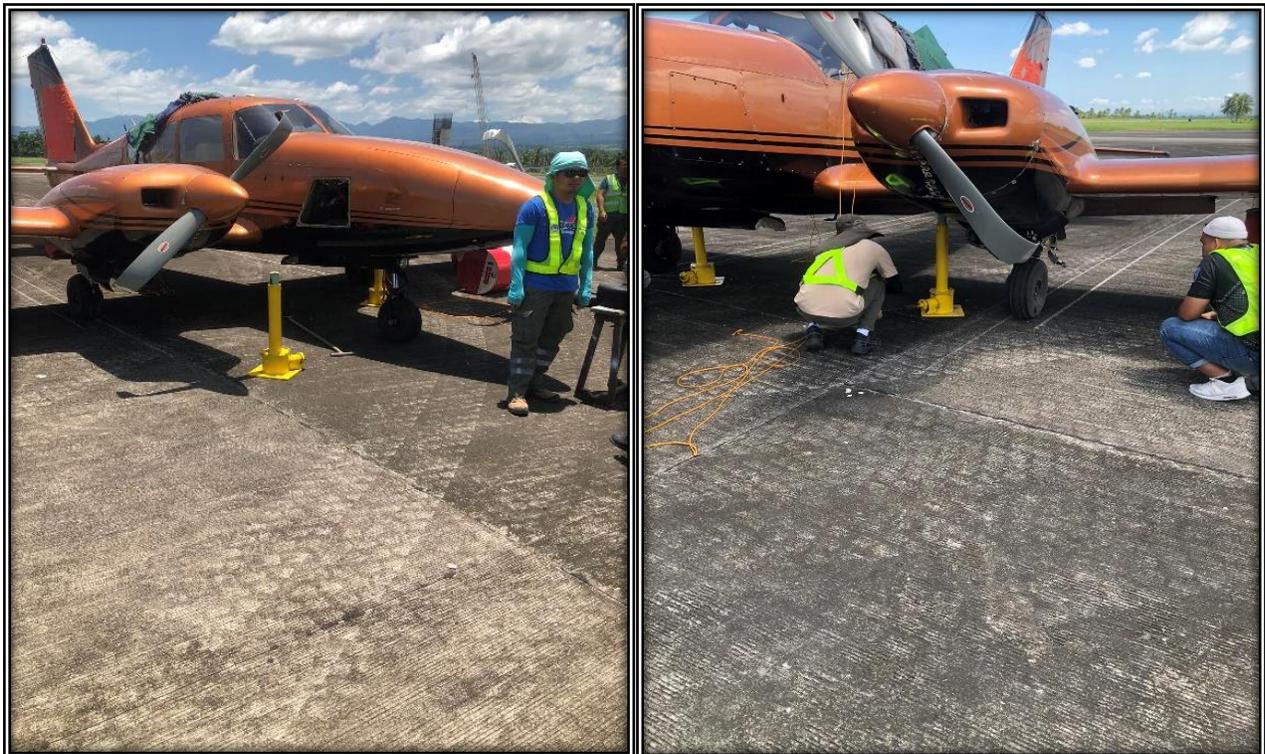
Meanwhile, a manual extension and retraction test was performed through the emergency hydraulic hand pump on the aircraft landing gears, as shown in the pictures below. This test was conducted to determine any malfunction or failure that might cause the accident. The test confirmed that the landing gear extension and retraction were operating normally.

Figure 2: The manual landing gear extension and retraction test using the emergency hydraulic hand pump
