### **FINAL REPORT**

**RP-C4321**  
**PIPER AIRCRAFT INC., PA-23-250**

**TITLE:** Incident involving a PA-23-250 type of aircraft with Registry Number RP-C4321 sustained damage on both propellers following a propeller strike at runway 06, Basco Airport, Basco, Batanes Philippines, on April 18, 2022/1505H

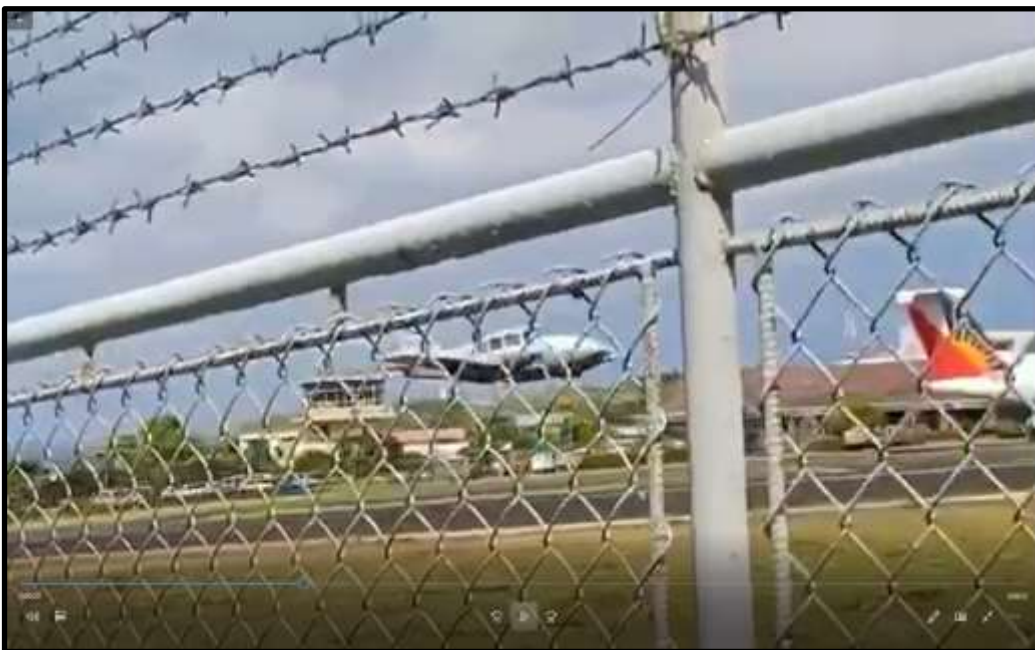
The pilot was on his fourth leg back to Basco, Batanes after departing from Itbayat, Batanes. The Pilot realized that the landing gears were not extended after the control tower informed him. He was able to perform the landing gear extension and land the aircraft. However, both right and left propellers sustained damages just before the landing gears were fully extended. There were sixteen (16) and ten (10) runway propeller strikes from both right and left propellers respectively that were seen 922 meters away from the threshold of RWY 06. One of the witnesses took a video while the aircraft was in short finals showing the landing gears were not extended prior to landing (Figure 1).

Figure 1. RP-C4321 without landing gears extended.

The Pilot was late in extending the landing gears that resulted to propeller ground strike.

- a. Strictly impose the mandatory use of checklist to its pilots.
- b. Reinforce training of pilots in the area of Crew Resource Management, and Situational Awareness.
