## AIRCRAFT ACCIDENT INVESTIGATION AND INQUIRY BOARD

### **FINAL REPORT**

**RP-C6198**  
**B300 SKA350I**

**TITLE:** An incident involving Super king Air B300-350i type of aircraft with Registry Number RP-C6198 operated by Challenger Aero Air Corp., that had a runway excursion event at Runway 31, Ninoy Aquino International Airport, Pasay City, Philippines, on January 17, 2023/1001H.

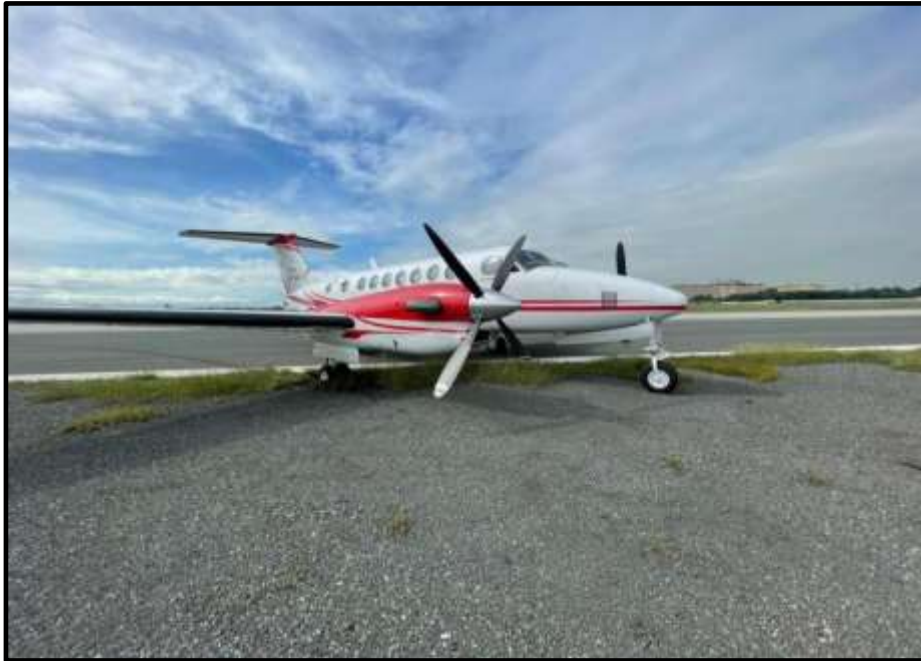
On January 17, 2023, at about 1001H local time, a Super King Air B300-350i type of aircraft with Registry Number RP-C6198, operated by Challenger Aero Air Corporation was on a general aviation flight when it experienced a low-speed runway excursion following a rejected takeoff. Onboard the aircraft were the Pilot-in-Command (PIC), Co-Pilot (CP), and nine (9) other occupants. During the take-off run, just before the CP could call out "Air Speed Alive," the right-hand propeller suddenly went into feather position, causing the aircraft to veer off to the right side of the runway. The aircraft came to a complete stop, with the Nose LDG Gear and RH Main LDG Gear settled in a grassy portion of the runway shoulder while the LH Main LDG Gear was still within the runway pavement of Runway 31.

Figure 1 – The aircraft at its final resting point.

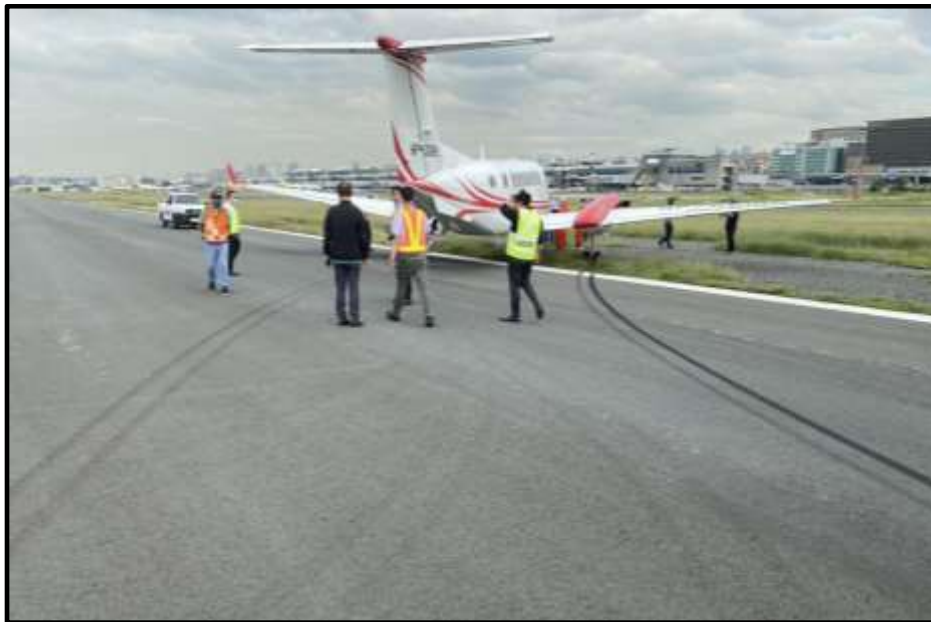
Figure 2 – The aircraft's visible skid marks going out of the runway.

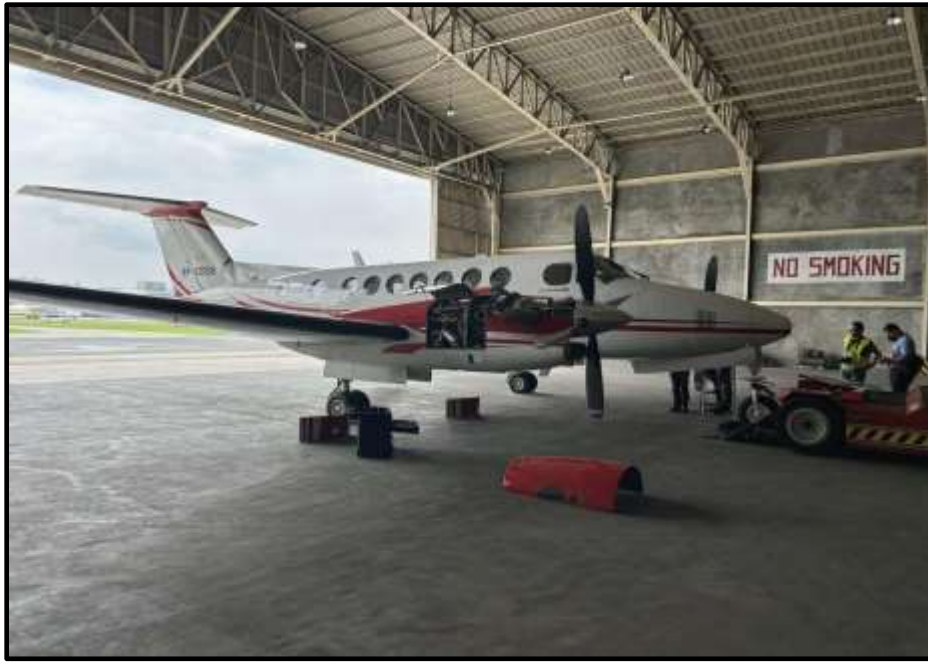
Figure 3 – The aircraft was towed to the operator’s hangar for further assessment.

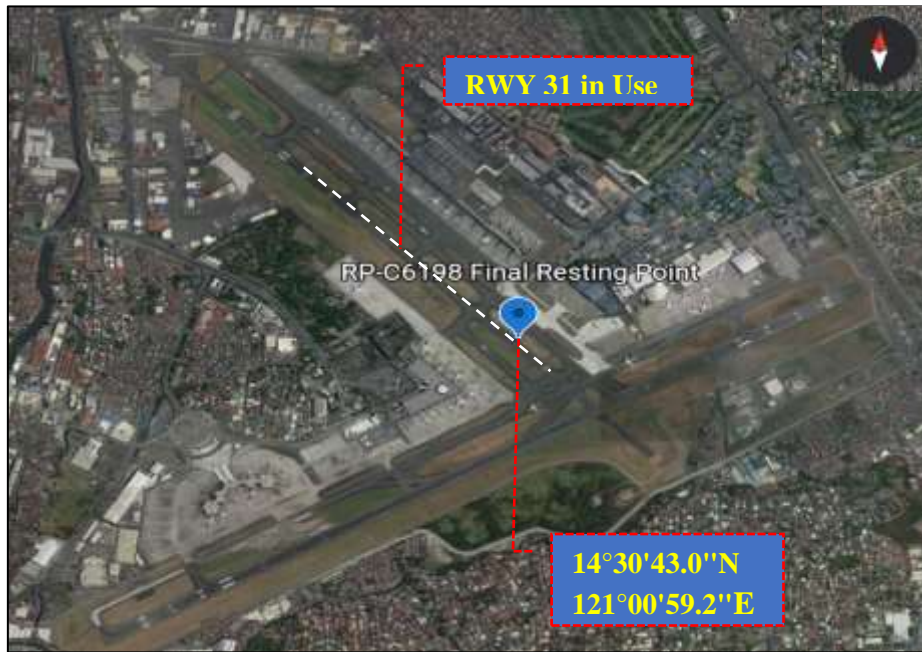
After landing, the aircraft departed the runway pavement and veered towards the grassy portion beside the runway. The aircraft slightly exited the paved surface of RWY 31 and stopped between taxiways F4 and F5, approximately 60 meters from the aircraft's take-off position, with coordinates at 14°3043.0 N and 121°0059.2 E and a general heading of 050 degrees (see Figure 5). MIAA Rescue and Firefighting Services immediately responded to help secure the aircraft, and passengers got off normally using the aft cabin door. Upon clearance from CAAP authority, the aircraft was relocated to the CAAC Hangar for further assessment. Initial damage assessment was carried out on the aircraft and found that the Right-Hand auto-feather low-pressure switch failed to de-actuate when activated (see Figure 6).

Figure 5. Coordinates of the aircraft's final resting point.

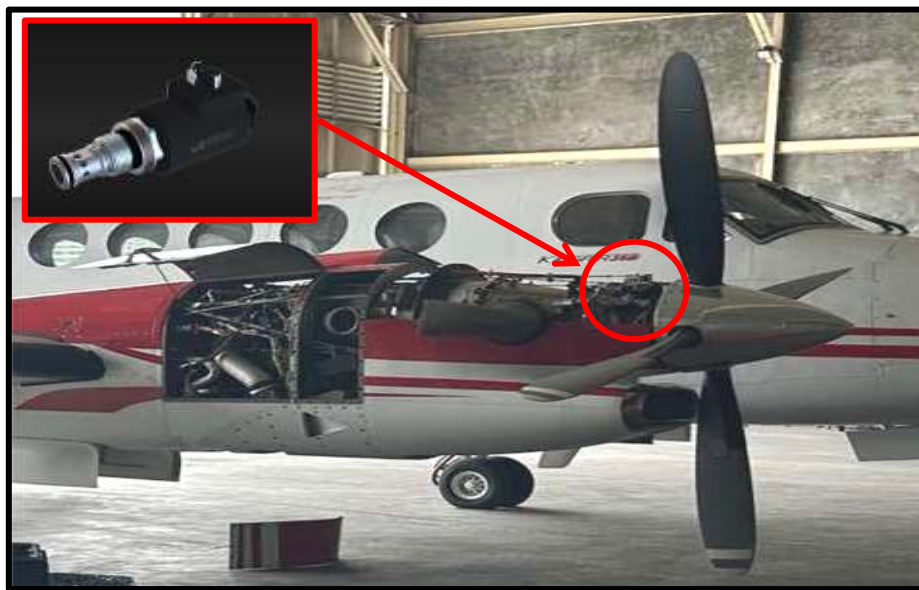
Figure 6. Right-Hand Propeller Auto-feather Low-Pressure switch

An auto-feather operating test was also done in accordance with SKA B300 AMM 61-21-00 REV 3. It was discovered that the right low-pressure switch with PN 50-389121-29 and SN 6336 failed to de-actuate, causing the right engine's propeller to feather. The component was scheduled for replacement.

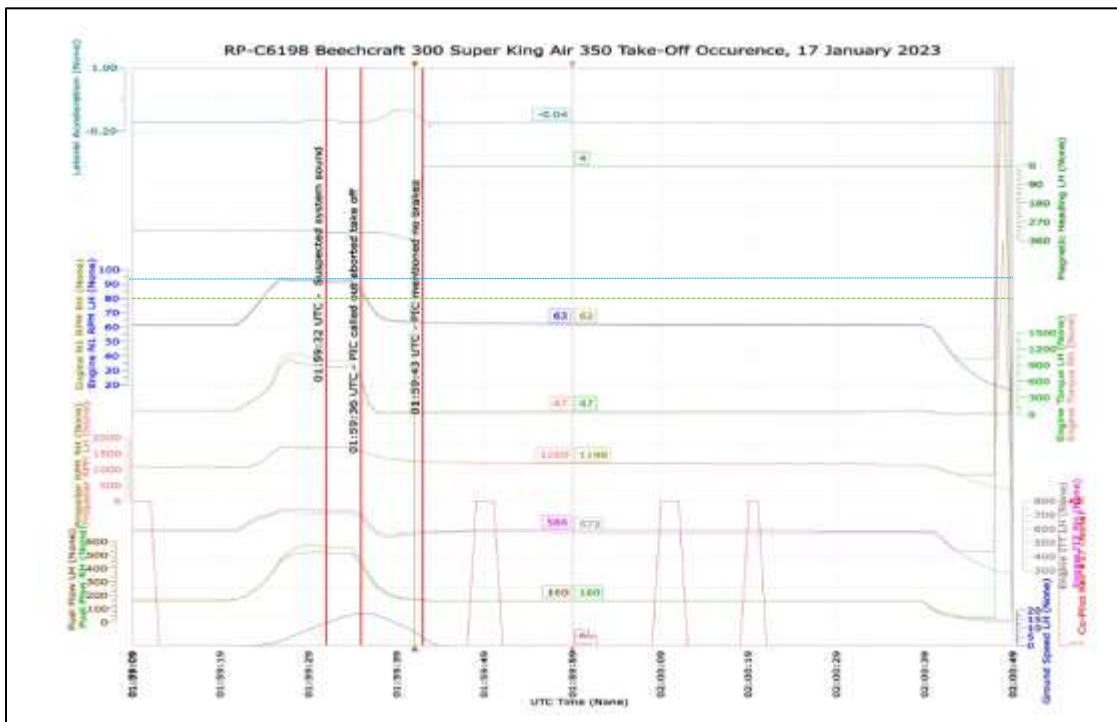
Figure 7. FDR data with CVR events, depicting 80% engine RPM - dotted green horizontal line; left engine N1 RPM and right engine N1 RPM that reached values of 93% and 94%.

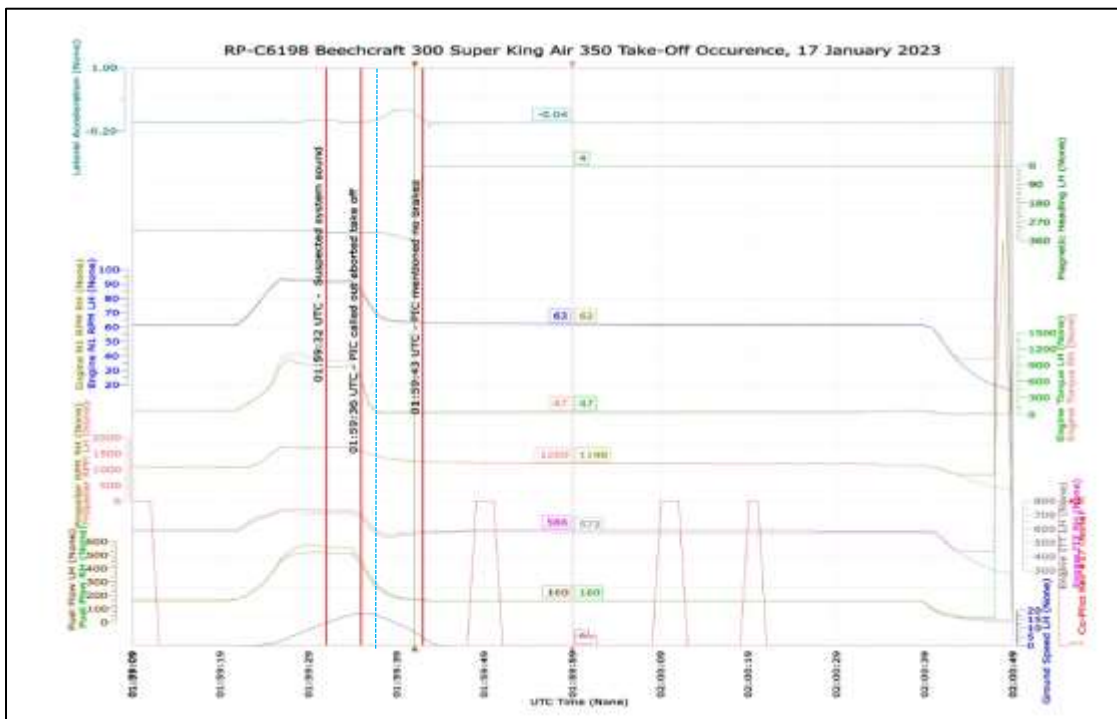
At 01:59:20 UTC, the aircraft heading was recorded at 313 degrees, consistent with the aircraft lining up on runway 31 in preparation for take-off. Over the next five seconds, the changes to the engine and propeller parameters, including left engine N1 RPM and right engine N1 RPM that reached values of 93 percent and 94 percent, respectively (Figure 7). These parameters were maintained over the next eight seconds, and the groundspeed increased from 0 kts to a maximum value of 19 kts at 01:59:36. During this period, the aircraft heading increased from 314 degrees to 319 degrees, consistent with the nose of the aircraft rotating right (Figure 8).

Figure 8. FDR data with CVR events, depicting the start of the aircraft's veering-off or lateral movement to the right - dotted blue vertical line.
