FINAL REPORT

RP-R8306
G-164B

TITLE: Incident involving an Allied Ag-Cat Productions Inc., G-164B type of aircraft with Registry Number RP-R8306 operated by Davao Agritech Incorporated that had a collision with electrical wires at Barangay Taytay, Cateel, Davao Oriental, Philippines, on August 10, 2022 at about 0730H/2330 UTC.

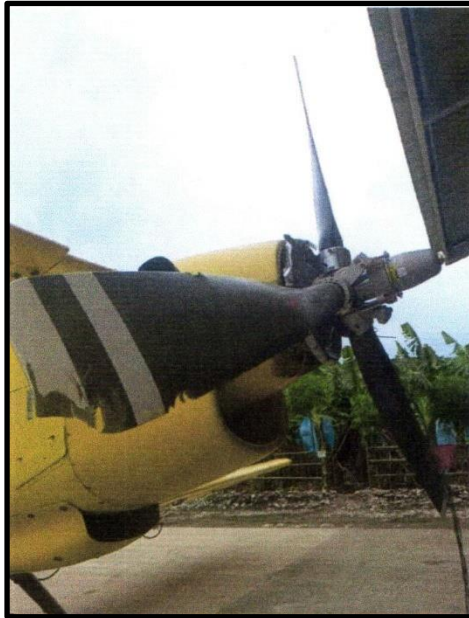
The pilot safely alighted from the aircraft. He inspected the propeller and saw the damage. Inspection of the aircraft shows it sustained impact damage on its lower nose engine cowling, propellers, and engine due to a propeller wire strike. No post-impact fire was noted during the inspection.

Figure 1. The aircraft with damaged propellers.

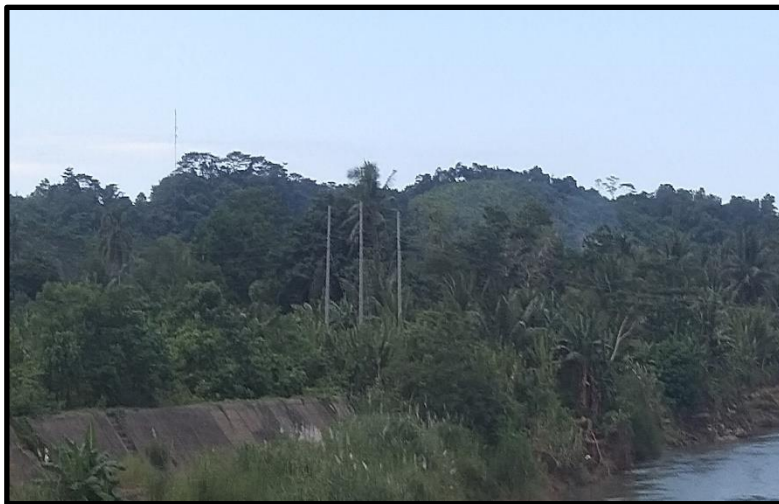
There is reported damage to commercial power lines one (1) nautical mile from the threshold of runway 17, Cateel airstrip.

While turning finals about one (1) nautical mile from the airstrip, the aircraft propeller struck a commercial power line that traversed along the riverside. The pilot saw a series of flashes in front of him and a jolt on the aircraft. The pilot continued the approach and landed at Cateel Airstrip without further events. The propeller wire strike caused the two (2) wires to break. Inspection of the aircraft shows obvious propeller damage, impact damage on its lower nose engine cowling, propeller spinner, and engine due to a propeller strike.

Figure 2: The power lines that the aircraft collided.

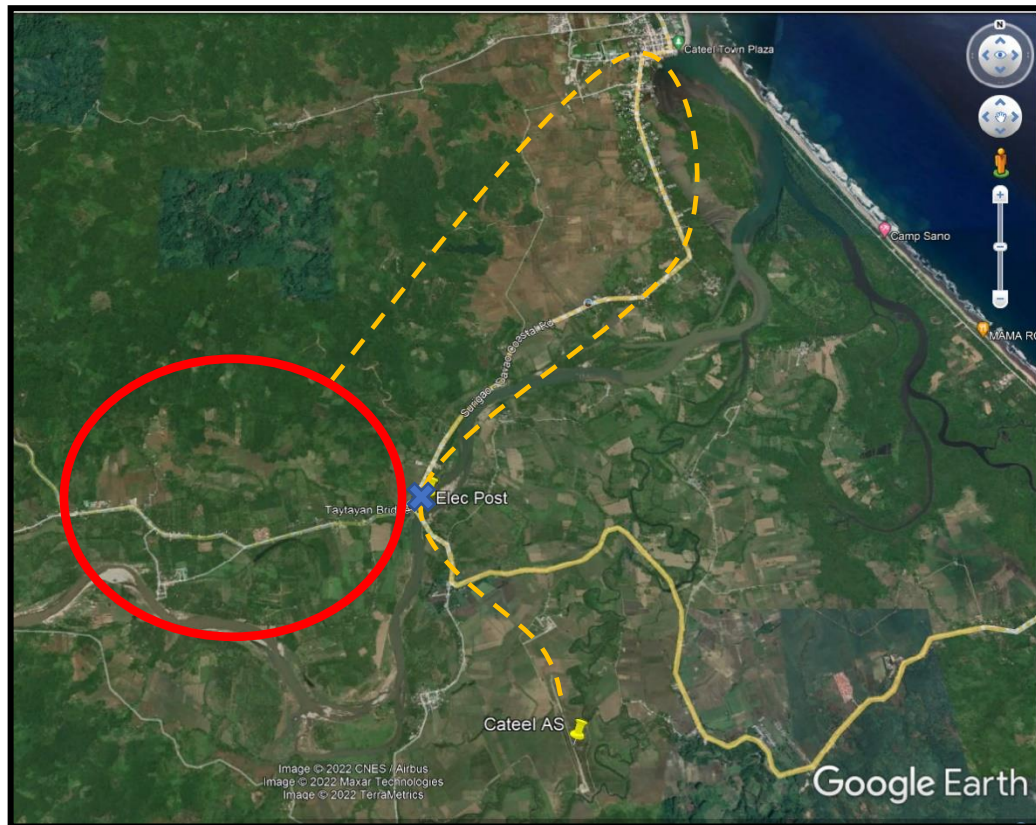
Figure 3. The

= area of operation which is Northwest from Cateel airstrip.

= aircraft flight path.

The aircraft was flying low while following the river and was fast on its approach to penetrate the low visibility condition for landing. The Pilot was, in a way, not aware of the potential risk that is critical for the flight to have a safe landing. The pilot's inappropriate actions and inactions are probably attributable to his becoming progressively overwhelmed by successive indications caused by his poor management of the aircraft's flight route and the weather. The investigation depicts the pilot's decision to proceed with the landing despite the poor visibility caused by the presence of low clouds; he should have proceeded to the alternate airstrip and waited until the fogs disappeared. When continuation bias interferes with the pilot's ability to detect important cues, or if the pilot fails to recognize the implications of those cues, breakdowns in situational awareness (SA) occurs.
