### **FINAL REPORT**

**RP-C 1028**  
**TEXTRON AVIATION CESSNA 152**

**TITLE:** Serious Incident involving a Textron Aviation C-152 type of aircraft with Registry Number RP-C1028 owned and operated by WCC Aviation Company, Inc. that had a forced landing incident at the diversion road of Brgy. Linmansangan, Binalonan, Pangasinan, Philippines, on April 21, 2022, at around 0630H.

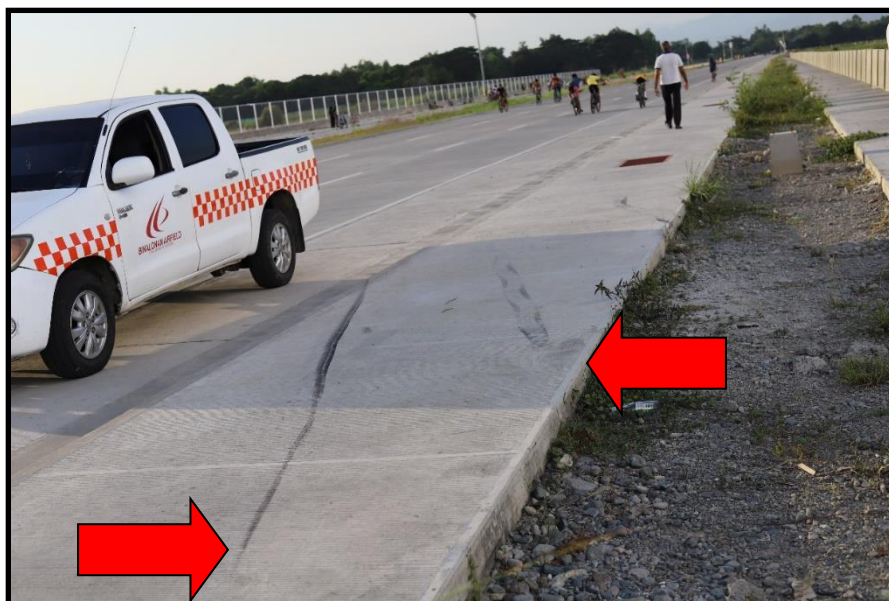
The incident site is along the newly constructed diversion road situated on the left-hand side of runway 35 which is about 150 meters from the runway centerline. Tire markings (Figure 1) indicated that the aircraft landed on the right-hand side of the road with its RH wing tip getting in contact with the concrete roadside barrier (Figure 2). After touchdown, the aircraft continued to roll for 270 meters and came to a complete stop at coordinates 16°03'05.8" N, 120°34'49.4" E with last heading of 300° (Figure 3). The FI and SP egress safely from the aircraft and later assisted by WCC Aviation personnel. The aircraft sustained damage on the following (Figure 4 and 5):

Figure 1 – Tire marks on the touchdown area of RP-C1028

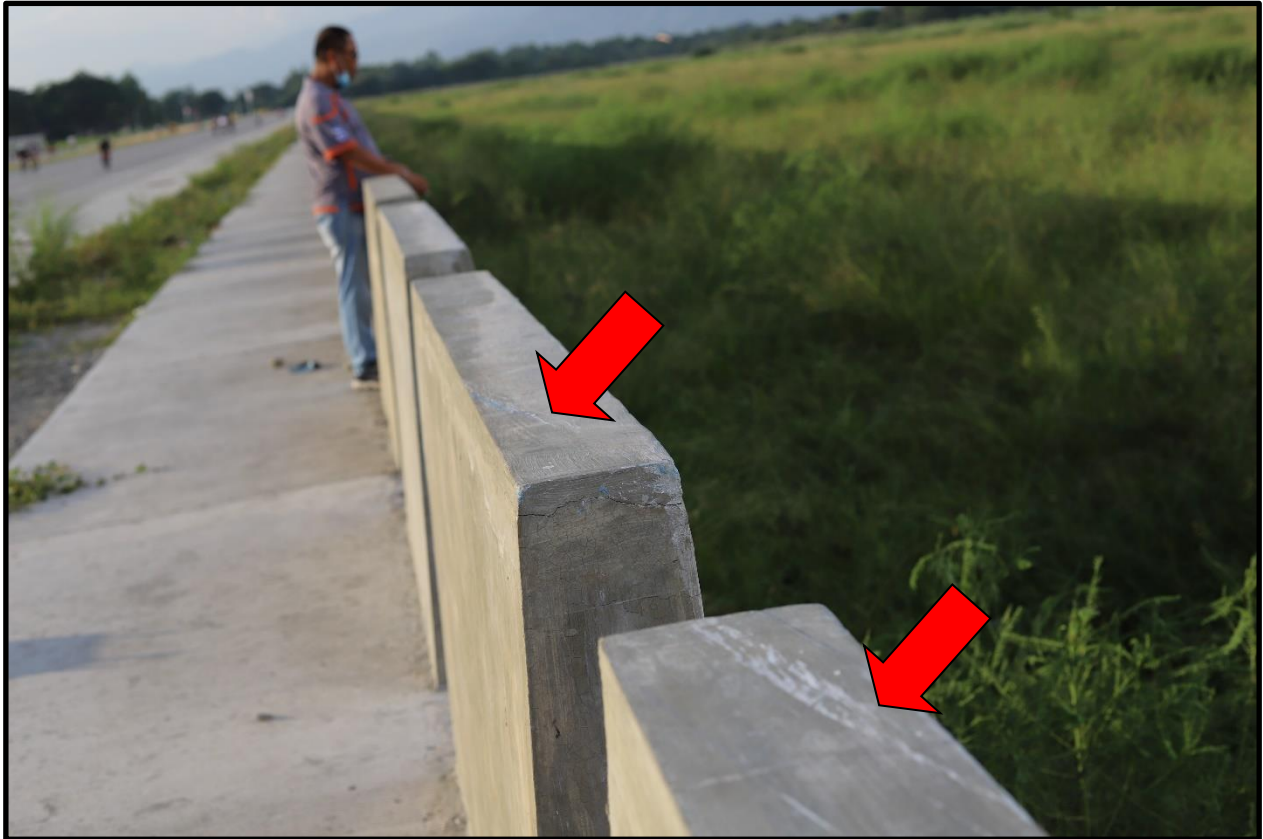
Figure 2 – Scratches on the roadside concrete barrier due to contact with the wing tip

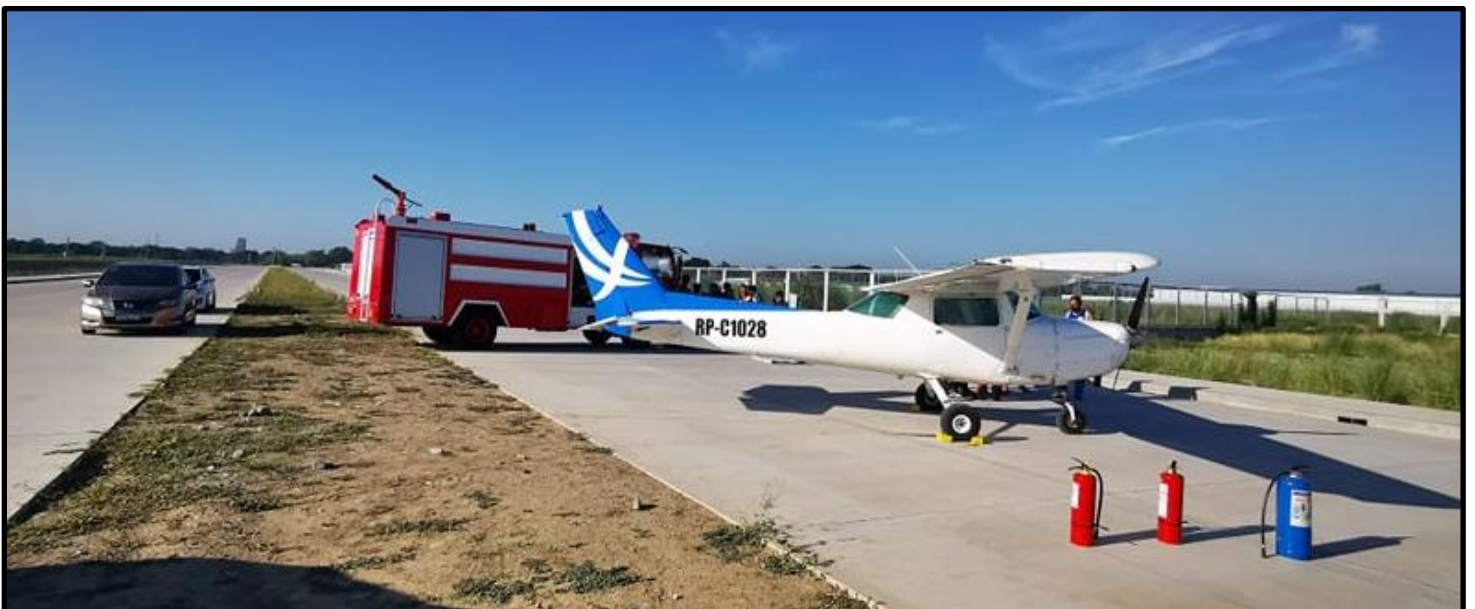
Figure 3 – RP-C1028 at the incident site

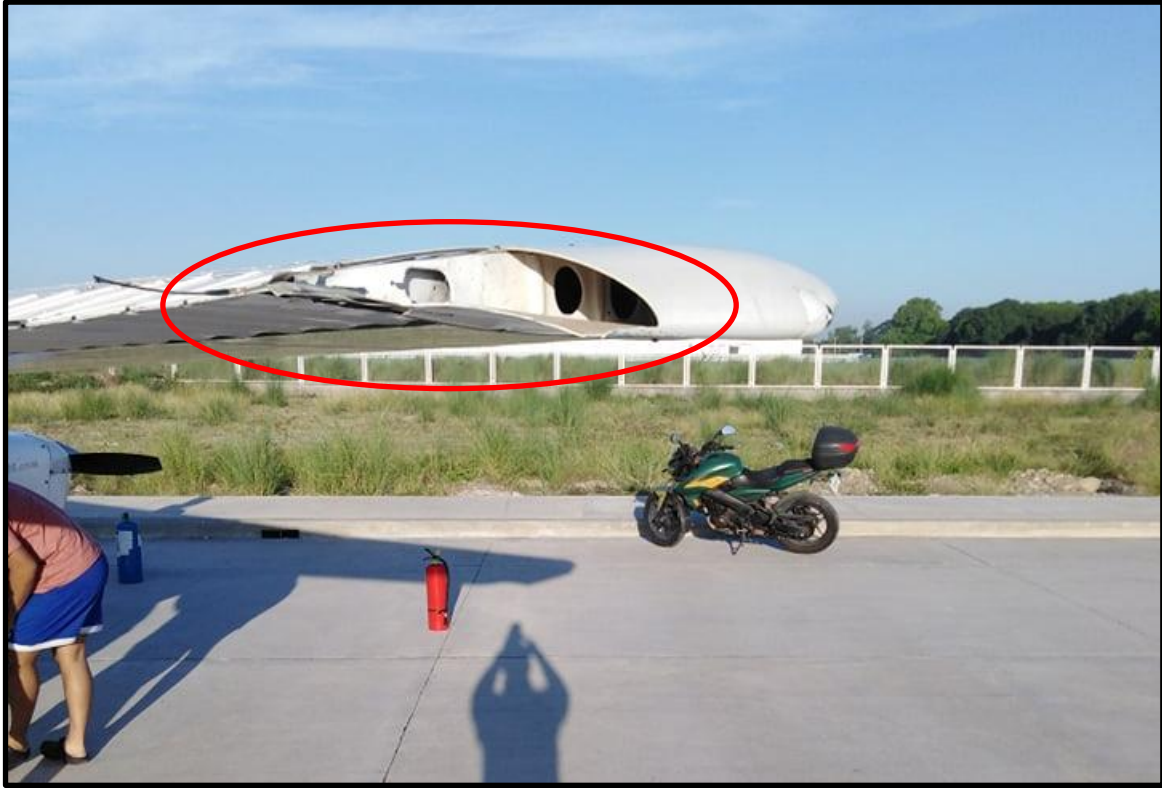
- a. RH wing tip damaged.
- b. Broken RH main landing gear brake assembly (bended brake disc, missing brake caliper and detached brake lining).

Figure 4 – Damaged on the RH wing tip

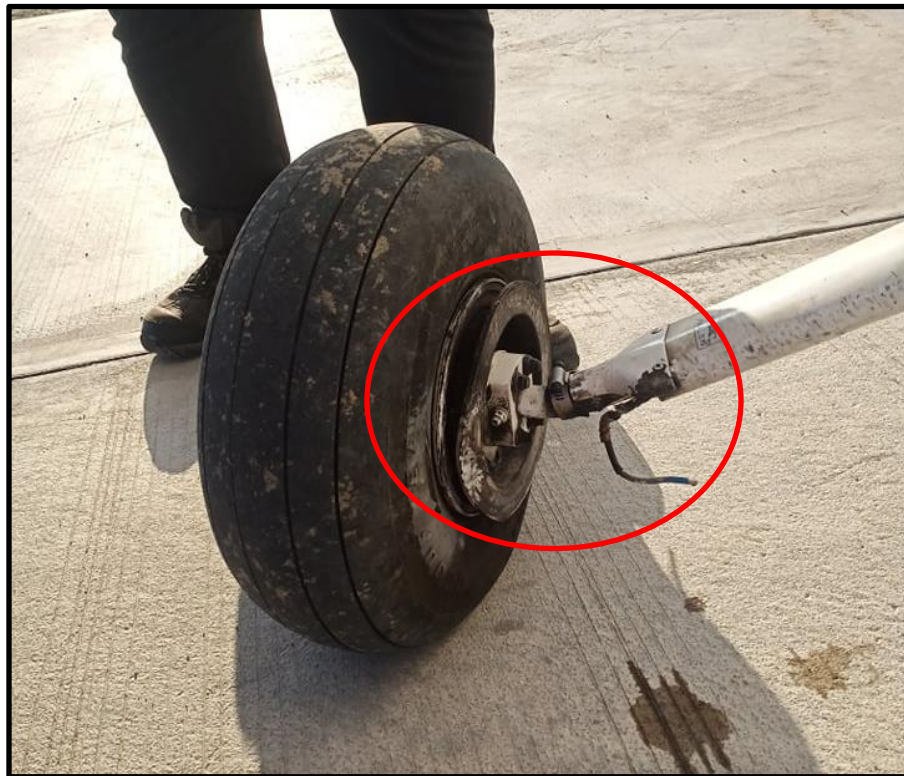
Figure 5 – Broken RH main landing gear brake assembly

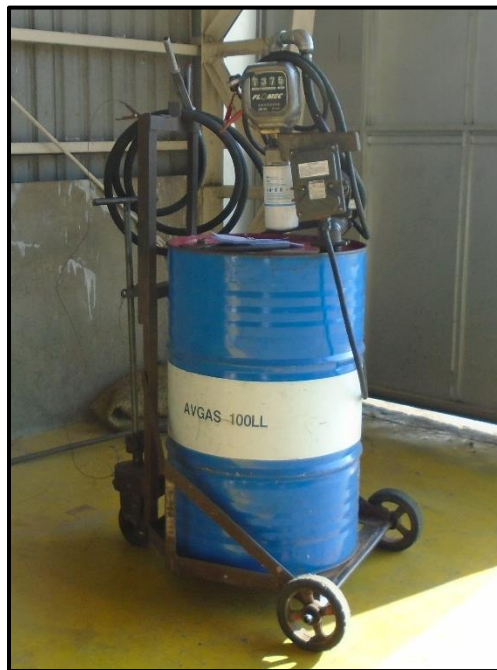
On the interview with the on-duty mechanic, he stated that refueling of the aircraft is usually being done after the last flight of the day to eliminate moisture build-up on the fuel tanks. Refueling is thru a fuel pump connected to a drum (Figure 6). Pumps are equipped with Facet's Fuel-Gard Aviation Spin-On filters to ensure that water and ultra-fine solids are absorbed. Though there are documented process available for WCC, these two (2) mentioned items are not yet part of the manual.

Figure 6 – Refueling drum with pump

- a.** Include in their existing manuals the following internal current practices:
  - 1.** Refuelling of the aircraft after each day's operations to prevent possible moisture build up on the fuel tanks;
  - 2.** Conduct of refuelling using pumps equipped with Facet's Fuel-Gard Aviation Spin-On filters to ensure that water and ultra-fine solids are absorbed during the process.
