FINAL REPORT

RP-C 1975 **TECNAM P2002JF**

TITLE: A serious incident involving a Tecnam P2002JF type of aircraft with Registry Number RP-C1975 owned and operated by WCC Aviation Company that experienced collapsed left main landing gear during landing at Vigan Airport, Barangay Mindoro, Vigan, Ilocus Sur, Philippines, on March 18, 2023/1150H

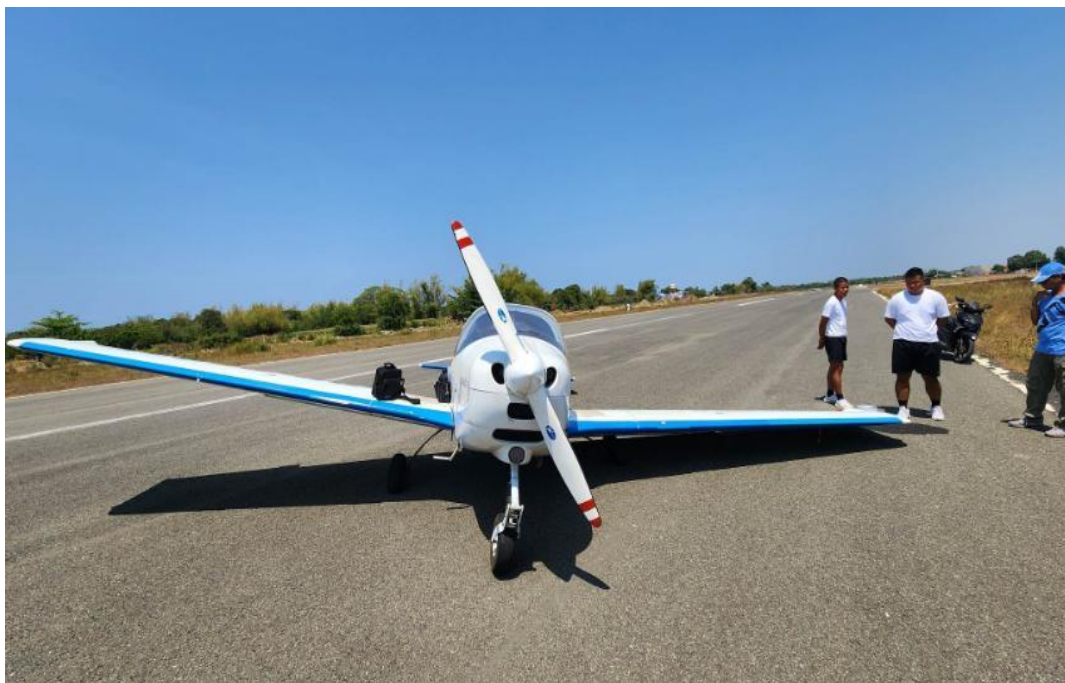
Figure 1. Aircraft's final resting point

The FI further said that while on landing roll, he noticed that the aircraft left wing was lower than the right wing. Immediately he took over the control from the SP as the aircraft continue to move towards the left of the runway for another 315 meters. It came to a full stop with a heading of 160 degrees and grid coordinates of 17° 33' 16.9" N; 120° 21' 21" E.

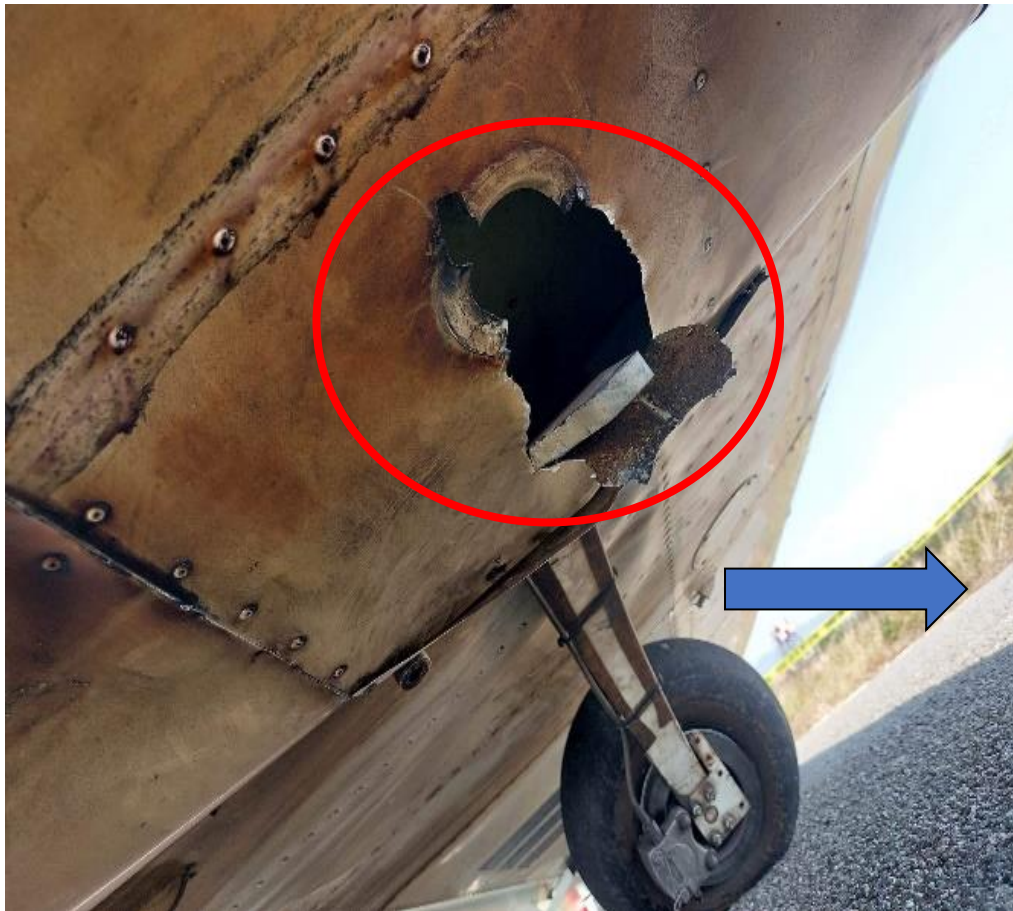
A teardown inspection on RP-C1975 left main landing gear after the occurrence was conducted by CAAP-Investigator together with the Operator's AMO last March 19, 2023. This was done to determine the cause of the landing gear failure. During the inspection on the aircraft revealed that the MLG leaf spring was partially disconnected which had caused a structural damage to the left-wing area (Figure 2). A more detailed inspection also shows that the Internal Hex Head Bolt connecting the MLG to the leaf spring was broken and is consistent with a material failure (Figure 3 and 4). The material fatigue in the Internal Hex Head Bolt was observed to be present long before it developed into a crack and continued to progress in time.

Figure 2 – Left Main Landing Gear leaf spring partially disconnected

- a. The MLG leaf spring was partially disconnected due to the failure of internal hex head bolt resulting to the collapse of the left main landing gear. (Material Failure)

- a. Revise the Tecnam P2002-JF, 50-hour checklist to include the inspection of main landing gear attachments, bolts, and bushing. The inspection must be particularly for cracks, corrosion, looseness, security of mounting points or any condition that can cause stress concentrations and eventual failure.

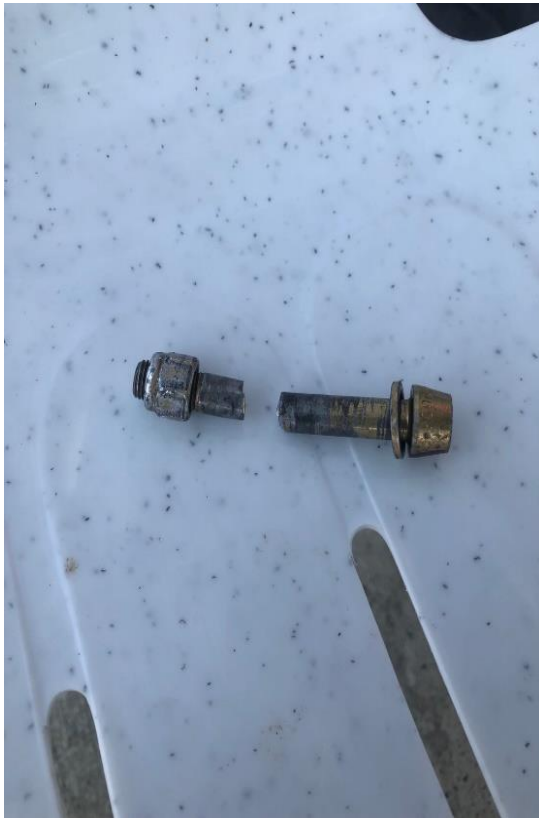
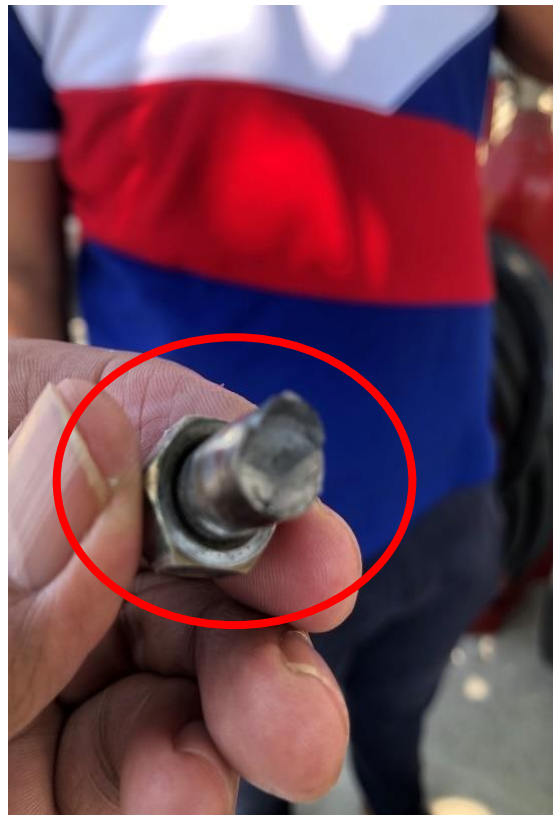
Figure 3 and 4 – Broken Left Main Landing Gear Internal Hex Head Bolt

- a. The non-adherence to Tecnam P2002-JF Maintenance Manual.
