## AIRCRAFT ACCIDENT INVESTIGATION AND INQUIRY BOARD

### **FINAL REPORT**

**RP-C5911**  
**DHC-8-402 (Q400)**

**TITLE:** A serious incident involving a DHC-8-402 type of aircraft with Registry Number RP-C5911 owned and operated by PAL Express Corporation that had a runway excursion at Runway 06, Basco Airport, Basco, Batanes, Philippines on April 16, 2023/0800H.

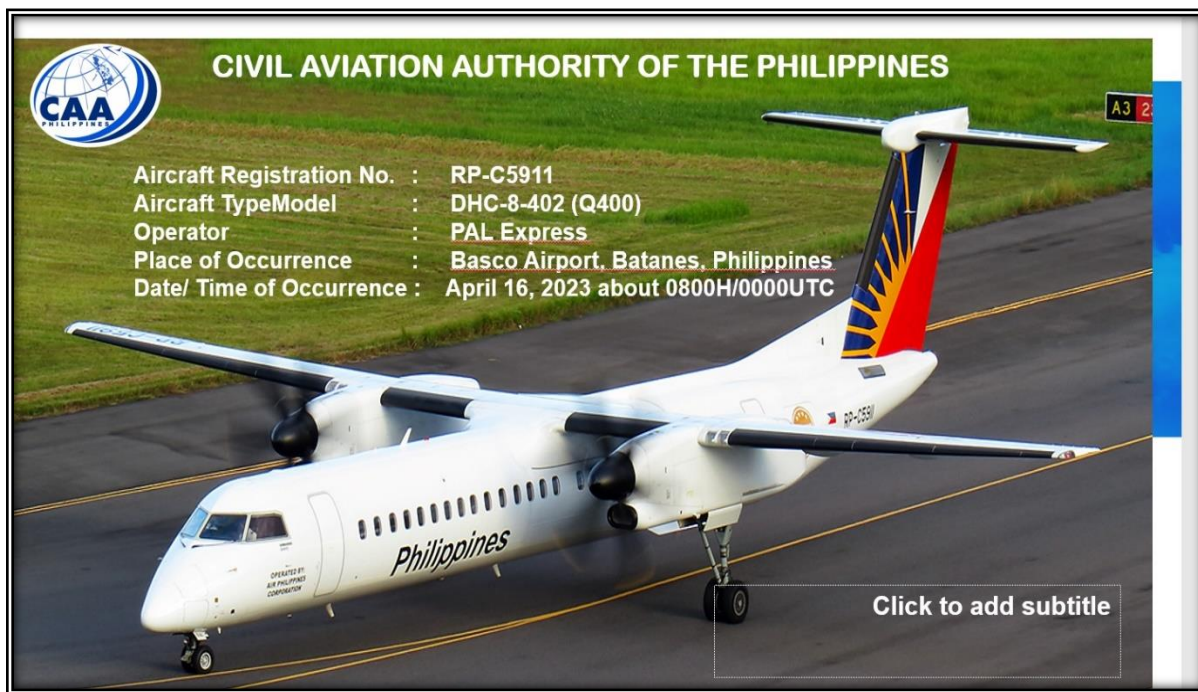
Figure 1- RP-C5911 aircraft

The aircraft did not sustain any damage. During site investigation, visible aircraft tire marks were seen on the runway and beyond the runway concrete pavement with a heading of 88 degrees and grid coordinates of 20°. 454277 N; 121°.98485” E. No collateral damages were

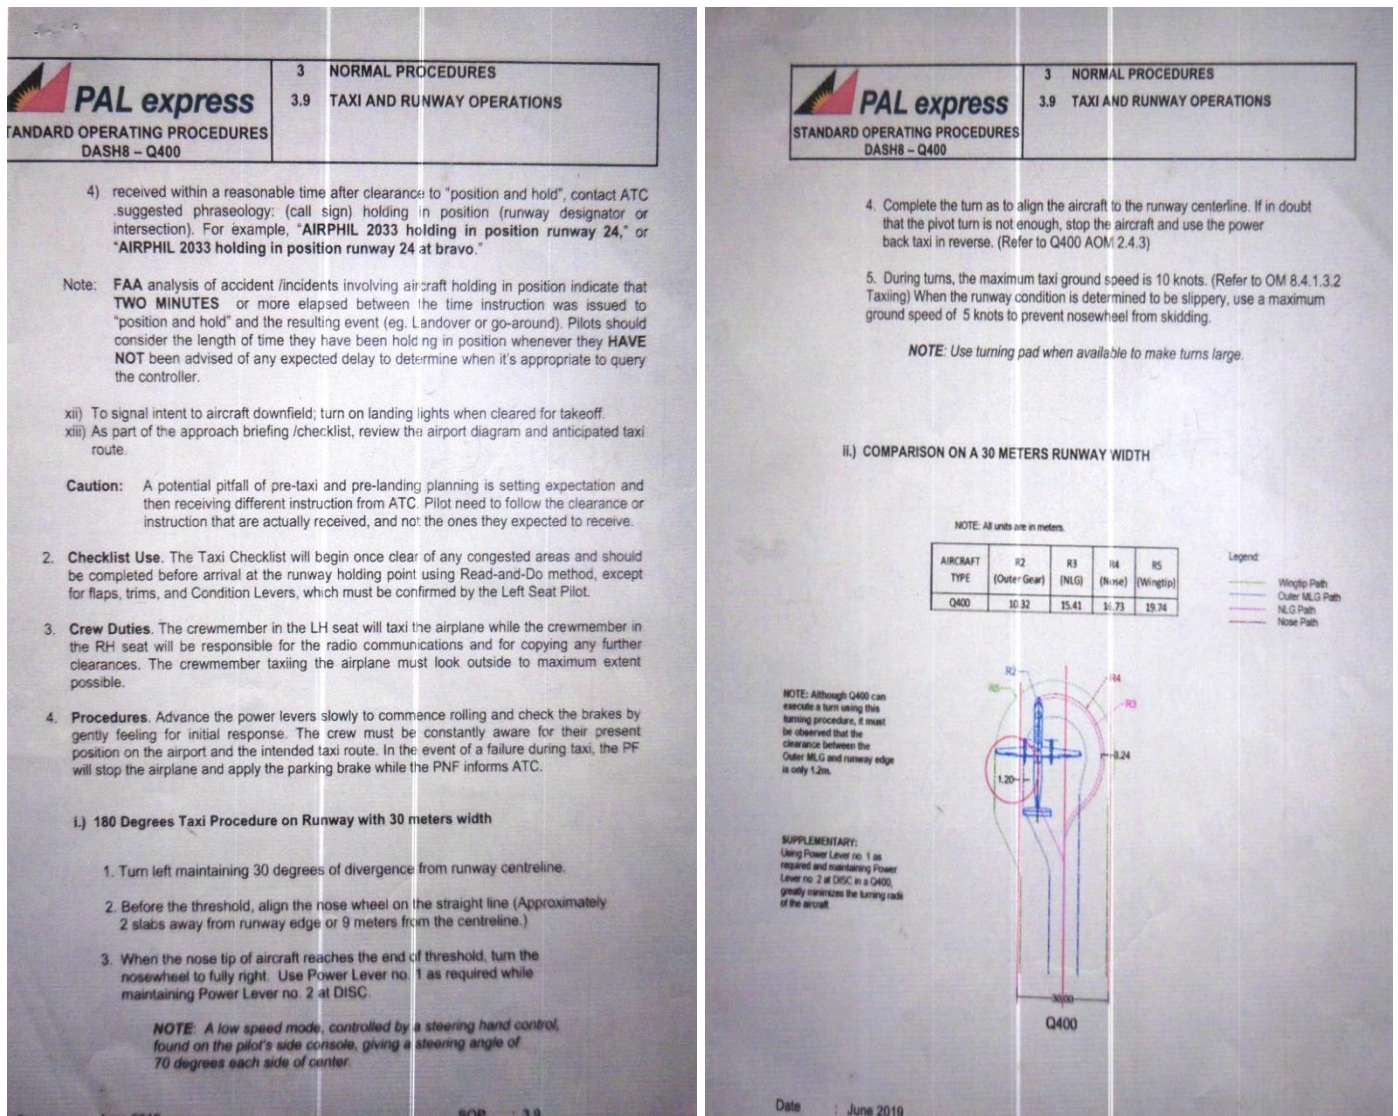
At 22:54:41 UTC, with 32 kts ground speed, brake pressure started to increase in the right brake pedal to 2,9776 psi compared to the left brake pedal of 2,947 psi. The heading of the aircraft changes to 75.3 degrees. The power lever started to increase from idle to 26.9 and 24.2, respectively. With the application of brake pressure at 32 kts ground speed, it appears that the aircraft was still on high-speed landing roll towards the end of the runway. There was a change in directional heading to the right with the application of a more right pedal brake and the increase of the power lever. This also confirms what the PIC revealed during the investigation, that he maneuvered the aircraft to the right before executing a 180-degree turn to the left. The application of the right pedal prior to making a 180-degree turn to the left is a crew decision error and does not conform with the operator's Standard Operating Procedures (SOP). Stipulated in the Operator's Standard Operating Procedures (SOP) DASH8-Q400/Normal Procedures/Taxi and Runway Operations, the 180-degree taxi procedure on the runway with 30 meters was to turn left while maintaining 30 degrees of divergence from the centerline. During the turns, the maximum taxi ground speed is 10 knots. The PIC performed a non-standard procedure turn. (Figures 2 and 3).

Figure 2 and 3 – SOP DASH8-Q400 Normal Procedures/ Taxi and Runway Operations

- a. The flight crew failed to follow the standard procedures for 180 degrees turn that resulted to runway excursion

- a. The PIC involved in the incident had undergone the line proficiency check and route qualification checks while the FO had undergone the line proficiency check.
- b. Memo for Company pilots, reminding to strictly follow and exercise caution in executing the SOP on 180 degree turns for runways with 30-meter width. (Appendix 1)
- c. Publication of SMS Bulletin: Notification of Accident and Serious Incident. Appendix 2)
- d. Accident & Serious Incident Reporting Meeting/ Table Top Exercise- Aircraft Runway Excursion Incident. (Appendix 3)

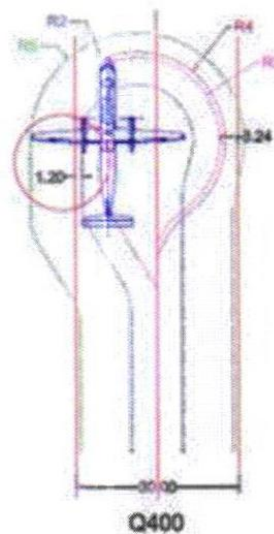
NOTE: Although Q400 can execute a turn using this turning procedure, it must be observed that the clearance between the Outer MLG and runway edge is only 1.2m.
