## AIRCRAFT ACCIDENT INVESTIGATION AND INQUIRY BOARD

### **FINAL REPORT**

**RP-C8054**  
**TEXTRON AVIATION INC. CESSNA 172M**

**TITLE:** A serious incident involving a Cessna 172M type of aircraft with Registry Number RP-C8054 owned and operated by Leading Edge International Aviation Academy, Inc. that had a runway excursion at San Fernando Airport (RPUS), Canaoay, San Fernando City, La Union, Philippines on June 23, 2023/0900H.

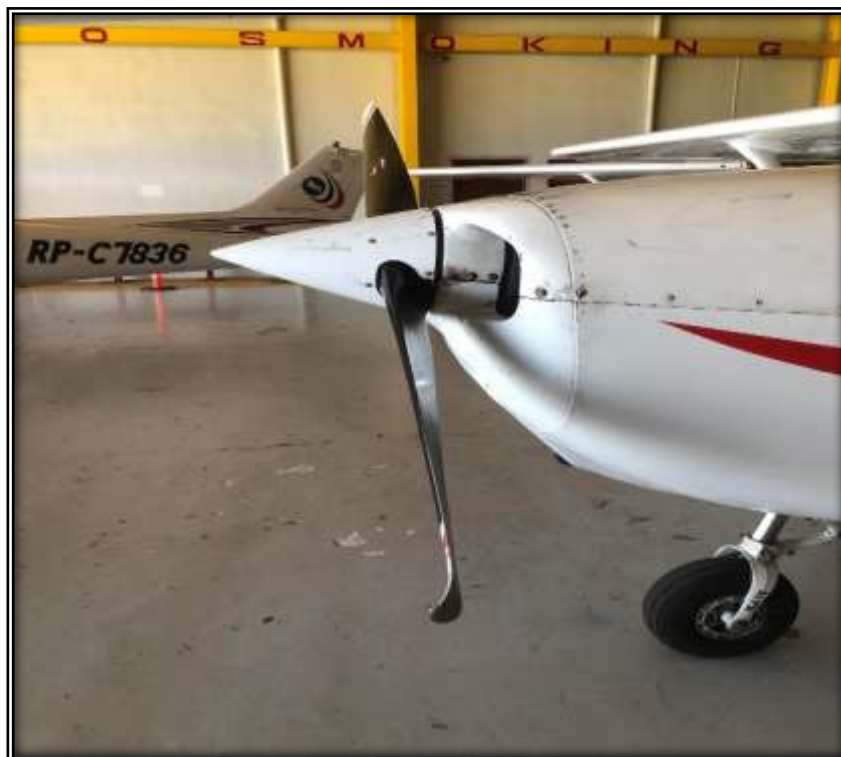
Figure 1. The aircraft bent propeller blade.

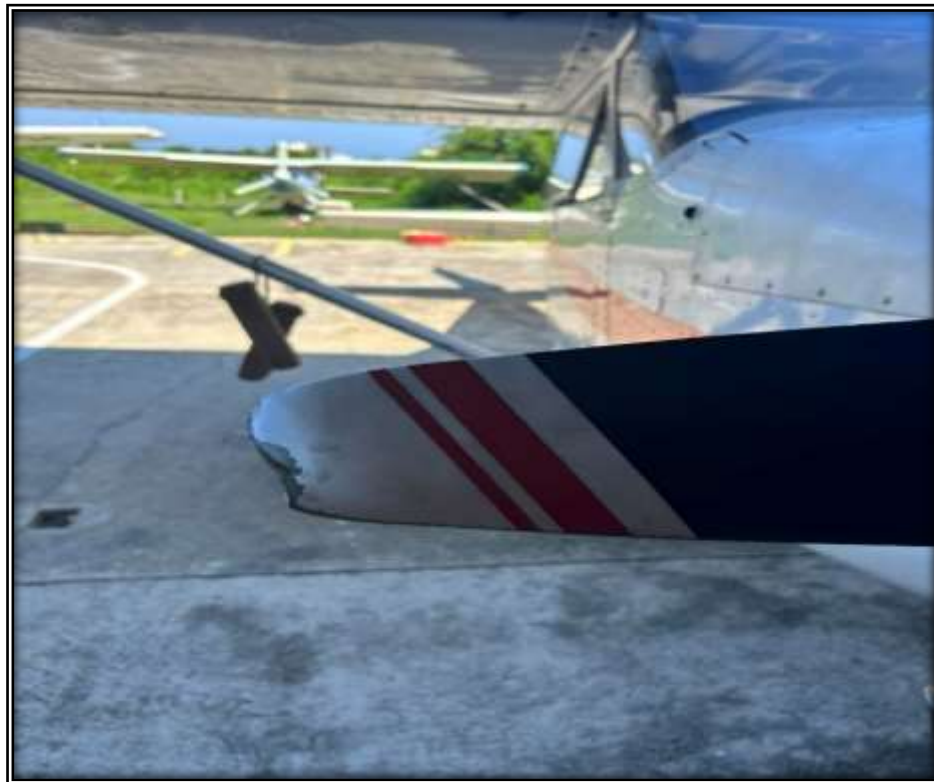
A post flight inspection of the aircraft shows that the aircraft sustained damage on the propeller blade and left main gear brake assembly.

Figure 2: Dent on the propeller blade tip

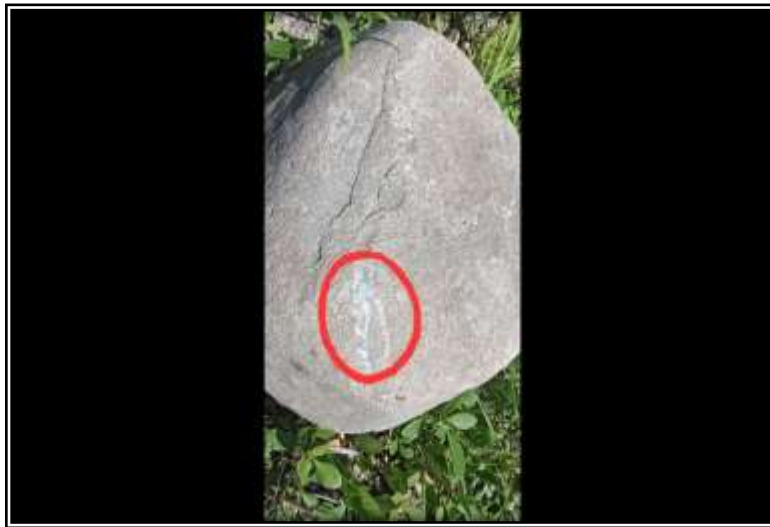
Figure 3: The boulder rock that the aircraft propeller blade hit.

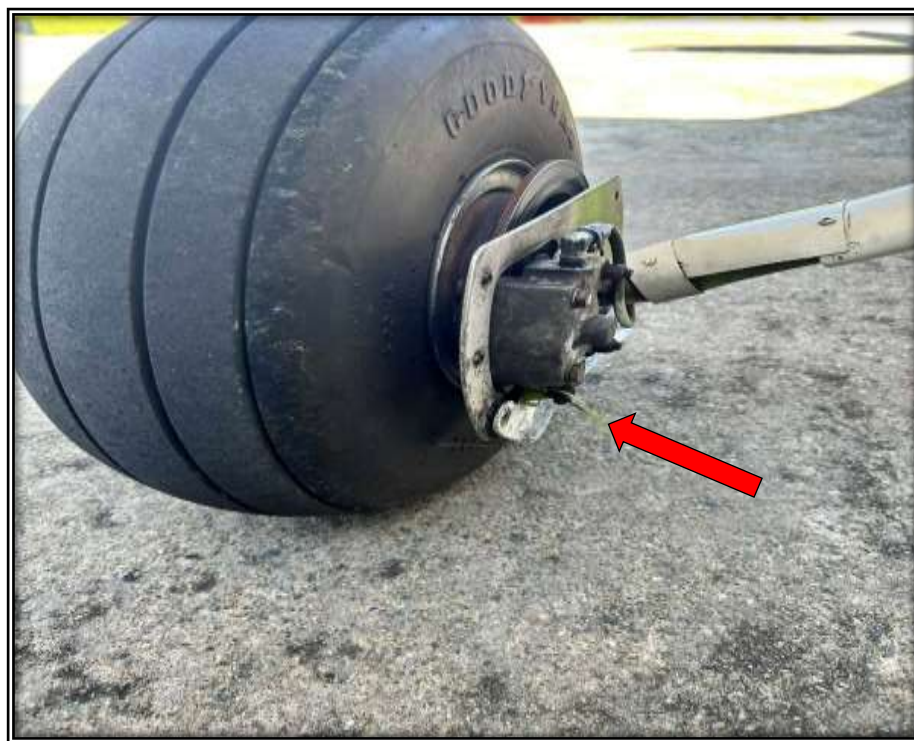
Figure 4: The aircraft's left main landing gear with grasses still stuck at the wheel.

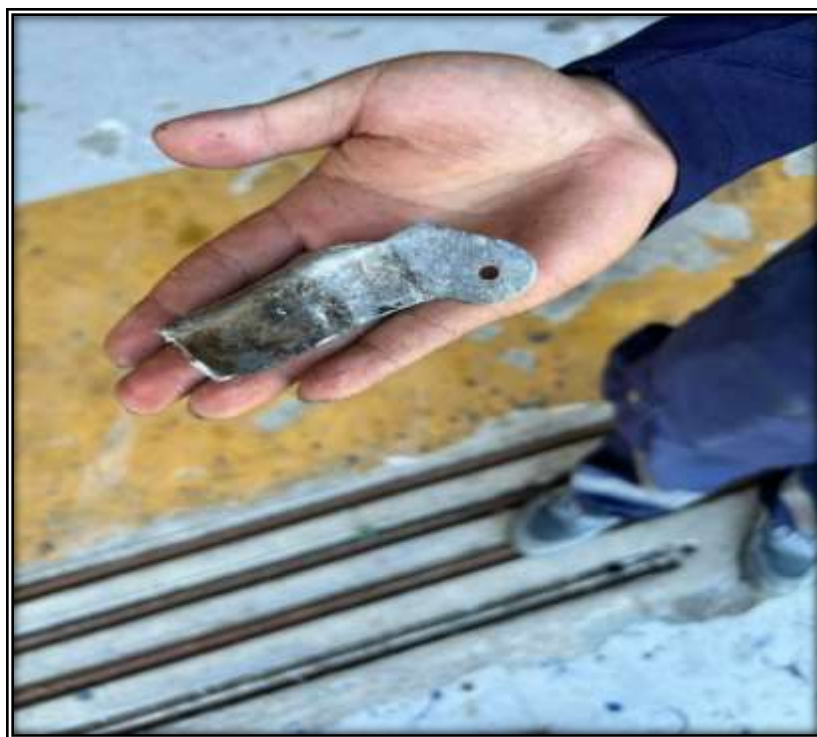
Figure5: Broken part of the aircraft's left main landing gear assembly.

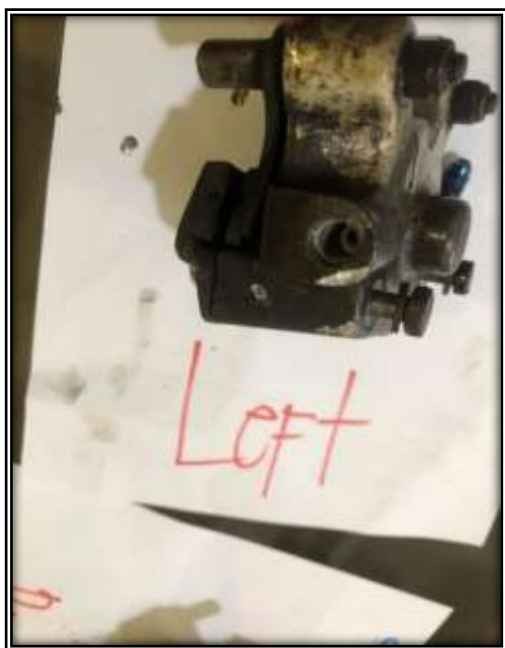
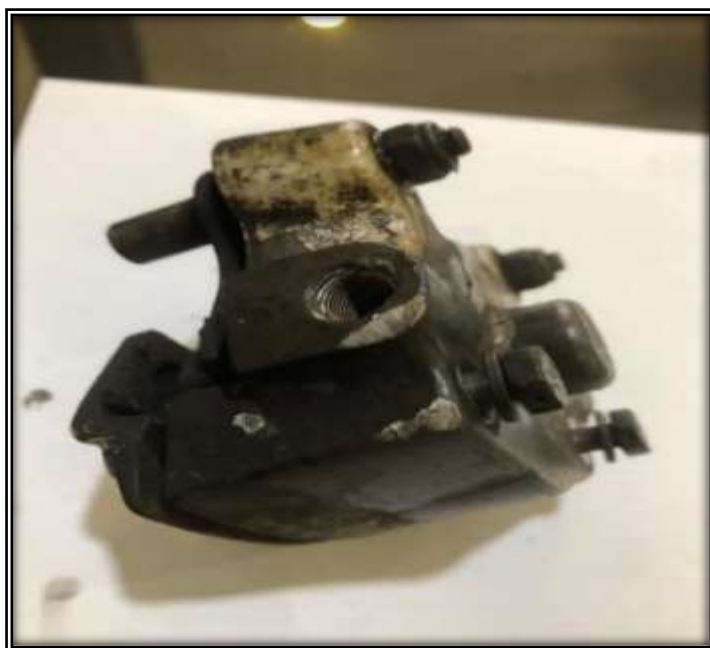
Figure 6 and 7- Dent on part of the aircraft's left main landing gear assembly
