AIRCRAFT ACCIDENT INVESTIGATION AND INQUIRY BOARD

FINAL REPORT

RP-C8811
CESSNA C172R

TITLE: Serious incident involving a Textron Aviation Inc., Cessna C172R type of aircraft with Registry Number RP-C8811 owned and operated by First Aviation Academy, Inc. (FAA) that had a bounced landing resulting to runway excursion at Omni Airfield (PH-0178), Civil Aviation Complex Clark Freeport Zone, Pampanga, Philippines, on August 16, 2022 at about 0844H/0044 UTC.

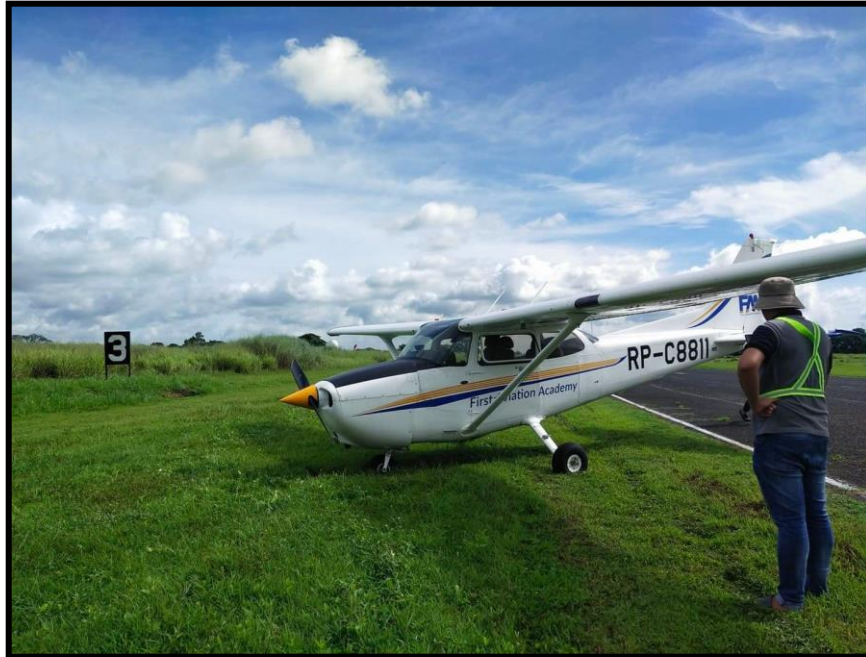
and-go was uneventful. In her second pattern, the SP landed approximately 70 meters after the threshold of runway (RWY) 20. The aircraft bounced three (3) times, consuming one hundred (100) meters of runway. The SP lost directional control of the aircraft, swerved to the right side of the runway, and eventually went out of the paved portion of the runway. The aircraft exited the runway pavement and settled on the grassy area about twenty (20) meters away from RWY marker three (3) at coordinates 15°10'23.22"N, 120°33'51.13"E, with a final heading of 261°. Witnesses rushed to the scene to help secure the aircraft. The SP alighted safely from the aircraft by herself. Inspection of the aircraft shows it sustained impact damage to its nose landing gear, engine fire wall, propeller, and engine. No fire ensued.

Figure 1: The aircraft at its final resting point.

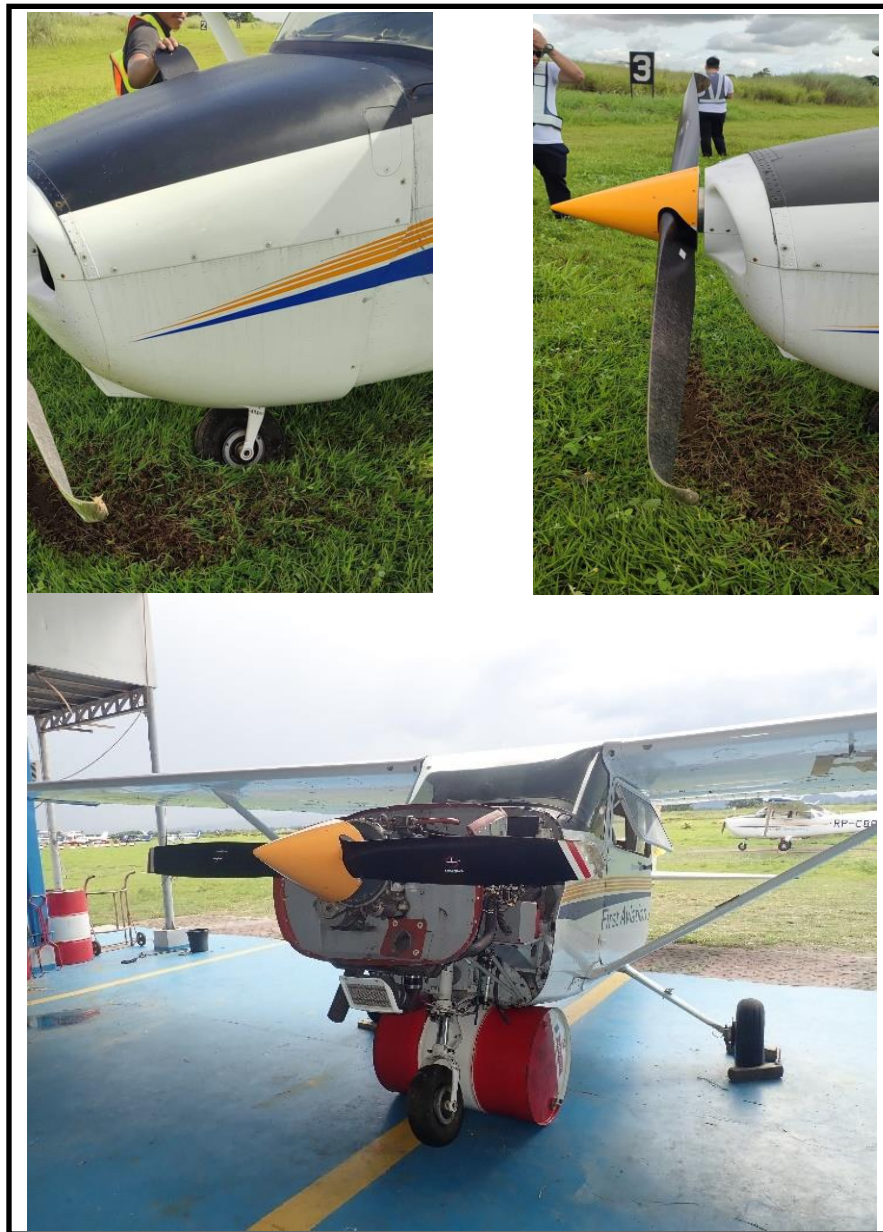
The SP landed approximately 70 meters after the threshold of runway (RWY) 20. The aircraft bounced three (3) times, consuming one hundred (100) meters of runway and sustaining damage to the equipment. The pilot lost directional control of the aircraft and swerved to the right, going out of the paved portion of the runway. The aircraft exited the runway pavement and settled on a nose-low position on the grassy area about twenty (20) meters away from RWY marker three (3) at coordinates 15°10'23.22"N, 120°33'51.13"E, with a final heading of 261°. Inspection of the aircraft shows it sustained impact damage to its nose landing gear, engine fire wall, propeller, and engine (Figure 2). No fire ensued.

Figure 2. RP-C8811 relocated at the Operator's hangar for further damage assessment.
