FINAL REPORT

RP-C8825
CESSNA 402B

OPERATOR: NORTHSKY AIR INC.

TITLE: Serious incident involving a Textron Aviation Cessna 402B type of aircraft with registry number RP-C8825 owned and operated by Northsky Air, Inc. that had a runway excursion at ACME airstrip (Maconacon), Maconacon, Cagayan Valley, Isabela, Philippines, on March 25, 2022 at about 1341H (local).

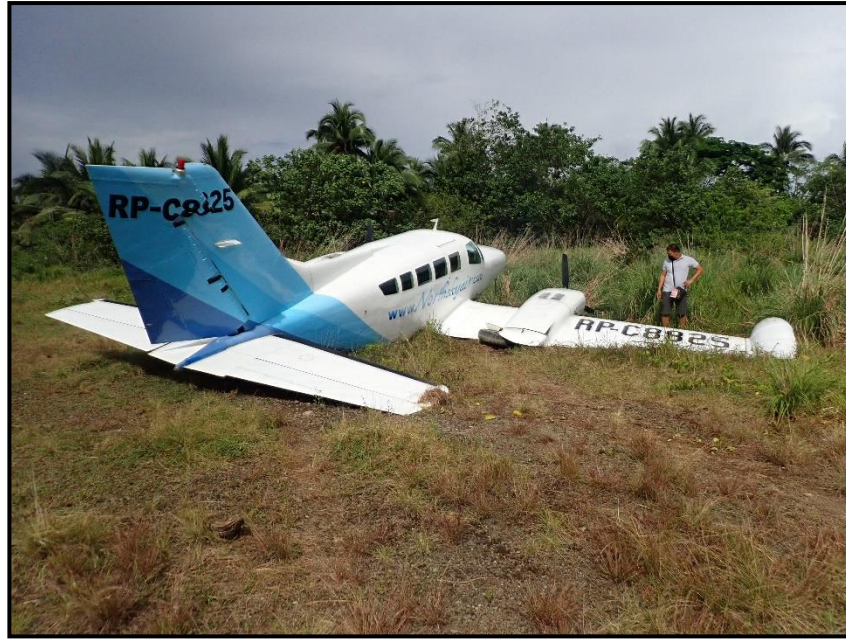
The aircraft landed about 200 meters from the threshold of Rwy 02. After rolling for about 300 meters, the aircraft started to exhibit a right-low-wing attitude. Subsequently, the aircraft started to veer towards the right side of the runway centerline. It continued to roll and entered the grassy portion of the runway edge between markers #5 and #4. The aircraft came to a complete stop with the nose gear lodged in a soft, muddy ground. The aircraft's final resting point was located at coordinates 17°23'2.45" N, 122°14'54.72" E, and heading

Figure 1. The aircraft at its final resting point.

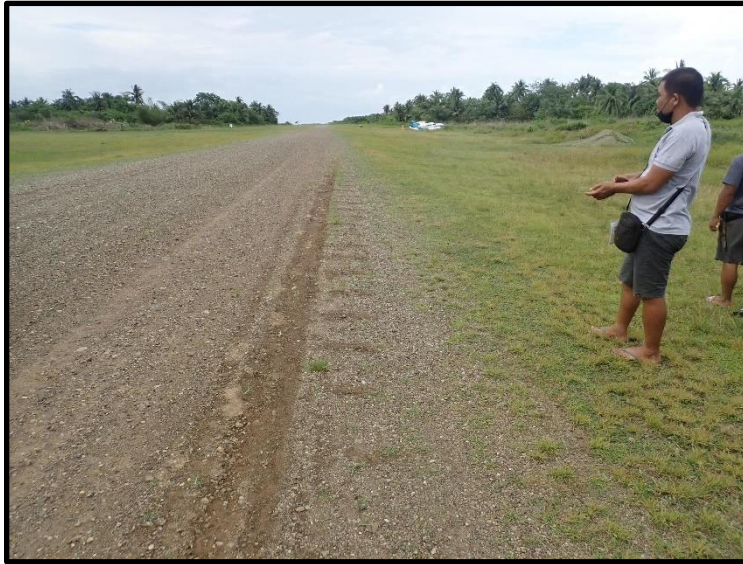
The runway had multiple scrapes caused by the aircraft sliding along its path, and the right-hand propeller came into contact with the runway surface (Figure 2).

Figure 2. Multiple right-hand propeller scrapes on the runway.

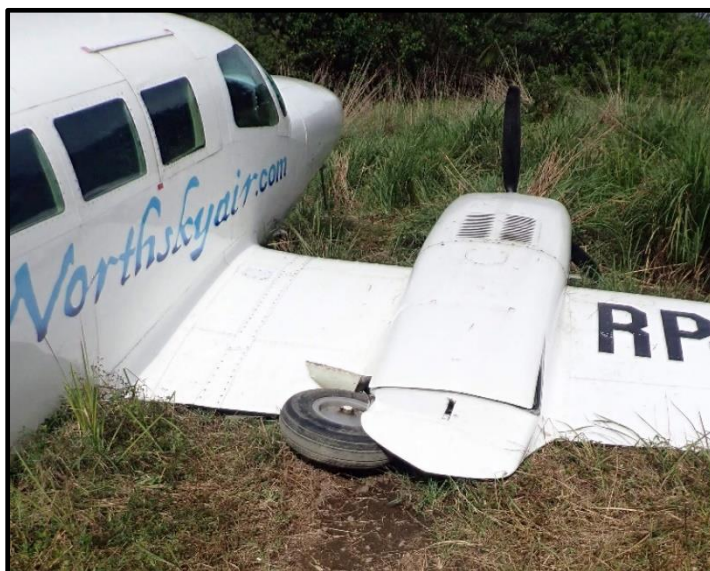
The aircraft touched down two hundred (200) meters away from the threshold of runway 02 and rolled for another 300 meters before it came to a complete stop. During the landing roll, the right-hand landing gear collapsed, resulting in damage to its right-wing tip tank, right wing engine, and propeller. Scrape marks were present on the runway from the time the RH main landing collapsed until it came to a halt. All the crew and passengers did not sustain injuries since the cockpit and cabin are still intact.

Figure 3. The RMLG did not break away from the aircraft upon landing.

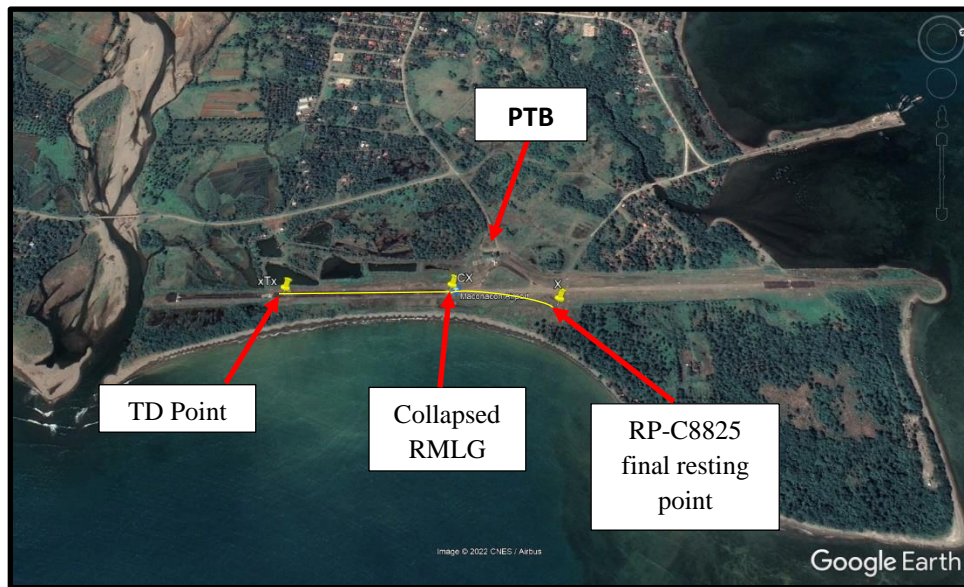
The aircraft landed about two hundred (200) meters from the threshold of Rwy 02. During the landing roll, about three hundred (300) meters after the touchdown point, the aircraft's right-hand main landing gear suddenly collapsed. The aircraft veered towards the right side of the runway centerline, passing the passenger terminal building (PTB), and continued to roll for another two hundred (200) meters before it entered the grassy portion of the runway.

The aircraft came to a complete stop with the RMLG lodged in a soft, muddy ground. The aircraft's final resting point was located at coordinates 17°23'2.45" N, 122°14'54.72 E, and the final heading was approximately 090 degrees.

Figure 4. The yellow line is the aircraft track to its final resting point. (Not To Scale)

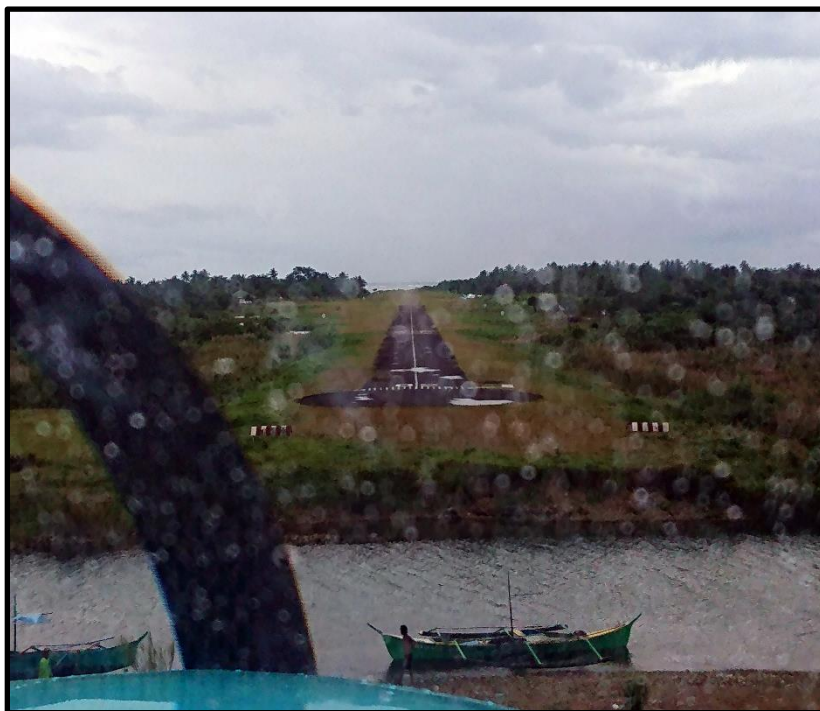
Maconacon Municipality is in charge of running the ACME airstrip, also known as Maconacon Airstrip. The airport used to serve general aviation flights for ACME Plywood & Veneer Co., Inc., in the area of Maconacon, Cagayan Valley, Isabela. One of the most remote and isolated communities in the province is Maconacon, which is located apart from the rest of the province by the Sierra Madre Mountains. It is classified as a municipality aerodrome by the Civil Aviation Authority of the Philippines (CAAP), which is responsible for overseeing the operation of airports in the Philippines. The Aerodrome and Air Navigation Safety Oversight Office (CAAP-AANSOO) carried out an initial assessment of the airstrip on December 15–16, 2015. The concerned operator needs to address any deficiencies found during the activity. However, in consideration of the efforts made by the aerodrome operator regarding the said findings, the airstrip was issued a probationary permit-to-operate (PTO). In a letter to the city mayor by CAAP dated November 27, 2017, it stated that it would implement the municipality action plan. This permit was extended until May 15, 2018. However, over time, the municipality was unable to comply with the Manual of Standards (MOS) for aerodromes, and no further action was reported to CAAP-AANSOO.

Figure 5. Finals at ACME airstrip runway 02.

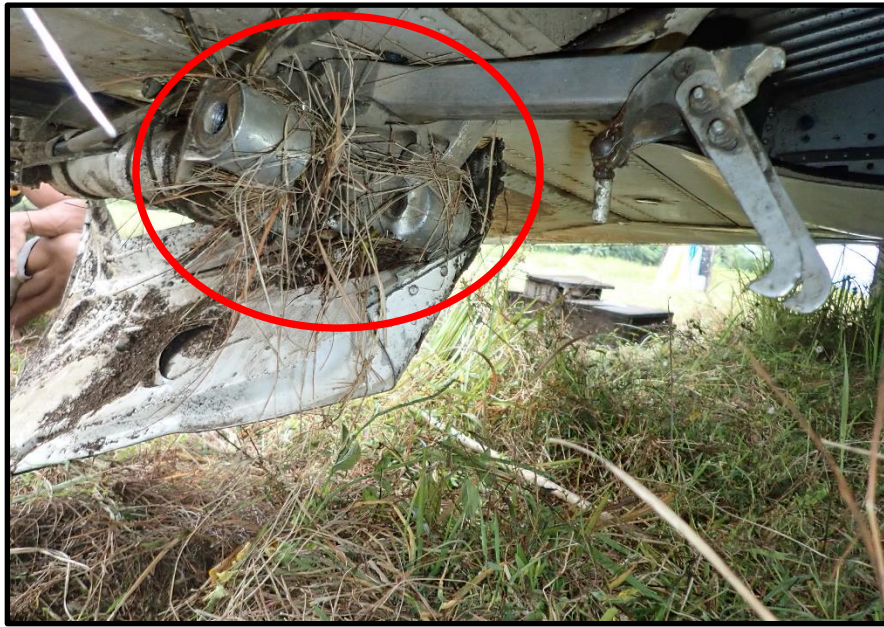
When the damaged landing gear was inspected, it was found that the RMLG shaft pin was missing and had broken off (Figure 6). This pin is part of the linkage for the RMLG strut assembly extension/retraction component. The torque tube was still connected to the extension/retraction component linkage.

Figure 6. Missing RMLG Shaft Pin.

Following the investigation, it appears that the material fatigue on the RMLG shaft pin and main landing gear fork bolt assembly were not noticed. The crack continued to progress until the material l fails.

The FAA issued Airworthiness Directive (AD) Schedule Aeroplanes DCA/CESS402/5 Cessna 402, 402B and 402C Series dated 31 May 2018 (Appendix 2). This AD applies to all model of Cessna 402 Series and to all serial numbers under FAA Type Certificate No. A7CE. Whereas, it is to replace the main landing gear fork bolts at intervals not exceeding 2000 hours TIS, except that bolts having more than 1800 hours TIS shall be replaced within next 200 hours TIS.

This airworthiness directive was issued to the operators to address the fatigue issues. The operator carried out inspections to the landing gear system but was not aware of the said AD as such it was not implemented.

- a. Strictly adhere to all Airworthiness Directives prior to the issuance of Certificate of Airworthiness.
- b. Has adequate maintenance program.

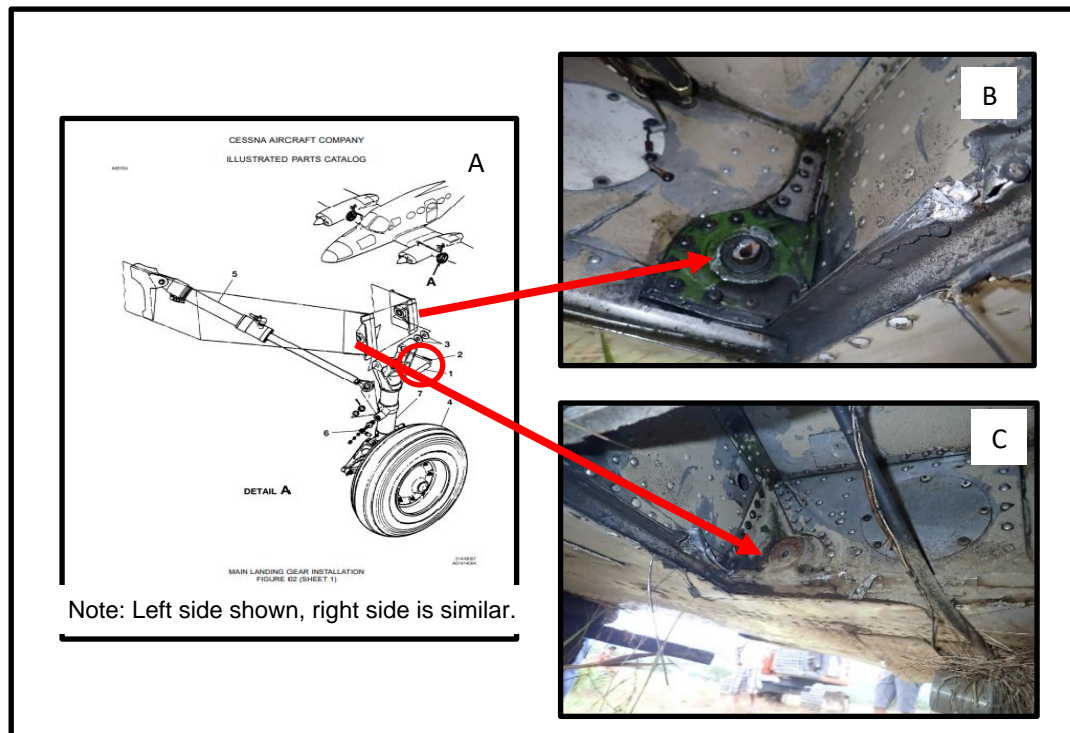
The shaft pin from the RMLG extension/retraction assembly linkage was missing, the right main landing gear's tube bolts were disconnected, and the landing gear was separated from its support frame (Figure 7). The RMLG strut extension/retraction assembly linkage, on the other hand, was discovered to have fully extended and to have remained in place. Furthermore, when it skidded on the runway, the RMLG assembly remained attached to the structure because the landing gear door covered it.

Figure 7. RMLG detached from its support.
