FINAL REPORT

RP-C9076
CESSNA 152

TITLE: Serious incident involving a Textron Aviation Inc., Cessna 152 type of aircraft with registry number RP-C9076 owned and operated by Orient Aviation Corp. that had a runway excursion at Cauayan Airport, Barangay San Fermin, Cauayan, Isabela, Philippines, on February 18, 2022 at about 1230H.

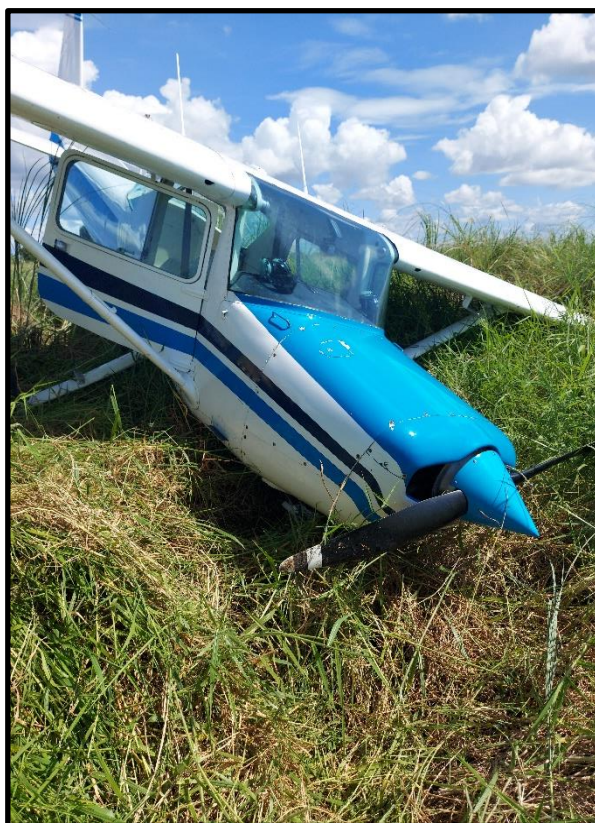
Figure 1. The aircraft final resting point.

After veering towards the right-hand side of runway 12, the aircraft came to a complete stop on the grassy area approximately 30 meters from the runway edge, with a final heading of 218° and coordinates of 16° 55' 52.9032" N, 121° 45' 0.0072" E (Figure 1). The aircraft incurred around 16 inches of damage from the tip of the propeller (Figure 2) and 1.5 x 2.5 inches of cracks on the leading edge of the left-hand wing tip (Figure 3).

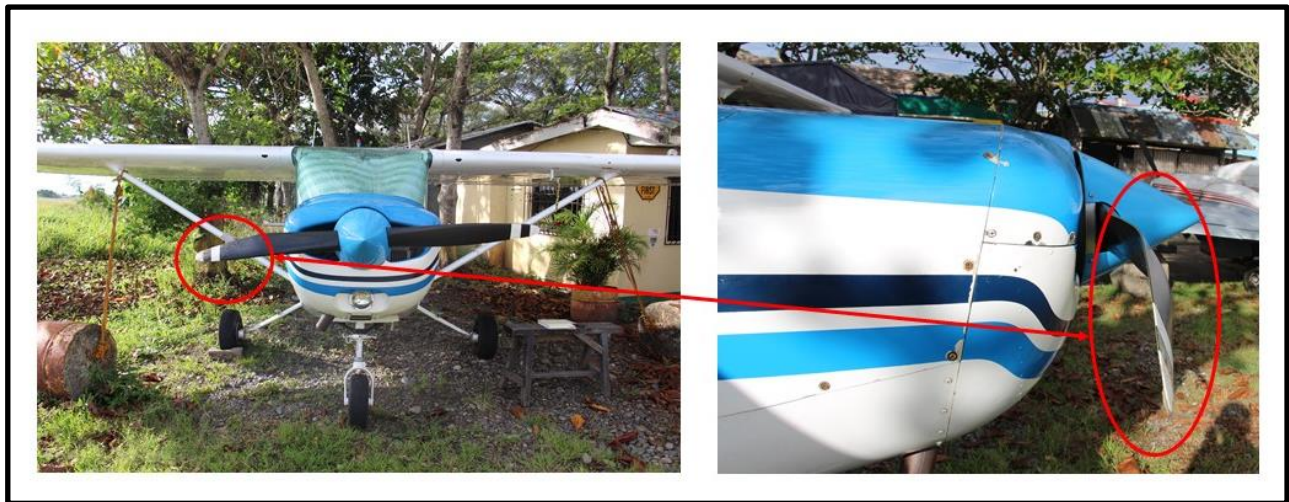
Figure 2 - Propeller damage

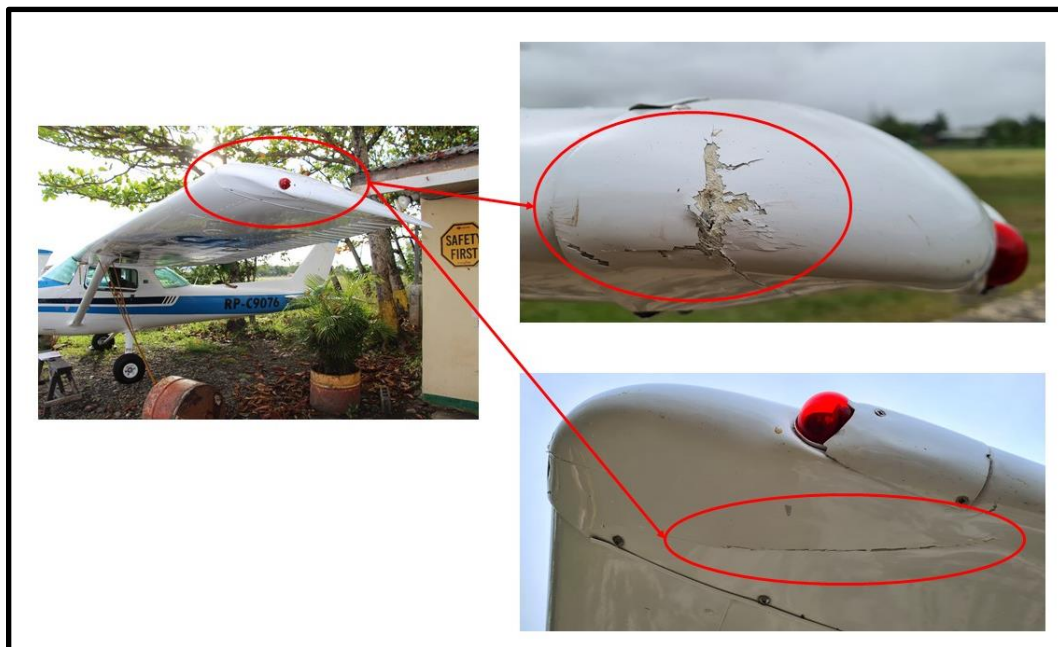
Figure 3- Left-hand wing tip damage
