FINAL REPORT

RP-R2018 **THRUSH AIRCRAFT S2R-T34**

TITLE: Serious incident involving a Thrush S2R-T34 type of aircraft with Registry Number RP-R2018, operated by Airwolf Aviation Corporation had a runway excursion upon landing at Runway 36 of Dapco Airstrip, Panabo, Davao del Norte, Philippines on June 26, 2023, at around 0728H.

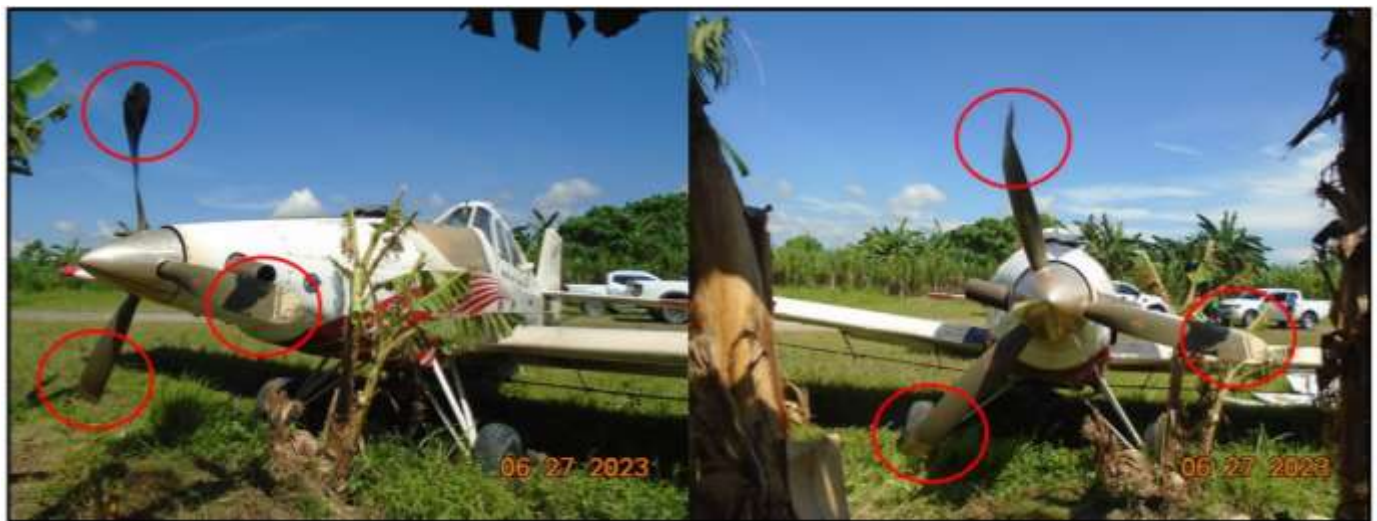
The aircraft incurred minor damage (Figure 1).

Figure 1 – Bended propeller due to propeller strike.

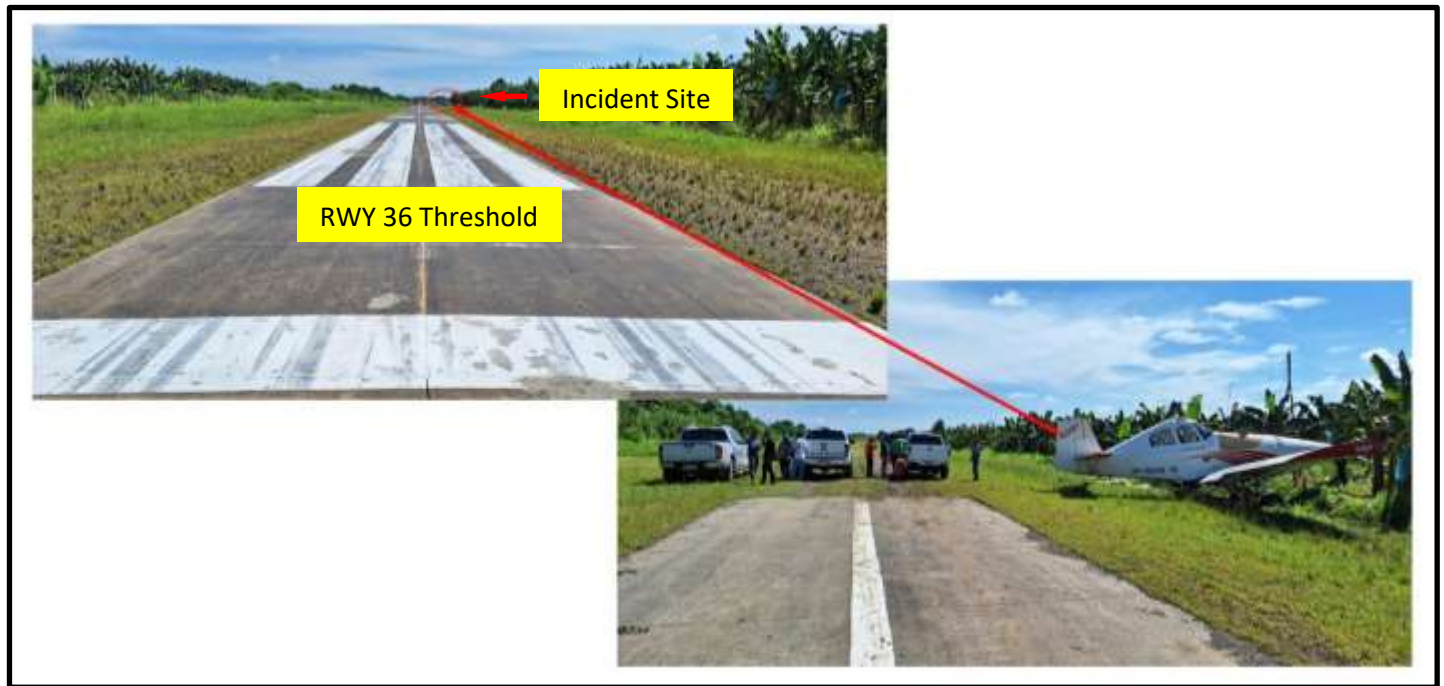
The aircraft final resting point was recorded at coordinates 7° 22' 51.3" N, 125° 35' 15.4" E and with a final heading of 117°. The location is approximately 285 meters from the threshold

Based on observed tire marks, the aircraft exited the runway around 231 meters from the threshold.

Figure 2 – Location of the aircraft from runway 36 threshold area.

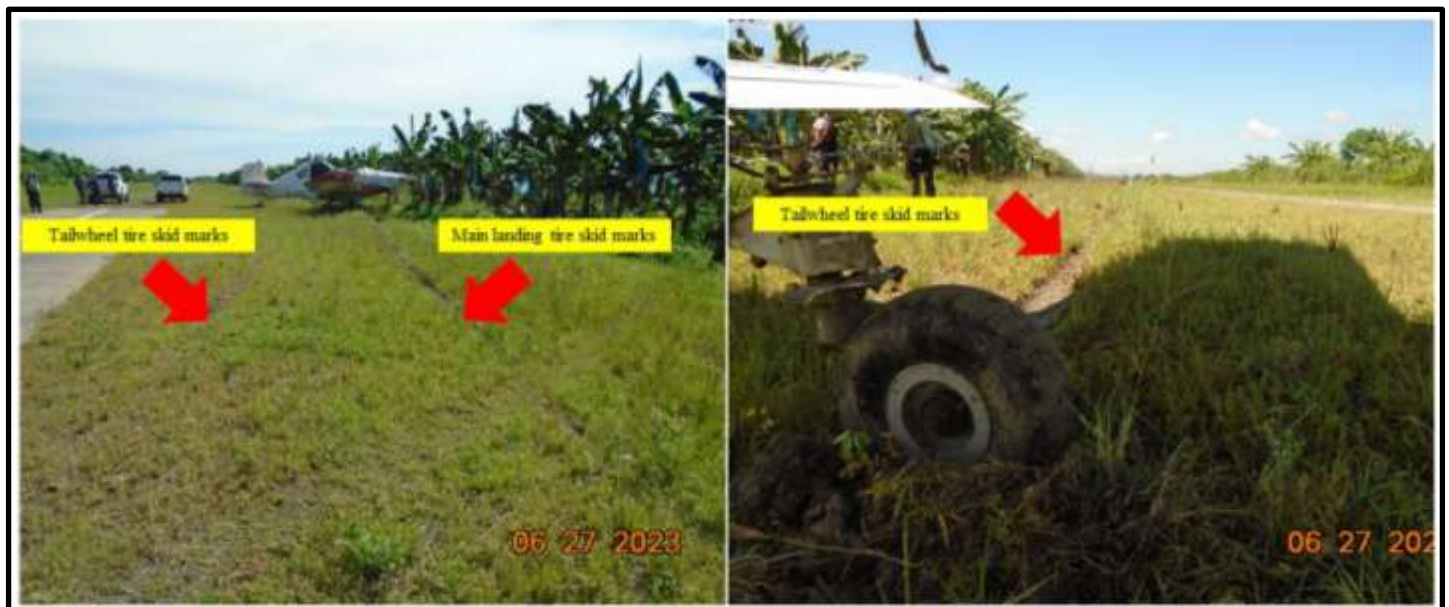
- a. Evidence of some braking actions can be observed on the paved portion of the runway and on the soft ground located on its right-hand side;
- b. The only notable damage on the aircraft was the bent propeller blades that struck the concrete perimeter fence post located on the right-hand side of the runway strip.

Figure 3 – Evidence of tire skid marks on the soft ground adjacent the runway.

At the incident site, investigators noted tire marks indicating that the brakes were applied when the aircraft began to veer. However, the number of marks did not confirm that the brakes were applied repeatedly or consistently, as the pilot mentioned during his interview. There were only about two instances of significant tire pressure marks on the ground, indicating braking action along the aircraft's path.

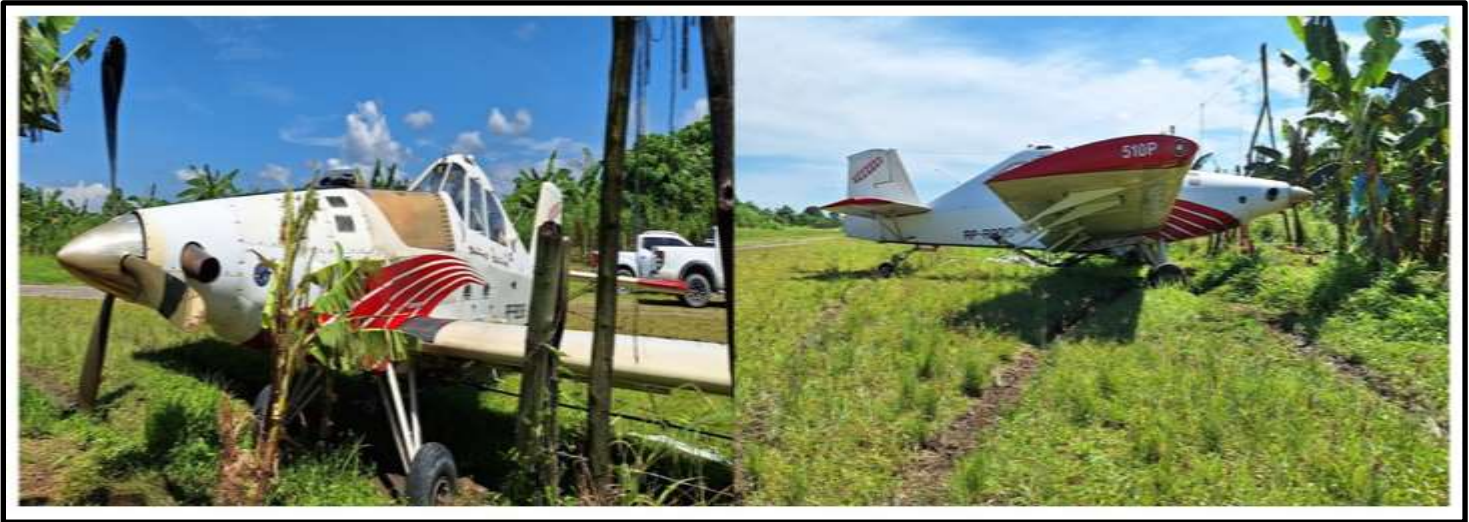
Figure 4 – The aircraft at its final stopping point.
