Republic of the Philippines
CIVIL AVIATION AUTHORITY OF THE PHILIPPINES

AIRCRAFT ACCIDENT INVESTIGATION AND INQUIRY BOARD

FINAL REPORT

RP-C8798
C152

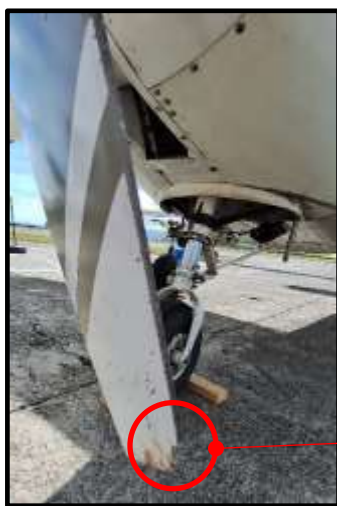
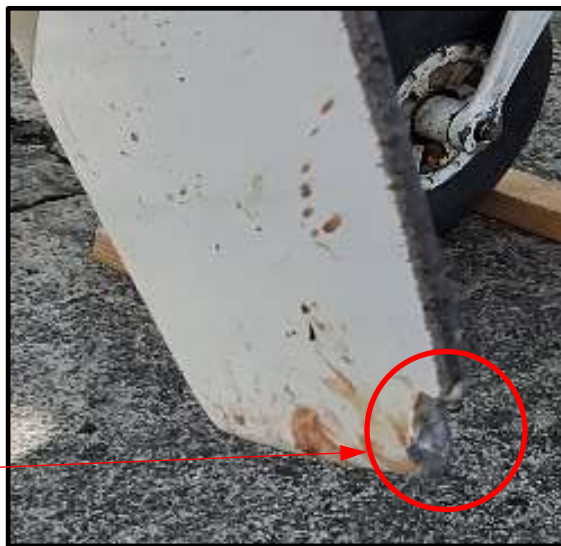
Figures 1 and 2 – Damage (nick) noted on the aircraft propeller.

The accident occurred while the aircraft was stationary at a full stop on the ramp. Minor surface damage, characterized by small nicks, was observed on the propeller. The airframe sustained no damage. The only point of contact was between the rotating propeller and the student pilot. No additional impact evidence or wreckage was identified at the scene.

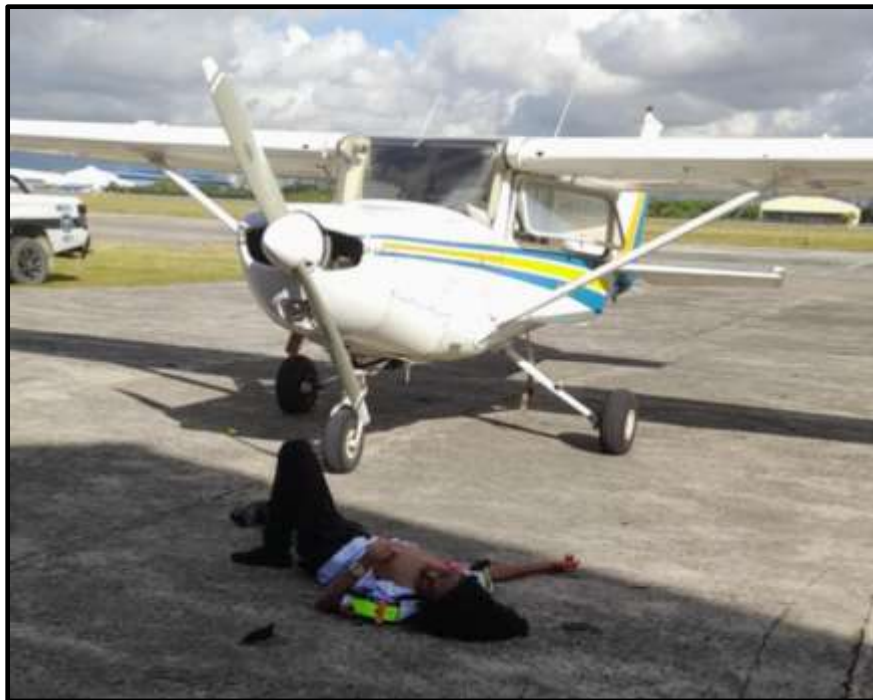
Figure 3 – The student pilot after being hit by the propeller.
