AIRCRAFT ACCIDENT INVESTIGATION AND INQUIRY BOARD

FINAL REPORT

RP-C1789
TECNAM P2006T

TITLE: Incident involving a Tecnam P2006T type of aircraft with registry number RP-C1789 owned and operated by All Asia Aviation Academy that had a gear-up landing resulting to Runway Excursion at Iba Community Airport, Iba, Zambales, on November 22, 2022 at about 1555H/0755 UTC.

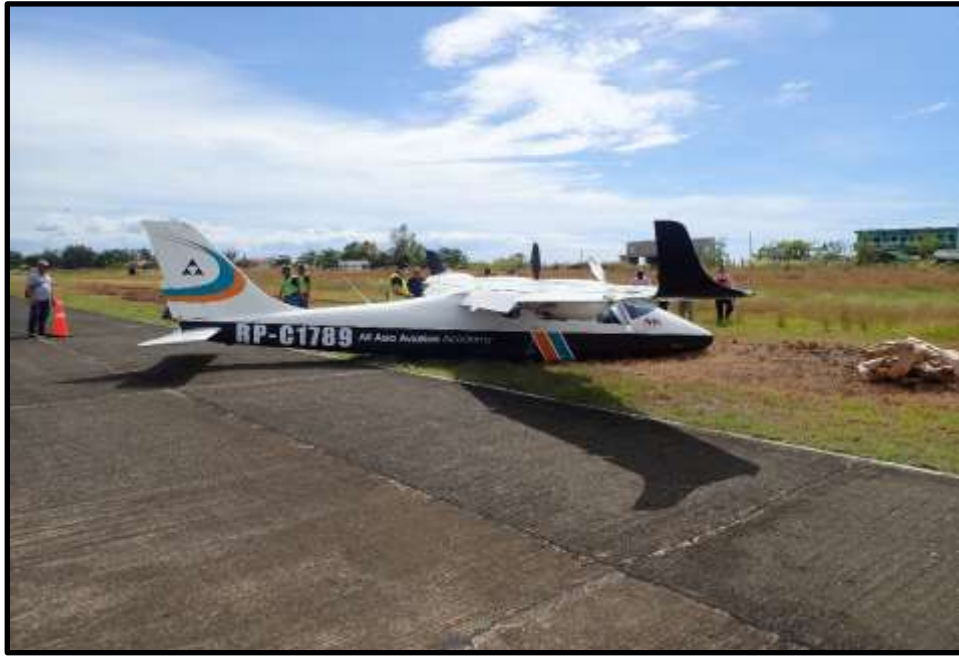
After finishing eight (8) touches and gos, the crew executed a “go-around” over Runway (RWY) 14 of Iba Community Airport due to the presence of a stray dog on the runway as seen by the pilots. Additionally, in anticipation of the closing of operations at the airport at 1600H/ 0800UTC, the FI commanded the FI trainee to perform a short pattern approach. However, during the approach, the crew failed to extend the aircraft's landing gears before touching down. The aircraft touched down 250 meters after the threshold of runway 14 and continued to move forward for another 160 meters directly over the runway centerline, then started to veer off to the right, creating runway scars and dents underneath the aircraft fuselage. The aircraft entered the grassy portion of the runway and stopped ninety-five (95) meters before the number #2 runway 14 marker, approximately 475 meters from the threshold of runway 14 with coordinates 15°19'32.43"N 119°58'6.59"E and a heading of 260 degrees (Figure 1).

Figure 1: The aircraft at its final resting point.

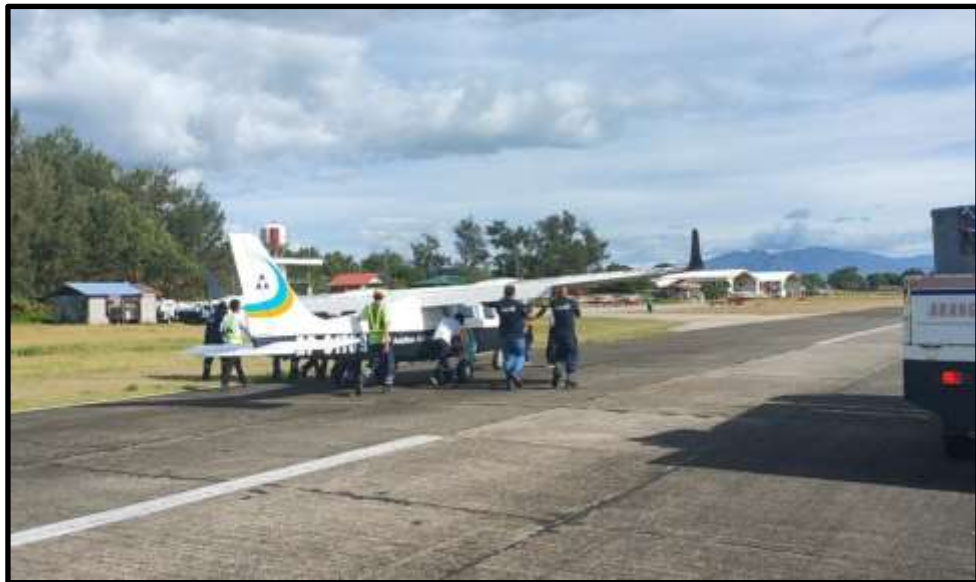
Figure 2: The aircraft was relocated to the hangar.

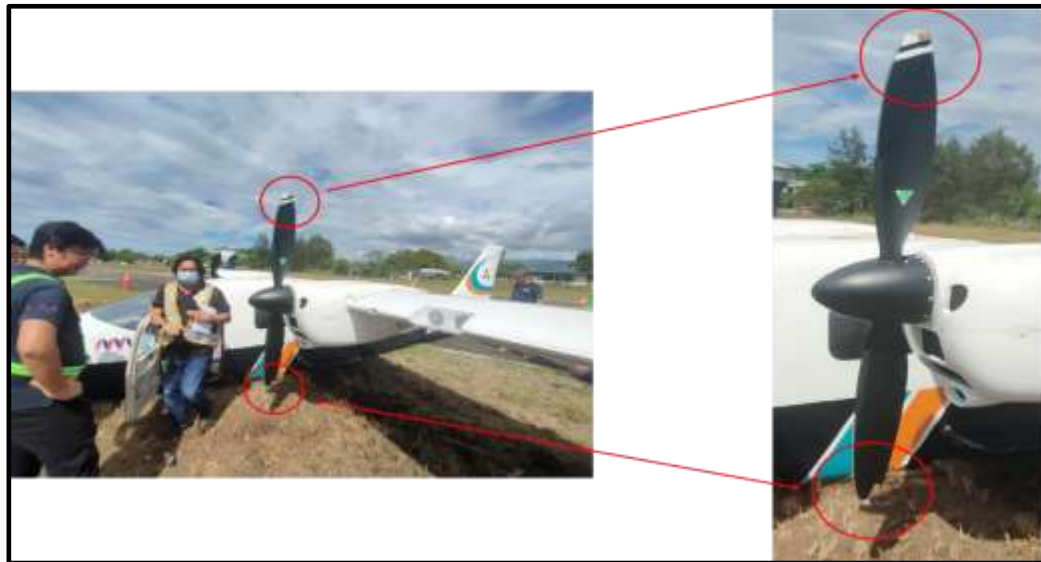
The aircraft sustained damage on the blade tip of the left-hand propeller assembly; impact damage on the left wing approximately one (1) meter from the tips; damage on the DME, ADF, transponder, and Com-1 radio antennas; and deep scars and dents underneath the aircraft fuselage.

Figure 3: Propeller damage

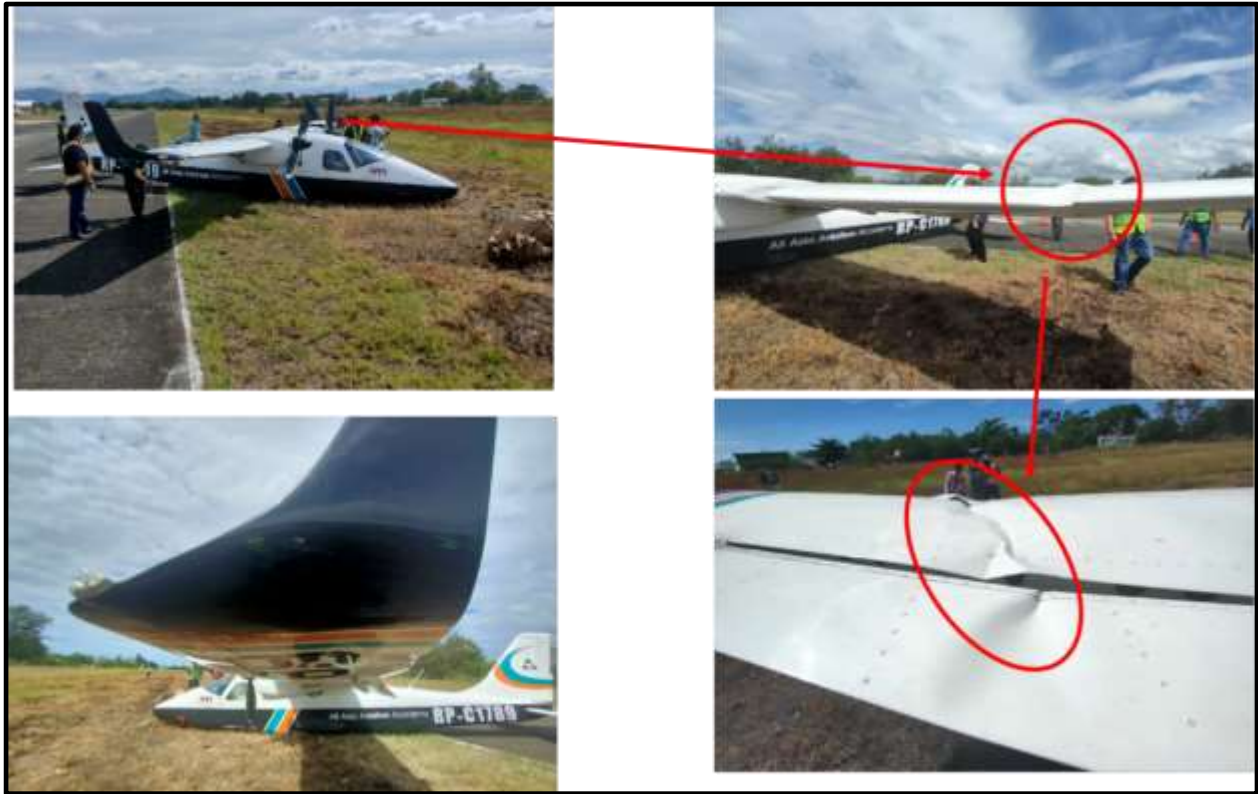
Figure 4: left wing damage

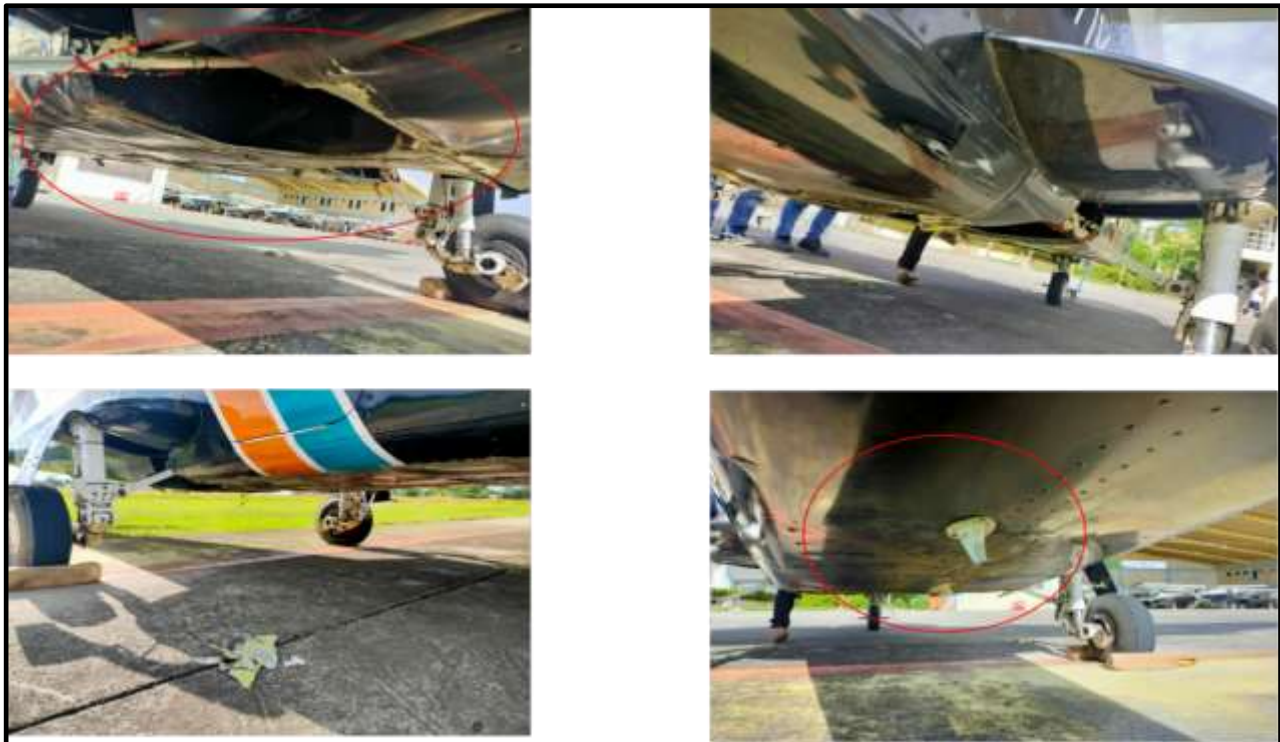
The aircraft touched down 250 meters after the threshold of runway 14 and continued to move forward for another 160 meters directly over the runway centerline, then started to veer off to the right, creating runway scars and dents underneath the aircraft fuselage. The aircraft entered the grassy portion of the runway and stopped ninety-five (95) meters before the number #2 runway 14 marker, approximately 475 meters from the threshold of runway 14 with coordinates 15°19'32.43"N 119°58'6.59"E and a heading of 260 degrees. The aircraft incurred serious damage on the tip of its left-hand propeller (Figure 3); serious dents on the left-side leading edge and aileron (Figure 4); and deep scars on the aircraft's belly or under carriage with damaged communication and navigation antennas (Figure 5).

Figure 5: fuselage/antenna damage.
