FINAL REPORT

RP-C2205
ARCHER II, PA-28-181

***PLACE OF OCCURRENCE: RUNWAY 06, SKY HAWK AIRPARK, TUY,
BATANGAS, PHILIPPINES***

TITLE: An incident involving a Piper Aircraft Inc., Archer II, PA-28-181 type of aircraft with Registry Number RP-C2205 operated by FAST Aviation Academy, Inc., that had a runway incursion at Runway 06 at Sky Hawk Airpark, Tuy, Batangas, Philippines, on January 16, 2021 at about 1604H/0804 UTC.

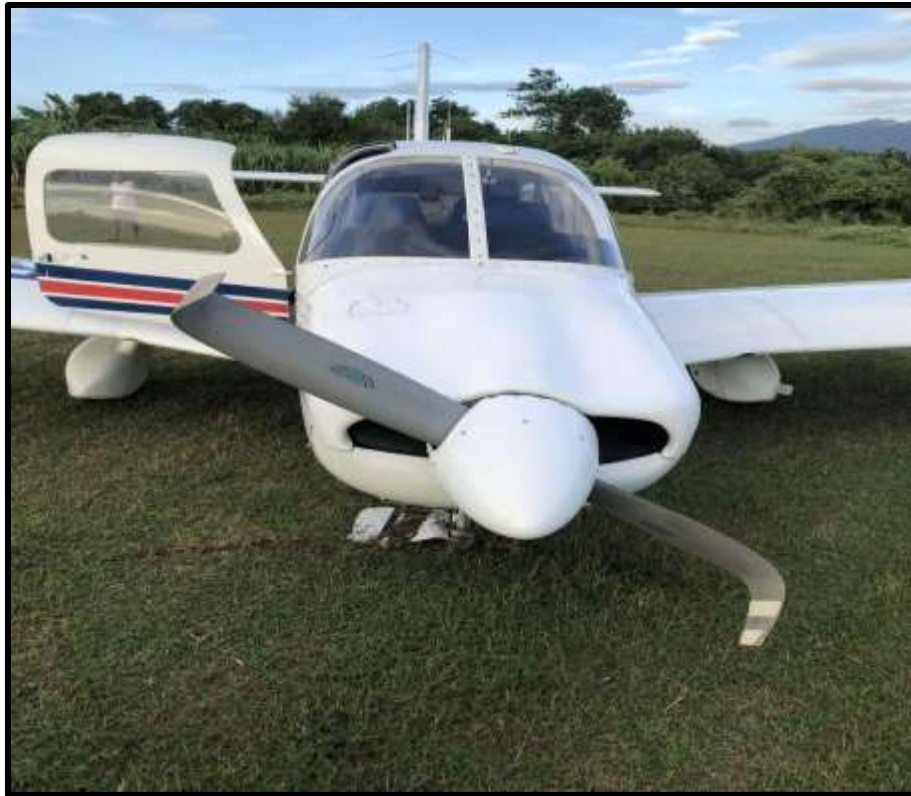
The pilot during the take-off run noticed a person riding a bicycle crossing the runway. The pilot aborted the take-off and applied maximum brakes to stop the aircraft, however the aircraft veered towards the left side of the runway. While maneuvering the aircraft back to the center of the runway, the aircraft propeller came in contact with the ground. The nose landing gear was also detached when it collided with the cemented end portion of the runway threshold. The aircraft came to a full stop and settled in an upright position with the aircraft final point is located at coordinates 14°0'58.99" N, 120°44'18.80" E and heading approximately 200 degrees.

Figure 1. The aircraft at its final resting point.

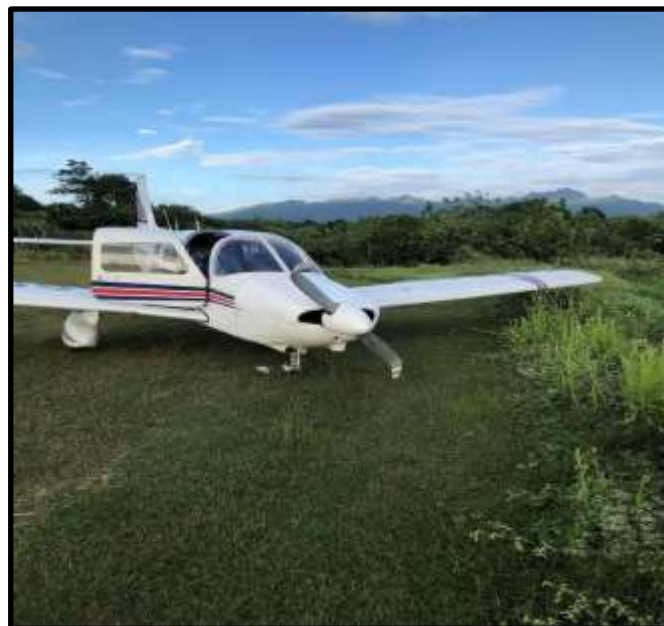
While maneuvering the aircraft for safety, the aircraft propeller came in contact with the ground. The nose landing gear was detached when it collided with the cemented end portion of the runway threshold. The aircraft came to a full stop and settled in an upright position with the aircraft final point is located at coordinates 14°0'58.99" N, 120°44'18.80" E and heading approximately 200 degrees.

Figure 2: The aircraft with damaged NLG and propeller

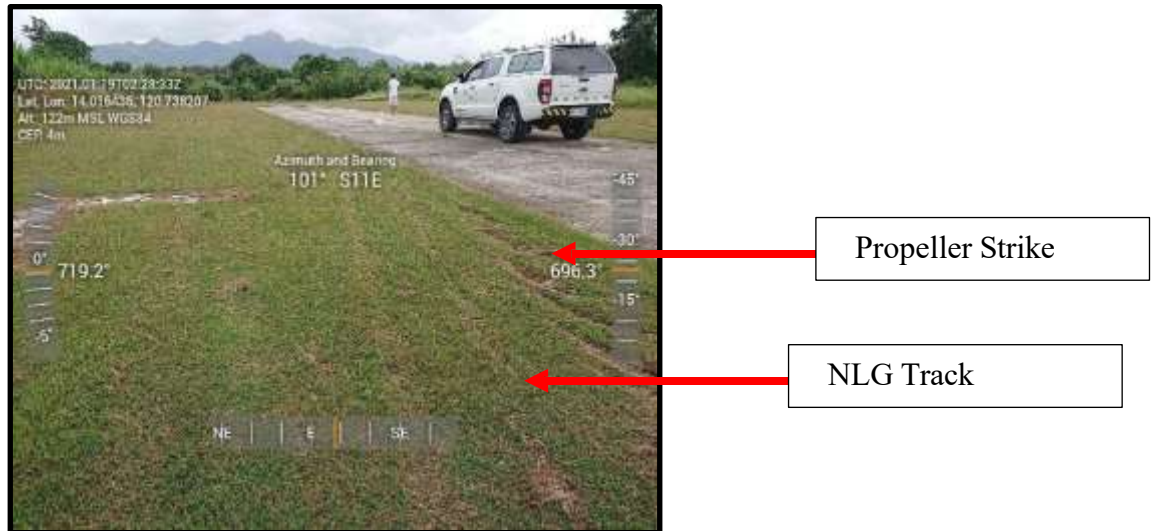
The pilot during the incident performed the general procedure for a rejected takeoff where the pilot set: Power Idle, Maintain Directional Control, Maximum Necessary Braking. There are a few things that the pilot should take into consideration when performing "maximum necessary braking." When the aircraft near rotation speed, there isn't much weight on the tires, because the wings are generating lift. It's easier to lose directional control if the pilot is aggressive on the brakes during a rejected takeoff. In this case, the Pilot aggressive brake application on the grass runway, reaching the declination and uneven parts of the runway surface tends to agitate the aircraft movement incurring propeller strike. The nose landing gear (NLG) collided with the runway concrete surface while skidding towards the right side. The NLG assembly was detached as a result of the collision.

Figure 3: Wheel tracks entering the concrete part of the runway

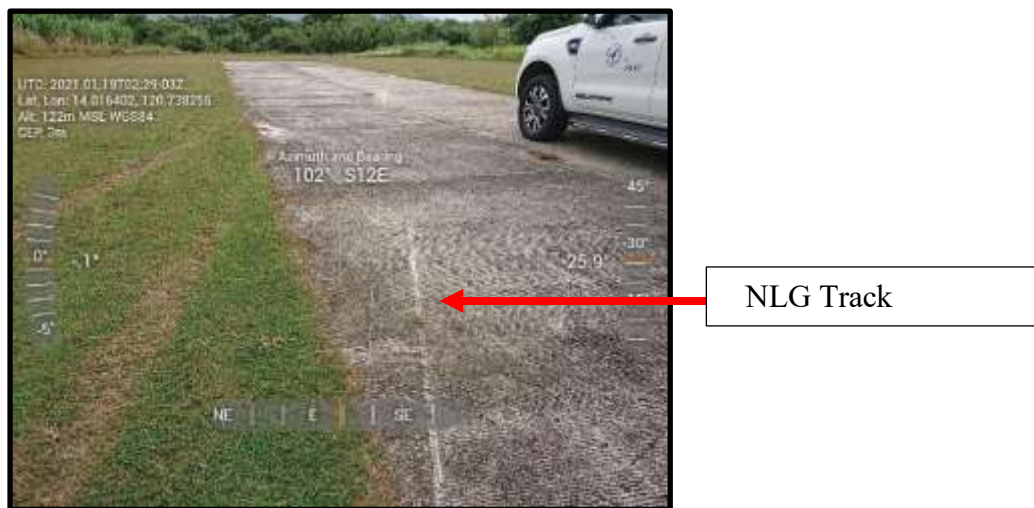
Figure 4: NLG scrape marks on the runway
