FINAL REPORT

RP-C979
TEXTRON AIRCRAFT INC. CESSNA U206B

TITLE: An incident involving a Textron Aircraft Inc. Cessna U206B type of aircraft with Registry Number RP-C979 operated by Batanes Islands Air Services Incorporated (BIASI) that had a taxiway excursion at Subic Bay International Airport (RPLB), Subic Bay Metropolitan Authority, Free Port Zone, Zambales, Philippines on June 3, 2021 at about 1115H/0315UTC.

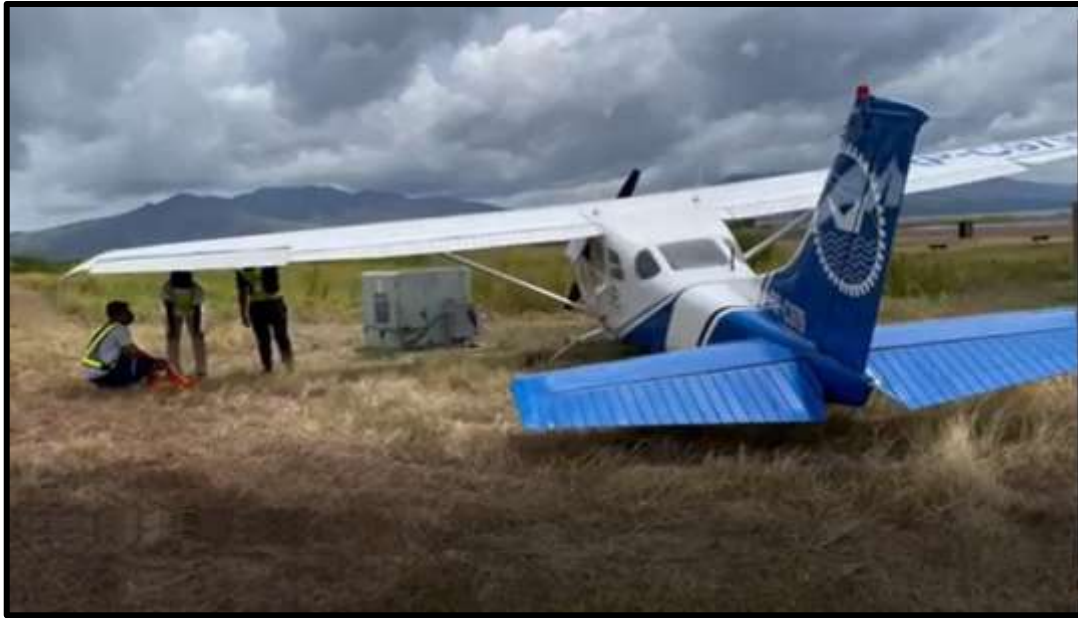
The aircraft was observed by air traffic controller to have turned left towards the grassy portion of the taxiway. The aircraft left main landing gear fell into a dug-out dirt which stopped the aircraft from further movement. The air traffic controller dispatched Crash Fire Rescue (CFR) units to help and secure the aircraft. The aircraft settled on its final position with heading of 270 degrees and coordinates 14.797316 N 120.281258 E. Subic Bay International Airport Closed Circuit Television Camera (CCTV) recorded the event.

Figure 1. The aircraft at its final resting point.

The aircraft was not damaged but due to the speed of the aircraft which made it uncontrollable it went out to the grassy portion of the runway. The aircraft left main landing gear fell on a dug-out dirt which stopped the aircraft from further movement, it then settled about ten (10) meters from the edge of the taxiway.

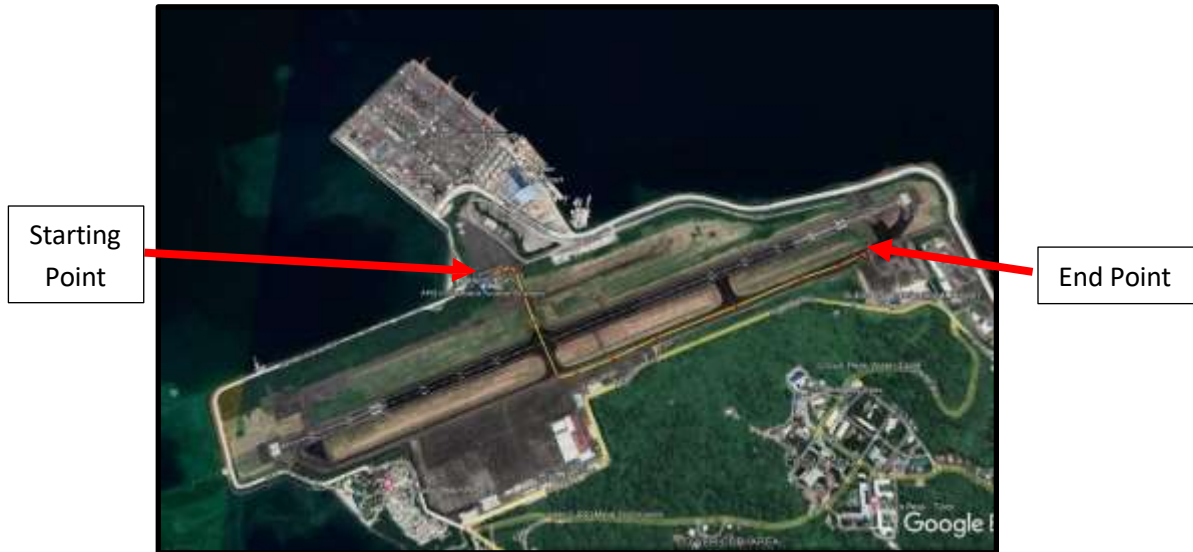
Figure 2. The yellow line is the aircraft path to its final resting point at RPLB.

Witnesses on the ground stated that about 1115H, the aircraft was observed to have suddenly turned left towards the grassy portion of the taxiway. The left main landing gear fell in a dug-out dirt which stopped the aircraft from further movement. The air traffic controller dispatched Crash Fire Rescue (CFR) units to help and secure the aircraft. Review of the document shows that the aircraft and pilot's documentation are in proper order. There were no significant remarks listed on the aircraft logbook before the occurrence. Subic Bay International Airport Closed Circuit Television Camera (CCTV) recorded the event and shows that the aircraft was moving faster than the expected taxi speed. Taxiing way above the taxi speed resulted to the aircraft being uncontrollable.

- 4.1 CAAP-FSIS** to ensure that the Operator strictly adhere to the SOP and POH operational guidelines to manage and execute appropriate aircraft speed while taxiing.

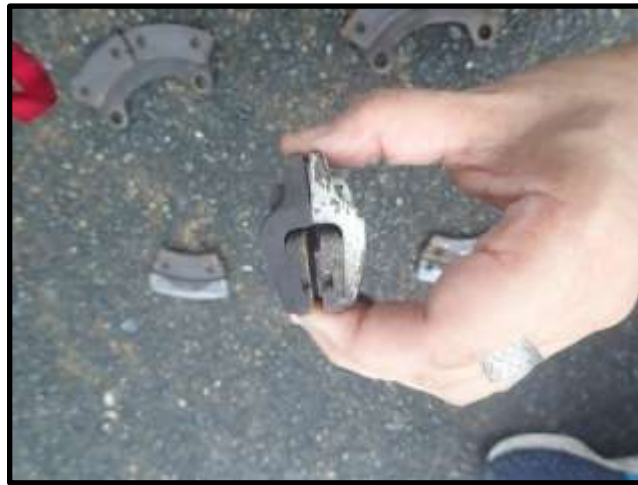
During the course of the investigation, the main landing gears brake pad were inspected. It revealed that the aircraft left side main landing gear brake pad is thinner than the right side. Based on the submitted documents, a record reflects servicing of the landing gears performed last February 3, 2020 with satisfactory remarks by the AMO.

Figure 2. The aircraft left side main landing gear brake pad is thinner than the right side.
