AIRCRAFT ACCIDENT INVESTIGATION AND INQUIRY BOARD

FINAL REPORT

RP-C1030
CESSNA152

TITLE: Incident involving a Textron Aviation Inc., Cessna 152 type of aircraft with Registry Number RP-C1030 operated by WCC Aviation Company that had forced landing due to engine mechanical failure at Barangay Pilar, Sta. Cruz, Ilocos Sur, Philippines, on February 12, 2020 at about 0900H/0100 UTC.

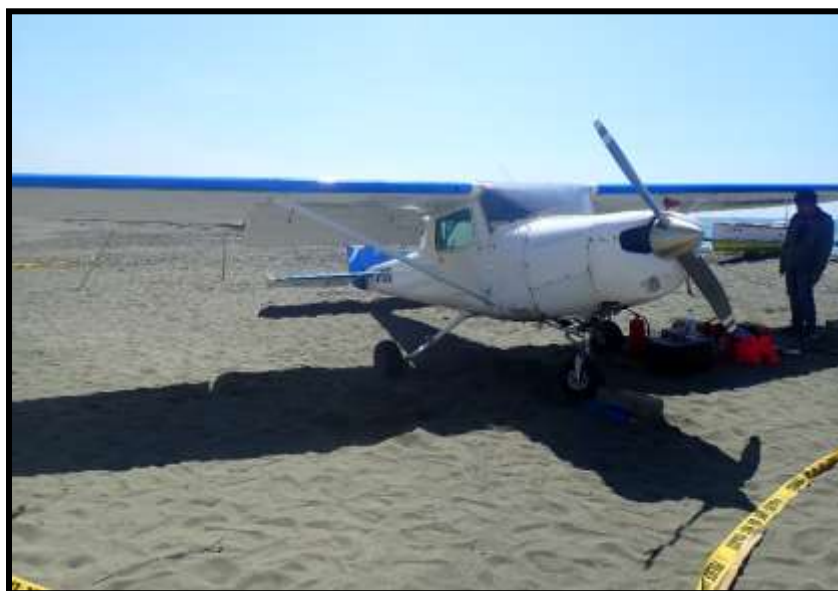
Figure 1. RP-C1030 at its final resting point.

The FI took control of the aircraft and discovered a forced landing area on the shoreline of Sta. Cruz, Ilocos Sur. During the landing roll, about one hundred (100) meters from the touchdown point, the aircraft nose landing gear (NLG) hit a drift wood and subsequently fractured the NLG arm assembly and steering bolt. The aircraft continued to roll for another thirty (30) meters, scrapping the beach with its propeller. The lower engine mounted to the firewall bolts were bent due to the NLG impact. The aircraft came to a complete stop, with the final resting point located at coordinates 17°4'31.86"N, 120°26'17.00"E and heading approximately north. The occupants then immediately performed engine shutdown procedures and alighted the aircraft with no injuries. No fire ensued. The barangay duty personnel and some fishermen on site immediately arrived to assist in securing the aircraft.

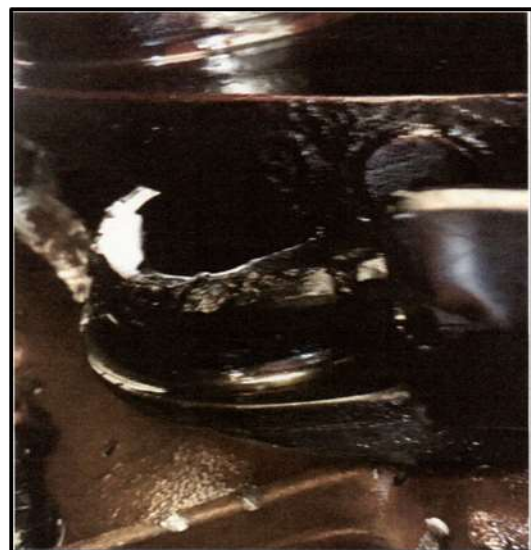
The engine teardown highlights the damage to cylinder #4's piston (Figure 2). The cylinder #3 was also damaged and its connecting rod big end cap bolt was broken (Figure 3). Additionally, the crankshaft was broken too (Figure 4). The connecting rod of cylinder #3 impacted the crankcase resulting to a hole above the oil sump. The misalignment between the cylinder and its rod resulted to the connecting rod becoming stuck in place (Figure 5). Assorted debris of engine materials were collected on the oil sump (Figure 6). The hole was measured roughly about seven point seventy-eight (7.78) centimeters (Figure 7). Hence result of the engine teardown on which the crankshaft was broken substantiated that the engine could not perform normal operation.

Figure 3. Cylinder #3.

- a. The failure of the cylinder #3 connecting rod big end cap bolt resulted to a sudden stoppage of the engine. (Material Factor).

- a. To ensure that the operator, WCC Aviation Company, include in the company policy and procedures manual the procedures for Cessna 152 pilots when breaking in a new propeller model, such as the Sensenich 72CK556-0-54.
- b. To ensure that the operator, WCC Aviation Company, install an operating placard in the cockpit to provide essential safety information and warnings to the pilot regarding the operation and limitations of the aircraft.

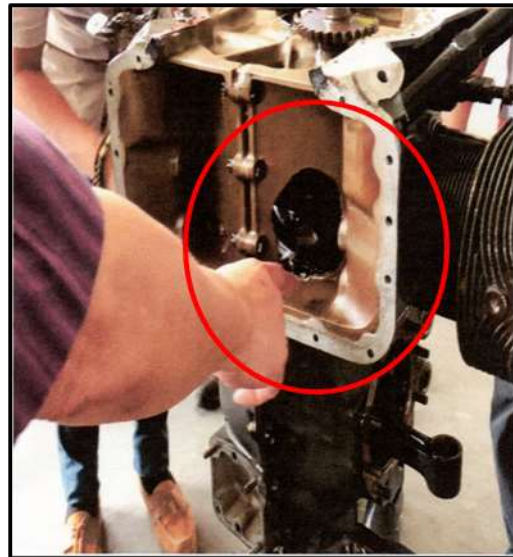
Figure 7. The hole in the crankcase
