## **AIRCRAFT ACCIDENT INVESTIGATION AND INQUIRY BOARD**

### **FINAL REPORT**

**RP-C3515**  
**CESSNA C172S**

**TITLE:** Incident involving a Cessna 172S type of aircraft with Registry Number RP-C3515 operated by AAGICAT that had a runway excursion incident at Iba Community Airport, Iba, Zambales, Philippines, on March 6, 2020/1500H.

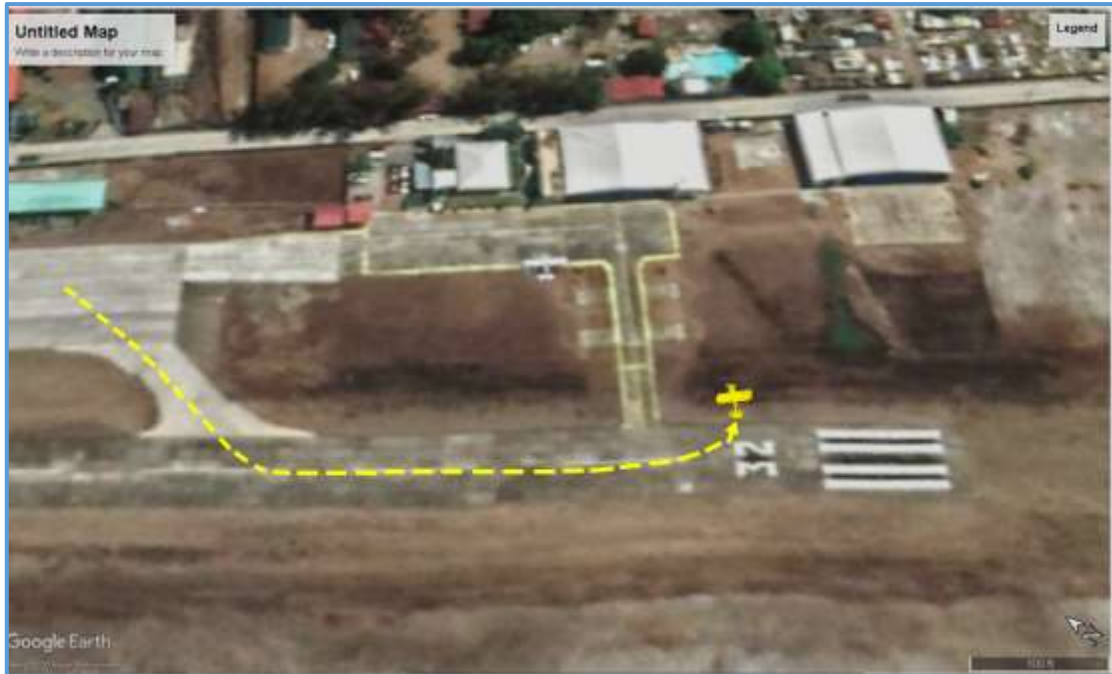
Figure 1. Approximate aircraft track

After performing three (3) touch and go landing (TGL) maneuvers the FI and SP made a full stop at Iba Airport Ramp. They again taxi out for runway 32 departure to perform another TGL maneuver. while turning to the left prior to executing a 180 degree turn for take-off on RWY 32, the aircraft continued to roll towards the left side of the runway. The wheels departed the pavement and came to complete stop in a soft ground about 4 meters from the runway edge (main wheels) with last heading of 39 degrees. Both occupants egress safely after performing engine shutdown procedure. Visual Meteorological Condition (VMC) prevailed at the time of the event. Wind was reported to be at 290 degrees at 6 knots.

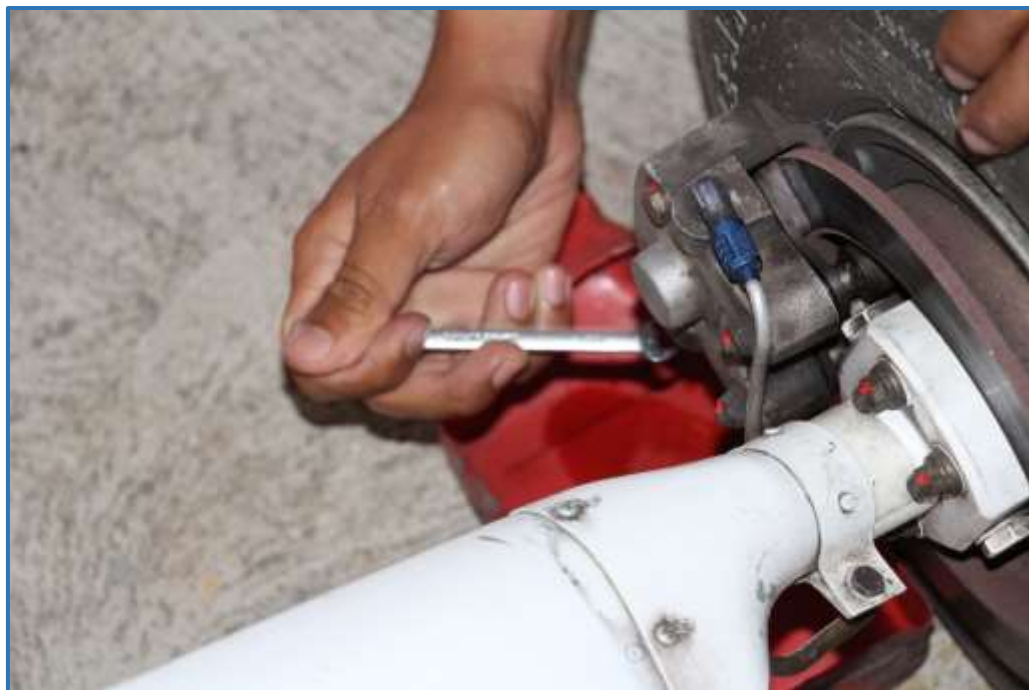
Figure 2: RH brake hydraulic bleeding

Inspection on the RH wheel brake system did not indicate any leaks that may cause the brake to fail. Additionally, brake pedal pressure test conducted disclosed normal and even brake pressure on both RH and LH pedals. Brake bleeding was also performed on RH hydraulic brake system to determine the presence of any air bubbles that may cause momentary loss of braking capability, however, it yielded negative result.

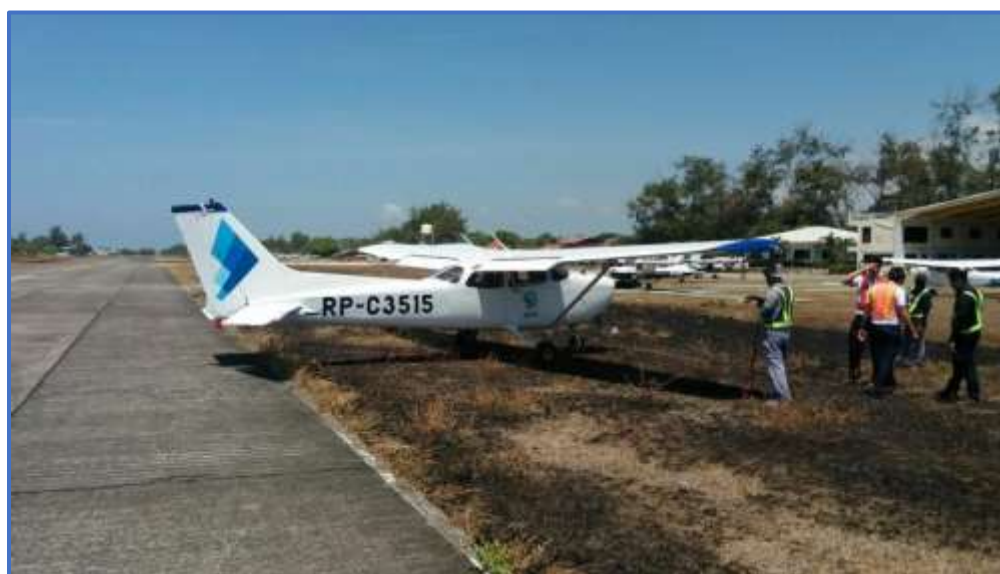
Figure 3: Aircraft's final resting position

On March 6, 2020, about 1155H local time, a Cessna, C-172S type of aircraft with Registry Number RP-3515, was taxiing for another departure after a stop and go landing at Iba Community Airport, Iba Zambales on board was a Flight Instructor (FI) and Student Pilot (SP). With the SP in the controls, while turning to the left prior to executing a 180 degree turn for take-off on RWY 32, the aircraft continued to roll towards the left side of the runway. The SP applied the brakes to stop the aircraft but it continued to move towards the left side of the runway. The FI took over the controls however the aircraft continued to roll towards the left side of the runway. The wheels departed the pavement and came to complete stop in a soft ground about 4 meters from the runway edge (main wheels) with last heading of 39 degrees (Figure 2).

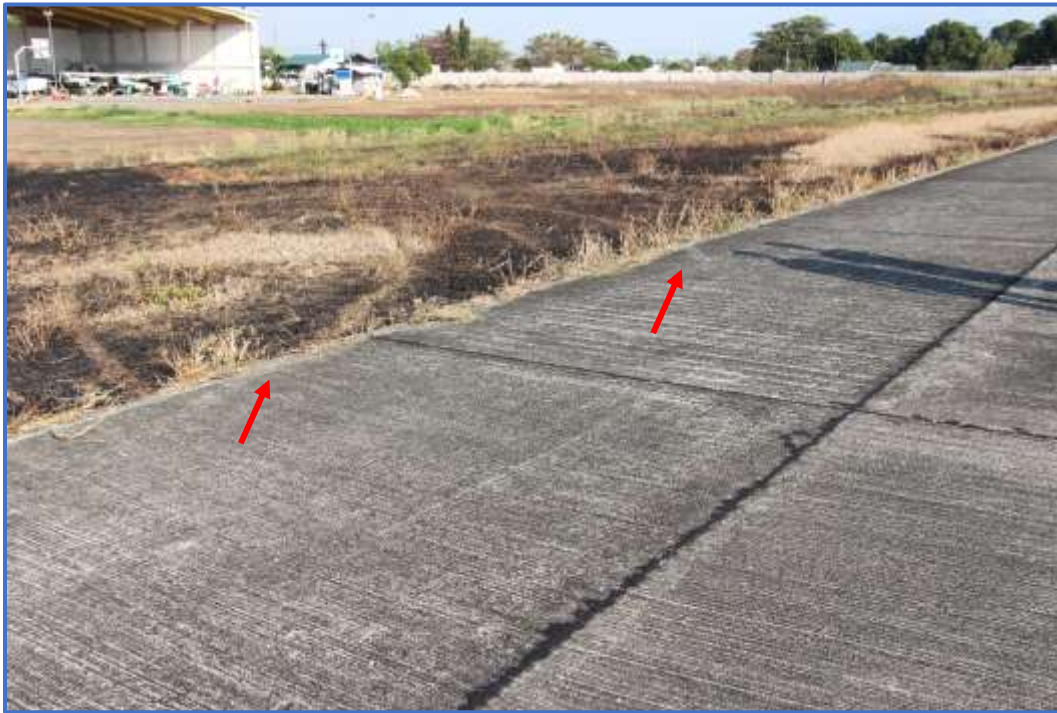
Figure 4. RH & LH Main wheels tire marks

According to the witnesses, they observe that the aircraft was on high-speed taxi when it entered the active runway and continue until it started to perform 180 degrees turn. The FI and SP also confirmed that they were fast or above the usual taxi speed at that time. Tire marks from RH and LH main wheels were also observed from the runway just before it departed the pavement. It Appears that the SP applied brakes however, the aircraft continue to roll towards the soft ground. It also indicates that the brakes were functioning at the time of the occurrence (Figure 3).
