AIRCRAFT ACCIDENT INVESTIGATION AND INQUIRY BOARD

FINAL REPORT

RP-C3521
CESSNA C172S

TITLE: Incident involving a Textron Aviation Inc., Cessna, C-172S type of aircraft with Registry Number RP-C3521 owned and operated by AAG International Center for Aviation Training, that veered off the side of the runway at Iba Community Airport, Iba, Zambales, Philippines, on August 14, 2020/1500H.

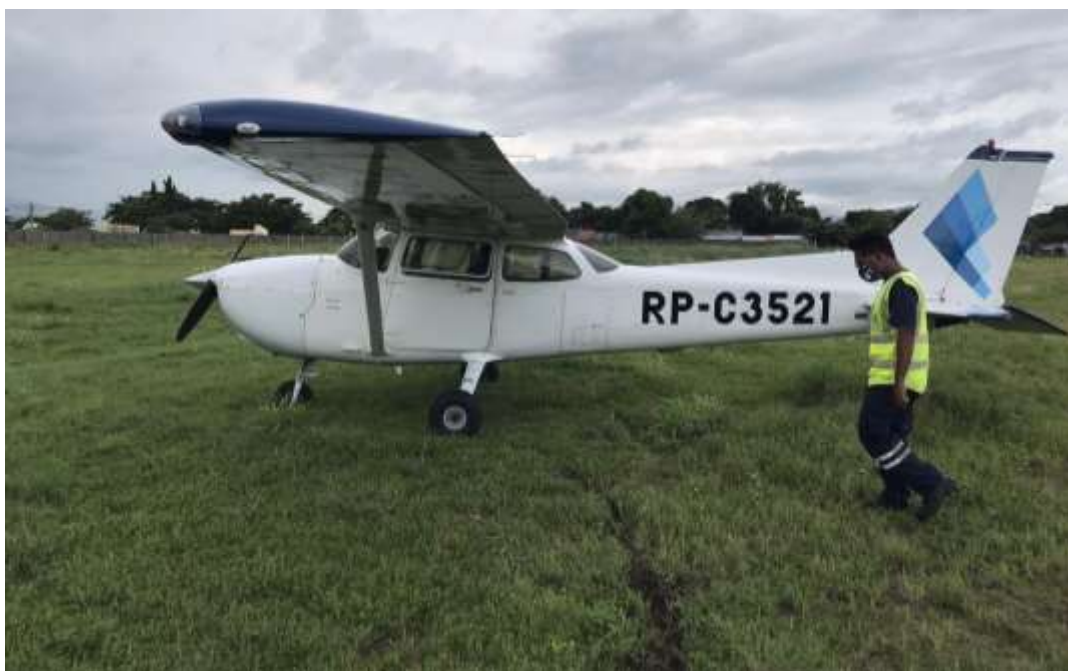
The aircraft while turning to the left prior executing a 180 degree turn for take-off on RWY 32, continued to roll towards the left side of the runway. The wheels departed the pavement and continued to roll for another 36 meters before it came to a full stop in a soft ground about 10 meters from the runway edge (main wheels) with last heading of 040 degrees and coordinates of 15 32.14 N, 119 97.11E. Review of the documents shows that the aircraft and pilot's documentation are in proper order. There were no significant remarks listed on the aircraft logbook before the incident.

Figure 1. Aircraft's final resting point
